SUMMARY EVALUATION,
CORRECTIVE OPTIONS,
AND ESTIMATED CORRECTIVE COSTS

ALASKA STATE
CAPITOL

Juneau, AK.

Date: 2/20/13

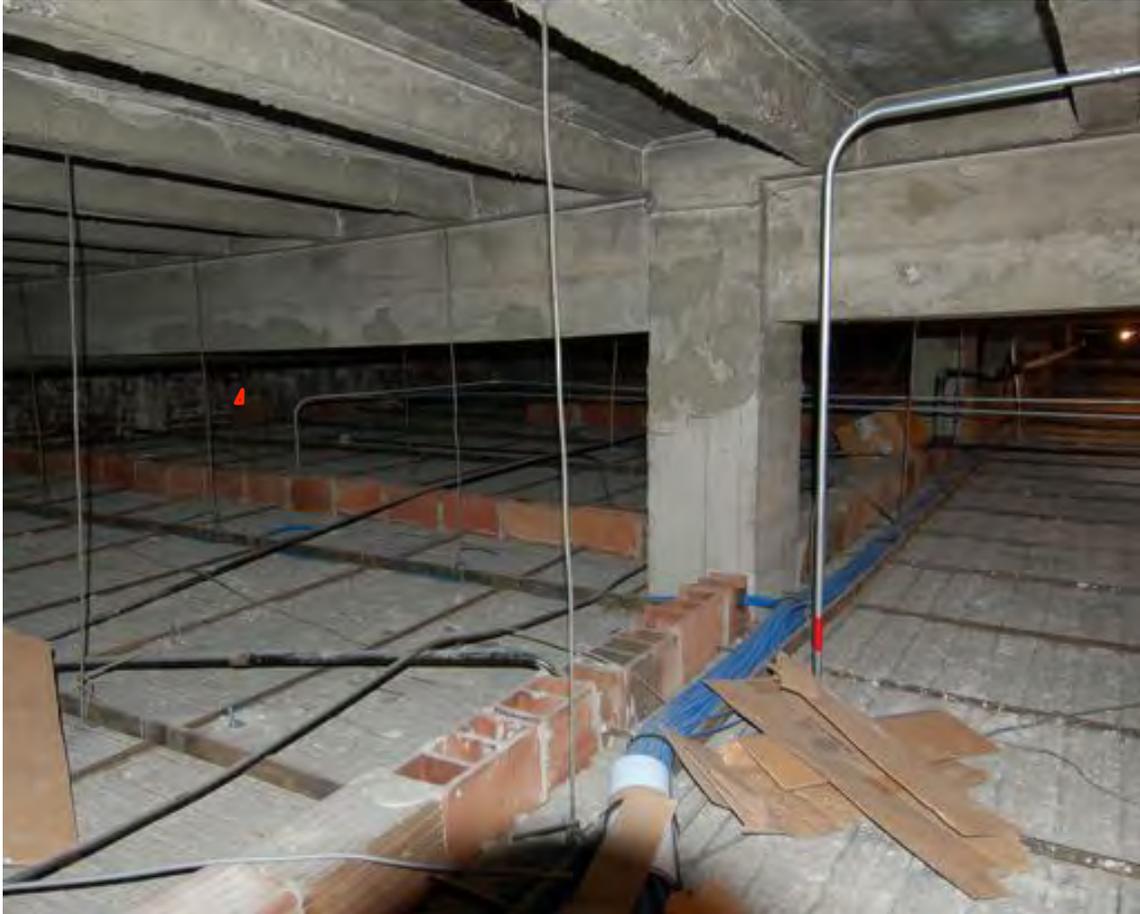
Many interior partition walls consist of 4" or 6" hollow clay tile, with plaster or other finishes applied over these. In many locations, these heavy partition walls do not extend to the underside of the concrete floor slabs or beams above them, and stop above the ceilings, with no connections to the upper floor slabs. Figure II-2.7(1) shows a typical example of this condition.

Fig. II-2.7(1): Un-Secured, Un-Braced Tops of Hollow Clay Tile Walls

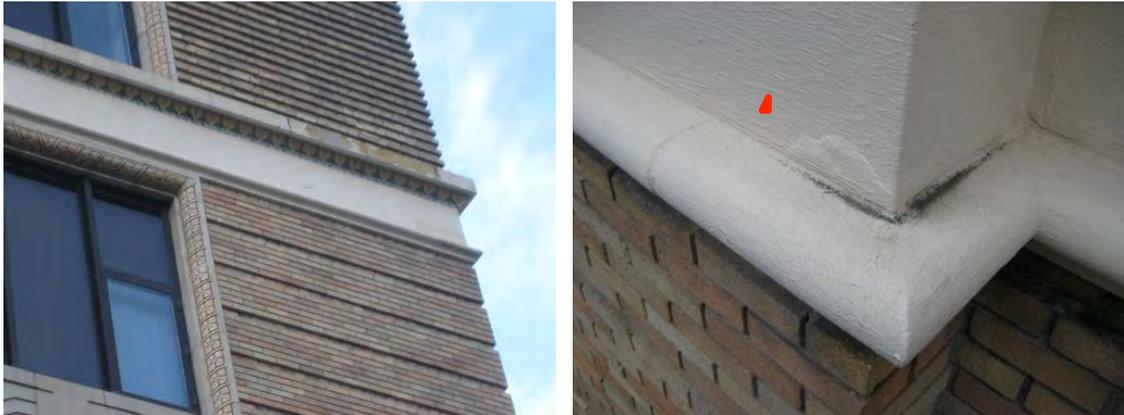
Similarly, the condition of the flat-panel terra-cotta band below the water table is also variable, though in general, this band displays notably lesser degradation, with only a few areas fully spalled-off and fewer areas of incipient spalling. In one location on the north side of the east wing, rust staining exiting a crack in this band indicates that corrosion is occurring behind this panel. Figures II-4.3(17-20) illustrate these observations.

Fig. II-4.3(17): Middle Band in Decent Cond. Fig. II-4.3(18): Incipient Spalling

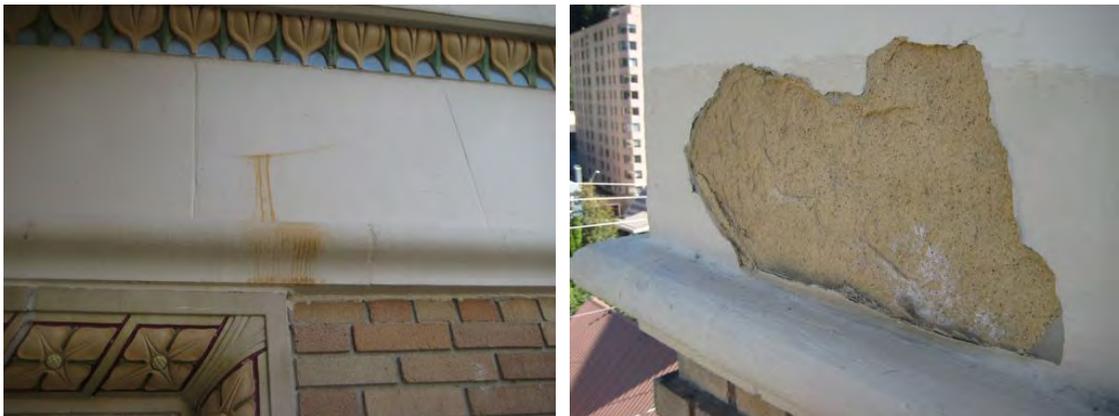
Fig. II-4.3(19): Corrosion Exiting Mid. Band Fig. II-4.3(20): Serious Spalling

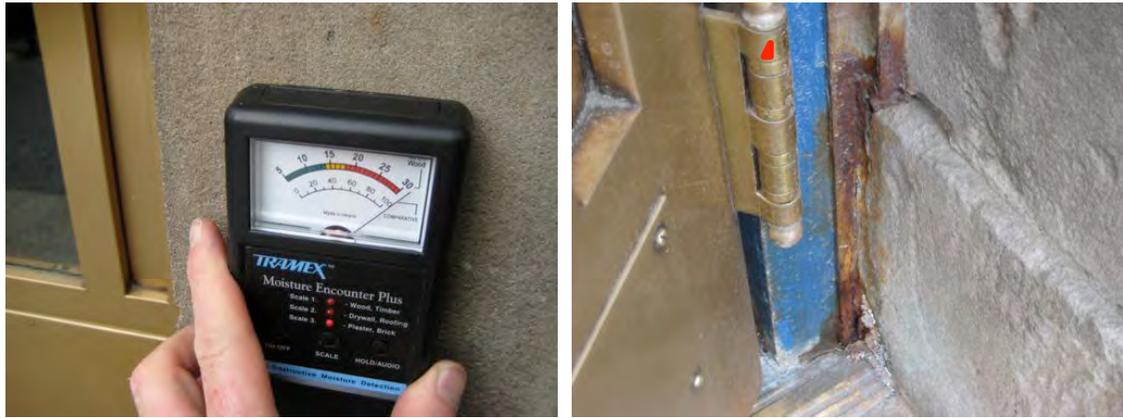
Fig. II-5.3(15): Moisture @ Sheltered Cldng. Fig. II-5.3(16): Shltrd. Jamb Corr.
