The Alaska State Capitol Building is a concrete-frame structure built in 1930. Its exterior skin consists of a multitude of masonry elements, extruded aluminum and steel sash windows, and EPDM and built-up asphaltic roofs. The building's exterior masonry elements include multi-wythe brick walls; terra-cotta claddings, water tables, and window surrounds; stone claddings, water tables, ceilings, and similar elements; marble columns and decorative panels; and granite cladding and paving at the entry. Small areas of stucco also occur near the building's upper reaches, in the back.

In 2012, PL:BECS was asked to assemble a team of specialized consultants who could perform a multidisciplinary evaluation of the entire structure, help determine recommended solutions, and provide very rough cost estimates for executing seemingly viable options. This report represents the culmination of this 3rd phase of this building's evaluation.

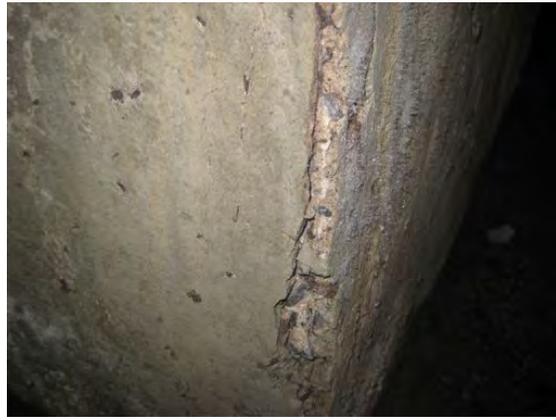
Fig. II-2.2(2): Concrete Spalling

The concrete spalling and efflorescence reflect degradation caused by moisture intrusion into the concrete. Some of the moisture enters the concrete from the damp atmosphere resulting from the running water within the crawl space. However, the specific pattern of the efflorescence on the concrete columns reveals that water also enters from the soils directly below the footings.

The surface spalling located away from steel reinforcing can result from freezing expansion of embedded water as well as through concentrated recrystallization of salts. Both mechanisms appear plausible, even probable, in this case.

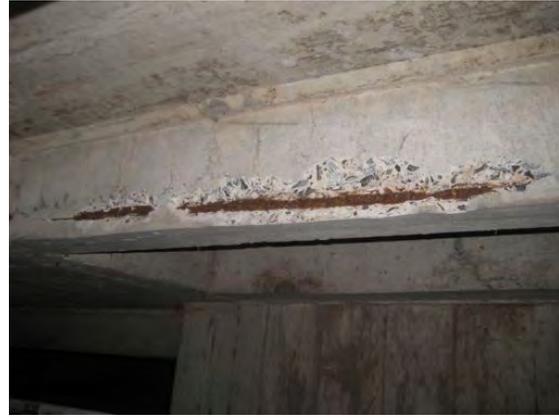
Fig. II-2.3(5): Spalling @ Joist Midspan

The concrete joist spalling reflects degradation caused by moisture intrusion. However, in contrast to the spalling affecting the foundations, the only moisture source reaching these joists consists of atmospheric humidity resulting from the wet crawl space.

The corrosive spalling of the concrete results from corrosion of the embedded reinforcing. As steel corrodes, it experiences large volumetric expansion, thus popping concrete off the surface.

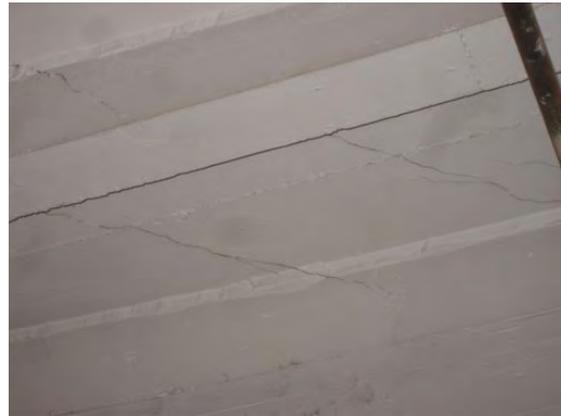
Fig. II-2.4(1): Straight Crack in Floor Slab

The straight crack across the west wing most likely occurs along a pour joint, where curing shrinkage would be expected to create such a crack. However, this crack is wider than one would expect from shrinkage alone, and it appears probable that it has been exacerbated by subsequent seismic displacement.

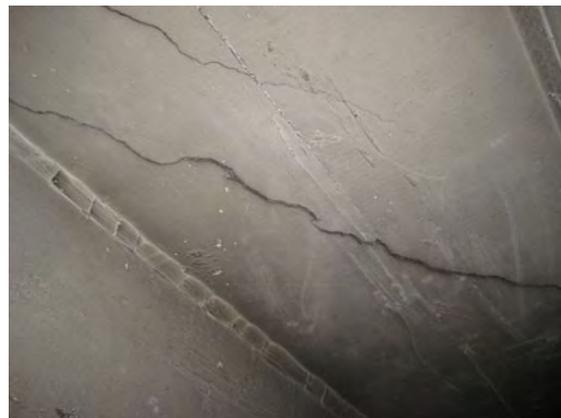
Fig. II-2.4(3): Diagonal Crack in Floor Slab

The diagonal cracks near the outer building corners cannot reflect curing shrinkage restraint, as these cracks are also typically far too wide, and often occur in closely spaced pairs. Shrinkage cracks would not occur closely spaced, as the initial crack would relieve any tensile stress, thus precluding the second crack from occurring. Due to their size, locations, and spacing, these cracks appear seismically induced.

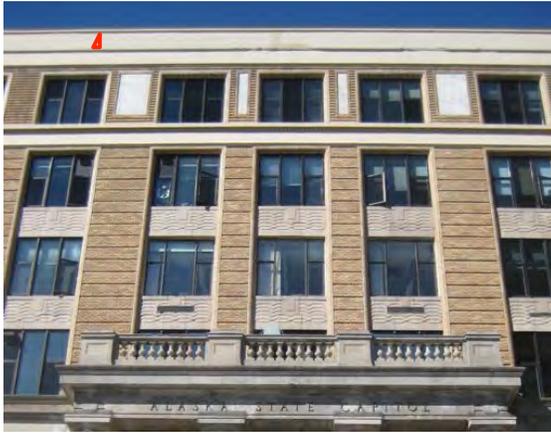
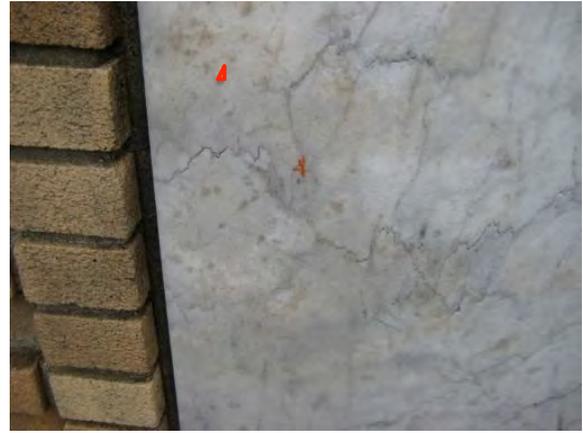
The large marble panels near the top of the south façade, directly above the portico, also do not appear to have any mechanical securement stipulated in the drawings, though some weak metal signals were detected in a few locations at some panels, indicating possible anchorage of some sort. Cracking observed at some panels may also indicate that these may be somewhat compromised. See Figures II-2.6(9 & 10).

Fig. II-2.6(9): Un-Secured, Marble Panels **Fig. II-2.6(10): Possible Small Anchor**

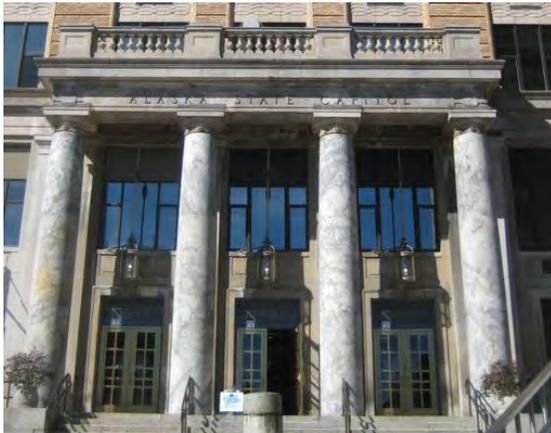
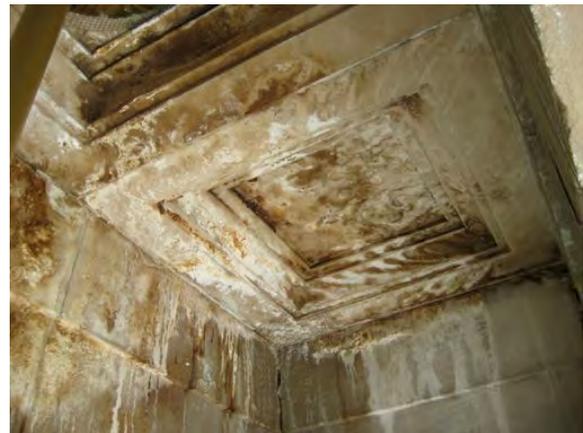
Some elements have a degree of mechanical securement, via steel dowels, straps, and similar methods, but such securement appears blatantly inadequate for holding these components in place under plausible seismic stresses. For example, the entire portico structure, which in totality weighs roughly 170 tons and consists of many individual stone elements, is secured to the primary structure with 7 or 8 small steel straps, each 2 ½” wide and ½” thick. These straps cannot resist lateral racking of the portico in the E-W direction, and the cracking pattern affecting the portico elements and the supporting stone cladding indicates that such racking had taken place. Further, though these straps, which are embedded within the portico ceiling, could not be examined, widespread staining on the portico ceiling indicates that these minimal straps have by now been largely compromised by corrosion. See Figures II-2.6(11-14).

Fig. II-2.6(11): Minimally Secured Portico **Fig. II-2.6(12): Water-Damaged Clg.**

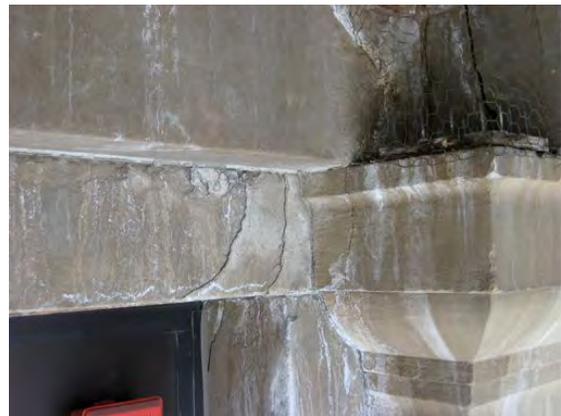
Fig. II-2.6(16): Cracked Stone Clng.

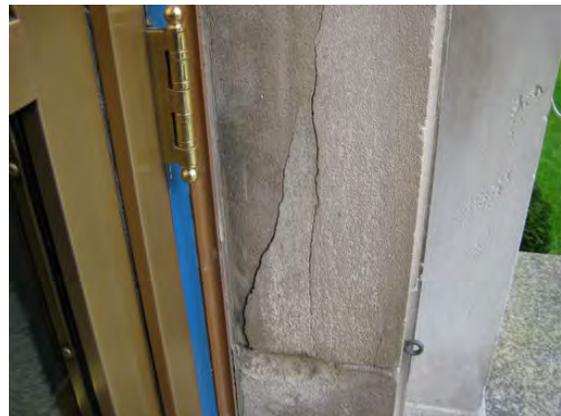
Fig. II-2.6(18): Cracked Stone Clng.

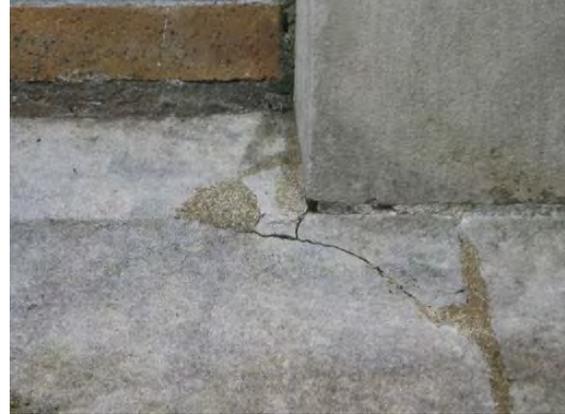
Fig. II-2.6(20): Cracks Near Anchor

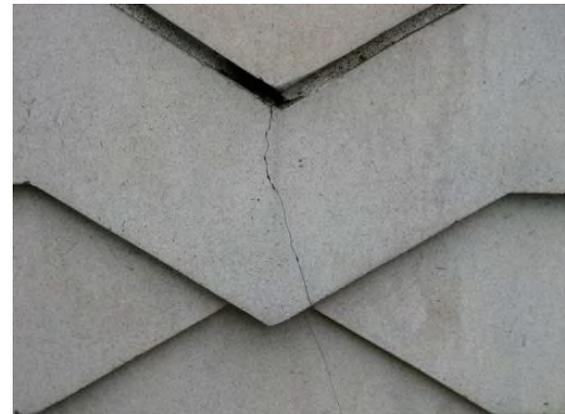
Fig. II-2.6(22): Crack Near Anchor

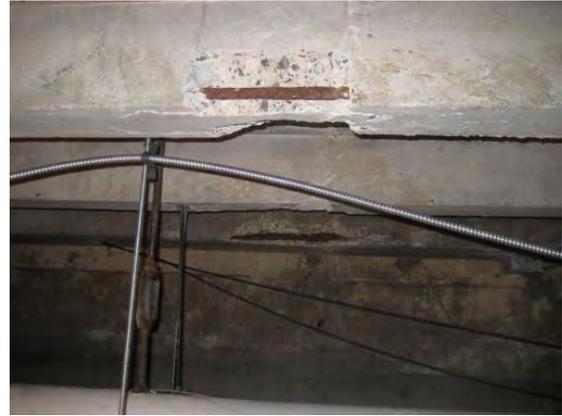
Fig. II-3.1(5): Spalling @ Joist Midspan

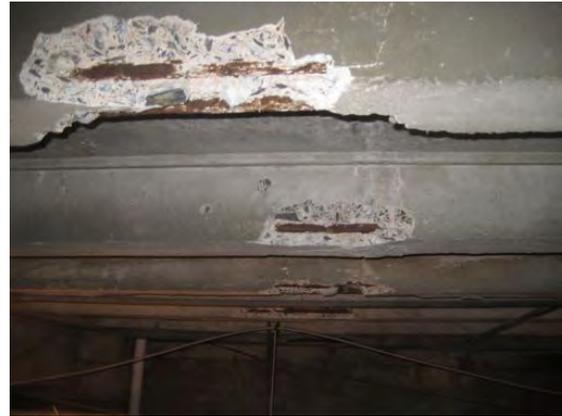
Fig. II-3.1(7): Spalling @ Joist Midspan

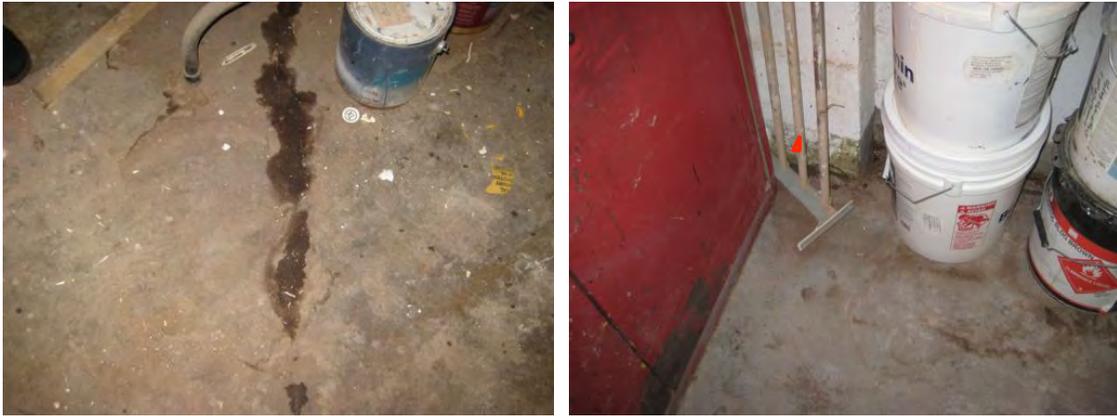
These floor slabs were examined only in the west wing. Random moisture readings at the shop area revealed elevated moisture levels within this slab, and occupant-staff reported occasional leakage via a crack in the slab and along the slab-floor juncture, both near the west wing's NW corner. No leakage was reported at the east-wing floor slab during a brief visit to this restricted-access space. Water and staining were visible along the floor crack and the floor-wall juncture where occasional leakage was reported. See Figures II-3.2(1 & 2).

Fig. II-3.2(1): Wet Concrete Along Fl. Crack Fig. II-3.2(2): Stained Floor Near Wall

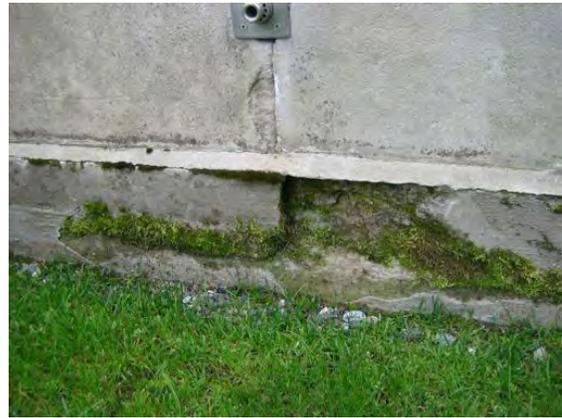
Fig. II-3.4(2): Spalled Stone Base

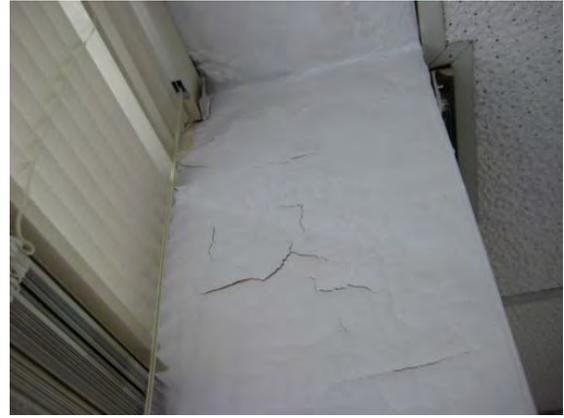
Fig. II-3.6(4): Interior Plaster Damage

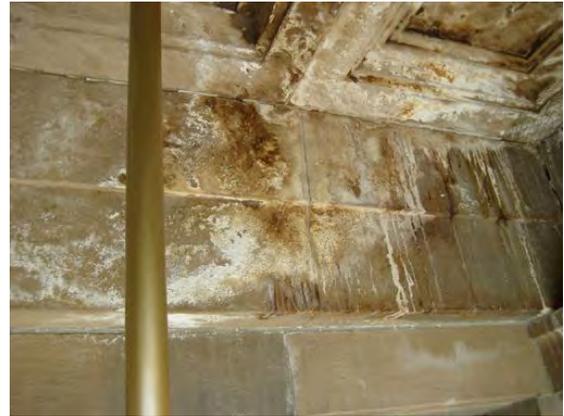
Fig. II-3.6(6): Portico Ceiling Damage

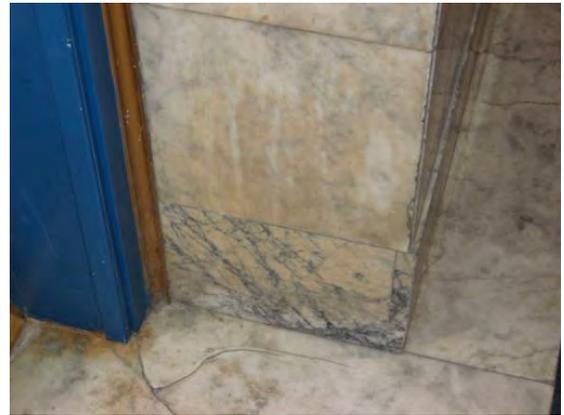
Fig. II-3.6(8): Corrosion Staining

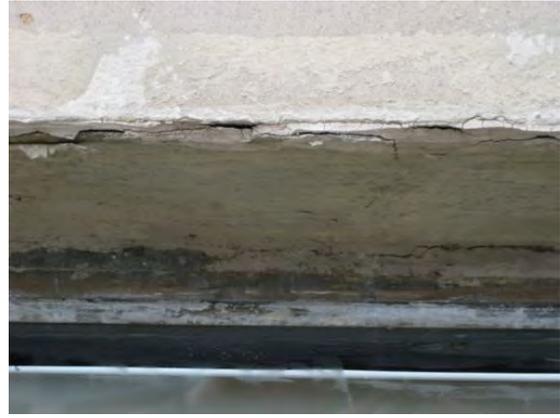
Fig. II-3.7(4): Serious Spalling @ Bot.

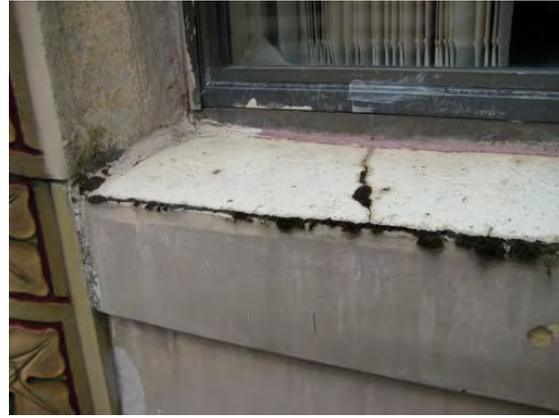
Fig. II-3.7(10): Sill Degradation

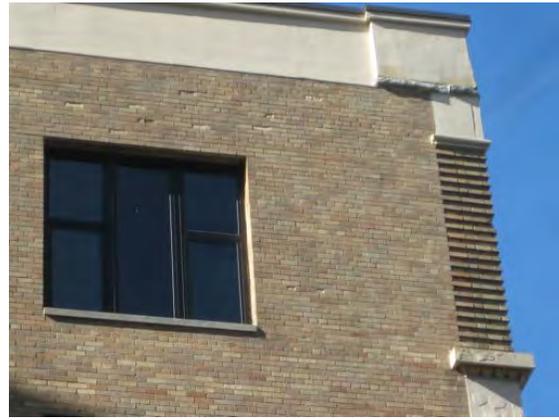
Fig. II-3.8(2): Spalling, E-Facing Wall

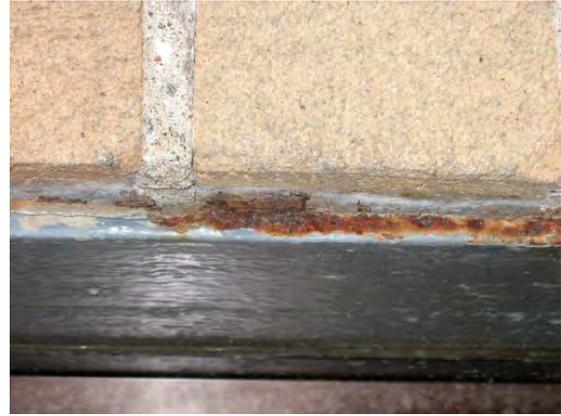
Fig. II-3.8(8): Lintel Corrosion, E.

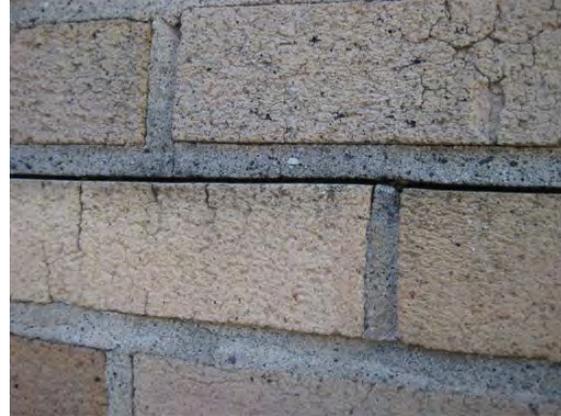
Fig. II-3.8(12): Crack Abv. Sag. Hd.

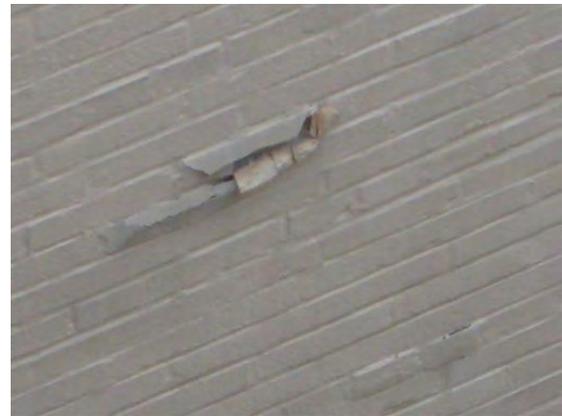
The east-facing wall suffers significant brick spalling, though partly concealed by the elastomeric coating, which has clearly been applied to address infiltration. The coating has not proved successful in fully precluding moisture entry, and spalling continues, with brick chunks in places hanging by only the coating. The north and west-facing walls are in notably better condition. See Figures II-3.9(3-5).

Fig. II-3.9(4): East Wall Spalling

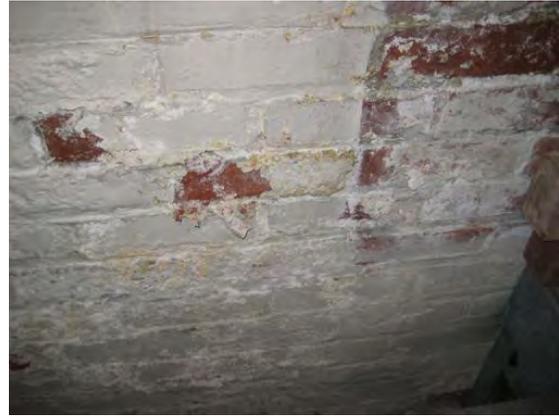
Fig. II-3.9(6): Flaking @ Int., S. Wall

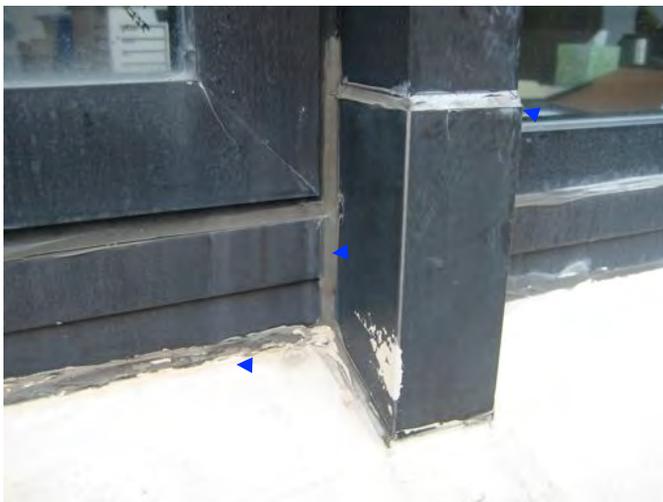
Figure II-3.12(10): Hole at Sill/Jamb Juncture Allows Water Into Sill Extrusion

- Sealant applied along extrusion joints is very unusual, probably reflects effort to stop leakage.
- >
- Sealant applied below sill extrusion precludes drainage of water out from under sill.

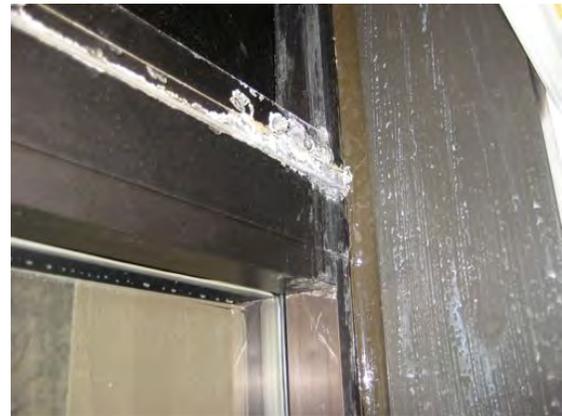
Fig. II-3.12(23): White Dep. At Joints

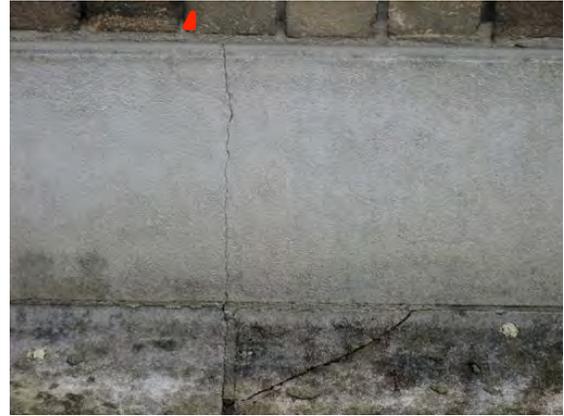
Fig. II-4.1(6): Crack Abv. & In W.T.

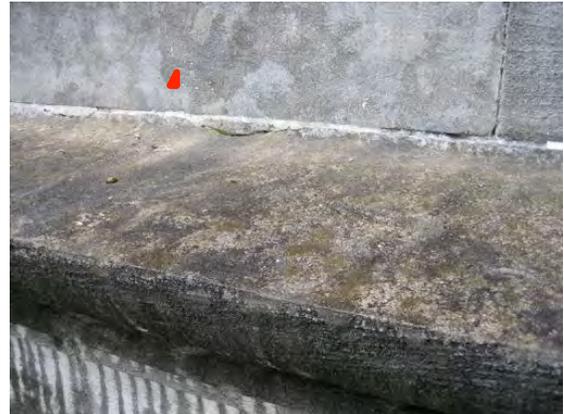
Fig. II-4.1(8): Spalling & Degradation

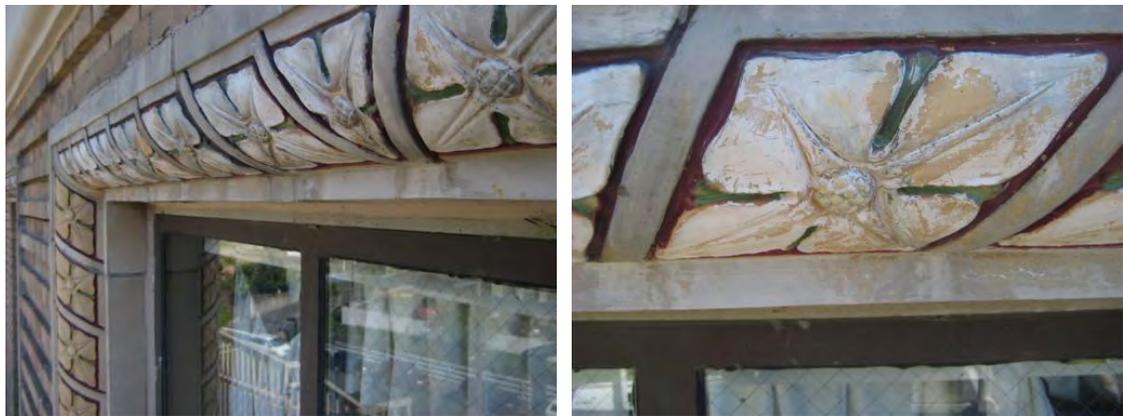
Elsewhere, many pieces are discolored by what appears to be lime. See Figures II-4.2(3-6).

Fig. II-4.2(3): Terra-Cotta Discoloration

Fig. II-4.2(4): T.-C. Discoloration

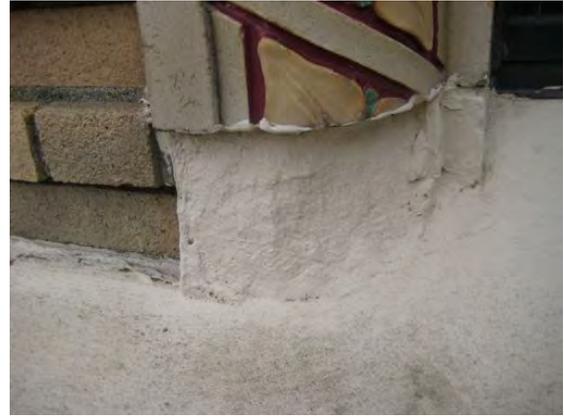
Fig. II-4.2(11): Terra-Cotta Face-Spalling

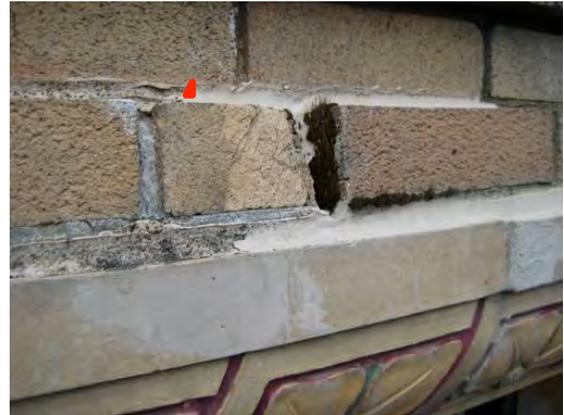
Let me return to the non-draining masonry above the terra-cotta window heads. As noted, the joints directly above these heads had typically been sealed with sealant, precluding drainage from behind the brickwork above. Lime staining below these joints, and moss growth in some mortar joints directly above them, as well as spalling and efflorescence on the underside of these heads clearly indicate that water is trying to drain out of the masonry above the heads. See Figures II-4.2(13 & 14).

Fig. II-4.2(13): Lime Streaks Bel. Sealed Jt.

Fig. II-4.2(14): Lime St., Moss Growth

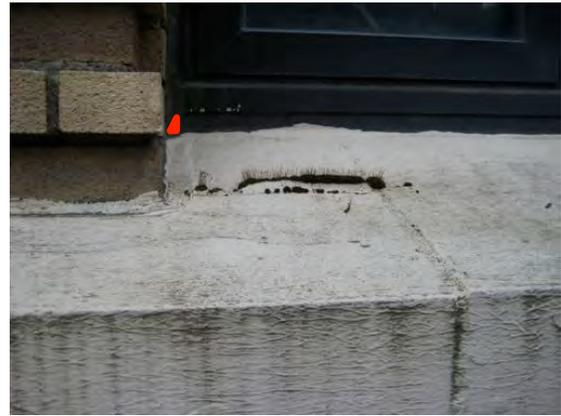
Fig. II-4.3(6): In-Progress Spalling

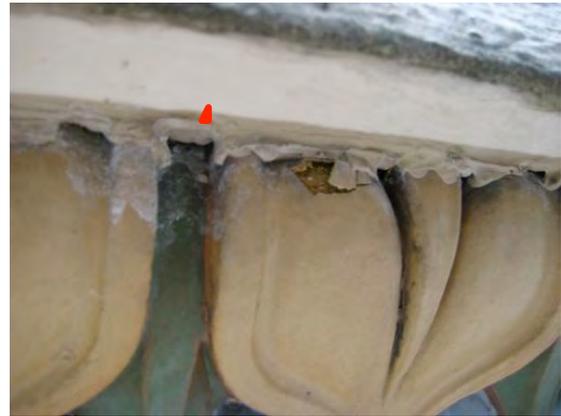
Fig. II-4.3(8): In-Progress Spalling

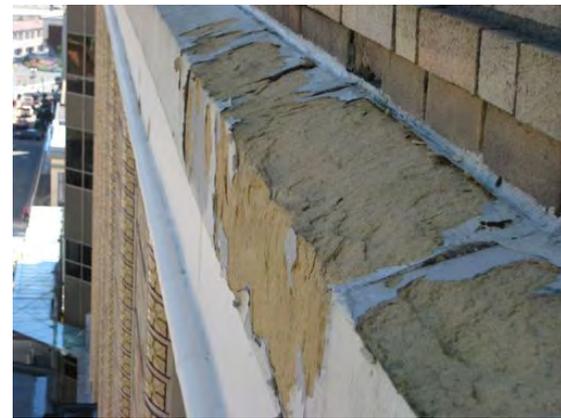
Fig. II-4.3(10): Serious Spalling

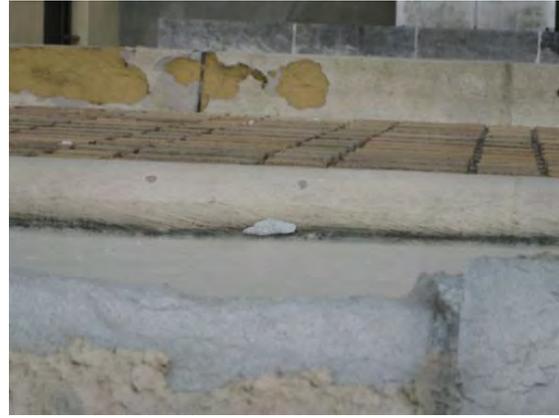
Fig. II-4.3(11): Serious Spalling of Top Band Fig. II-4.3(12): Serious Spalling

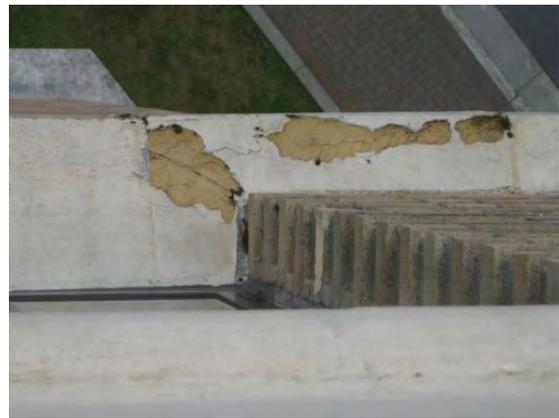
Fig. II-4.3(15): Serious Spalling of Top Band Fig. II-4.3(16): Serious Spalling

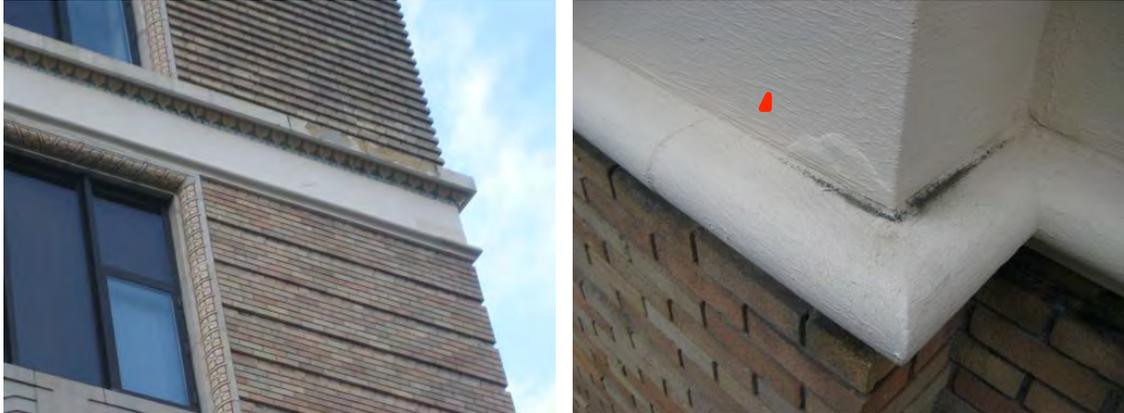
Similarly, the condition of the flat-panel terra-cotta band below the water table is also variable, though in general, this band displays notably lesser degradation, with only a few areas fully spalled-off and fewer areas of incipient spalling. In one location on the north side of the east wing, rust staining exiting a crack in this band indicates that corrosion is occurring behind this panel. Figures II-4.3(17-20) illustrate these observations.

Fig. II-4.3(17): Middle Band in Decent Cond. Fig. II-4.3(18): Incipient Spalling

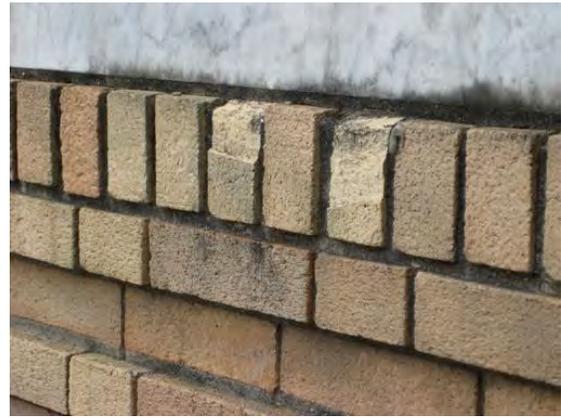
Fig. II-4.4(5): Black Staining at Panel Bott. Fig. II-4.4(6): Staining, Spalled Brick

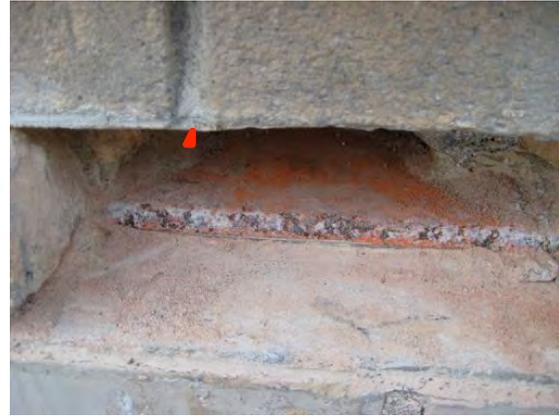
Fig. II-4.5(9): Disintegration

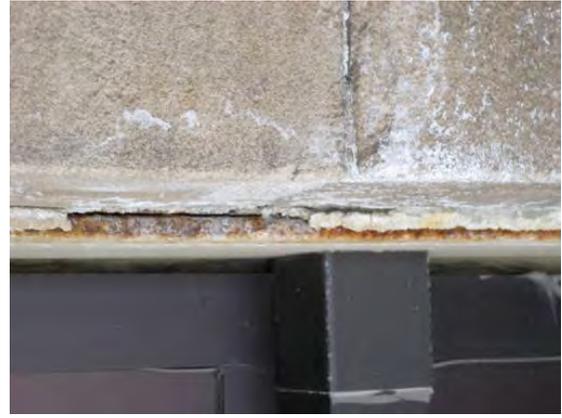
Fig. II-4.7(6): Moderate Corrosion

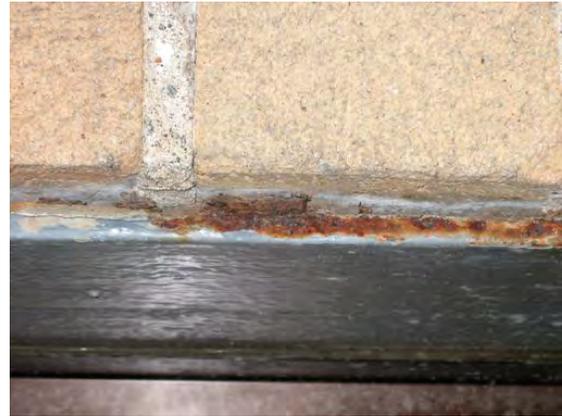
Fig. II-4.7(8): Moderate Corrosion

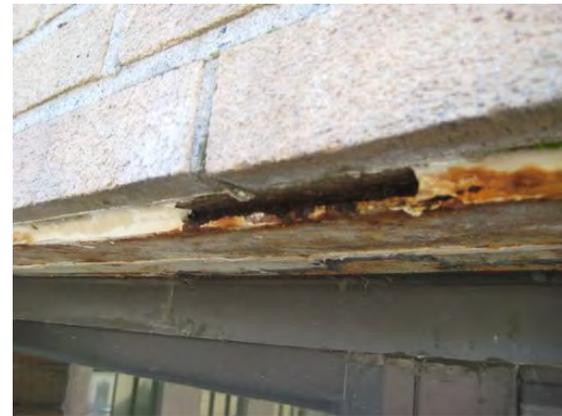
Fig. II-4.7(10): Moderate Corrosion

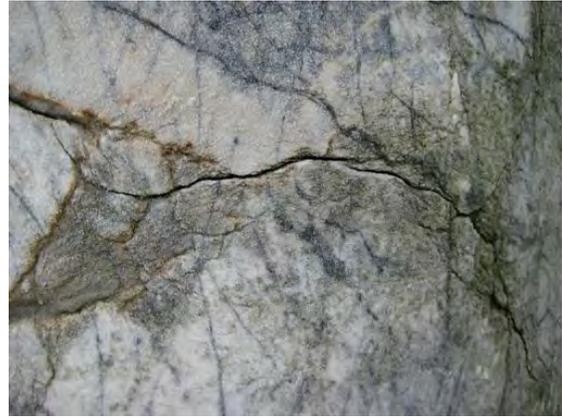
Fig. II-5.2(4): Deep Cracking

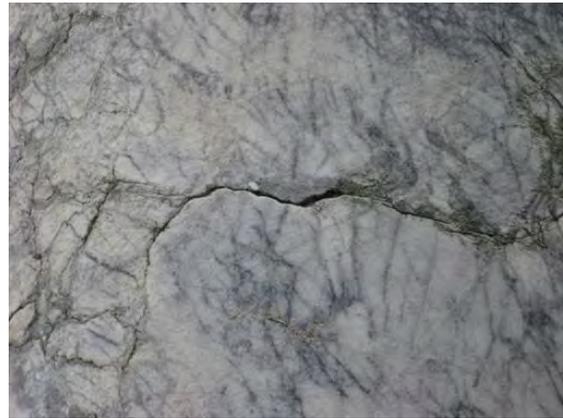
Fig. II-5.2(6): Deep Cracking

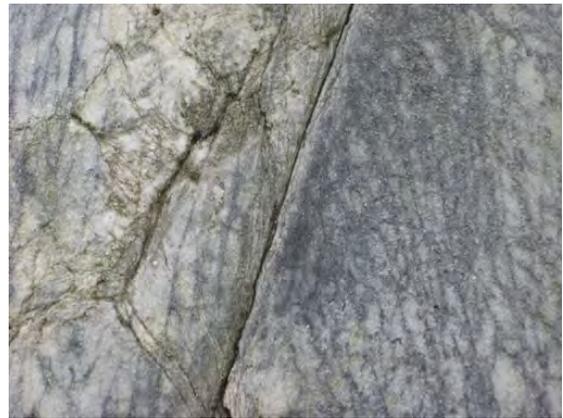
Fig. II-5.2(8): Deep Cracking

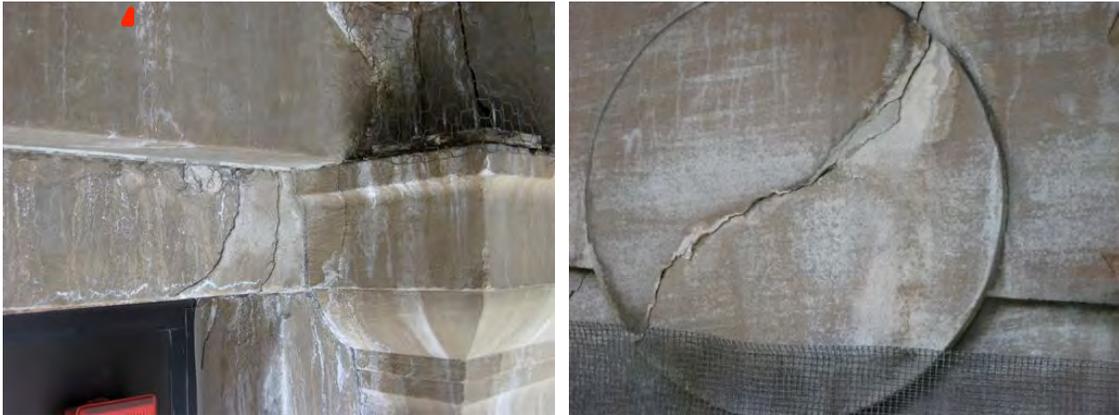
Two primary observations relate to this cladding's condition. The first pertains to widespread and, in places, severe cracking of the structural cladding pieces as well as in the portico base below this cladding and in the portico roof structure supported by this cladding. Wide, sometimes closely spaced cracks occur in the granite paving directly below the cladding pilasters, in the pilaster pieces, at the stone window heads below the portico roof, and in the stone capitals as well as in the stone beams supporting the portico roof. While I found relatively minor symptoms of such stress in the stone cladding away from the portico, major cracks were observed at the bases of the jambs of all three entry doors below the portico. These also occur below the large, short stone crossbeams at the portico ceiling. Figures II-5.3(1-8) depict such cracking, generally starting at the top and proceeding downward.

Fig. II-5.3(1): Cracks in Head, Capital, Beam Fig. II-5.3(2): Cracked Roof Beam

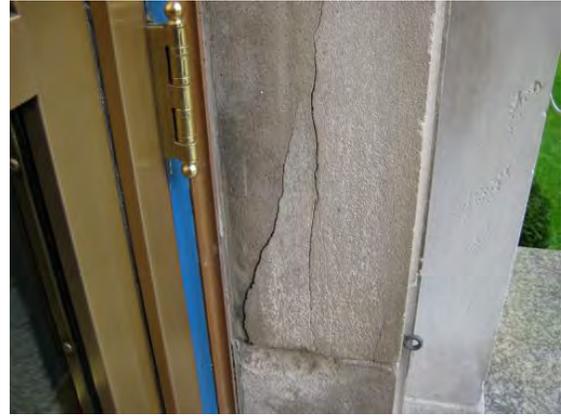
Fig. II-5.3(4): Cracked Str. Cladding

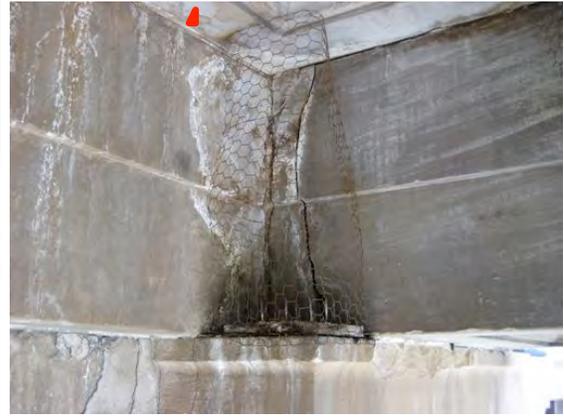
In short, it appears that the roof structure was inadequate to begin with, and has been appreciably compromised by seismic damage. Figures II-5.4(1-12) illustrate these observations.

Fig. II-5.4(1): Cracks in Head, Capital, Beam Fig. II-5.4(2): Cracked Crossbeam

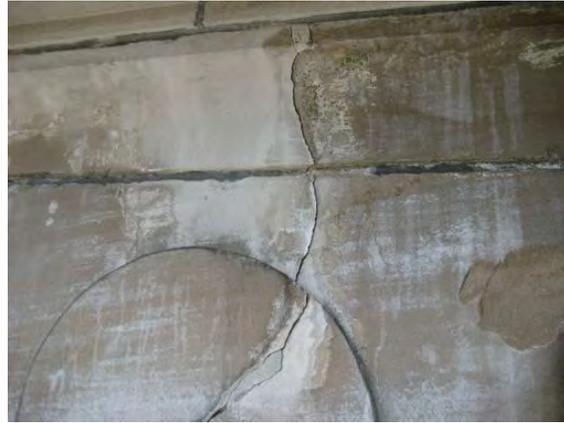
Fig. II-5.4(3): Cracked Beam End

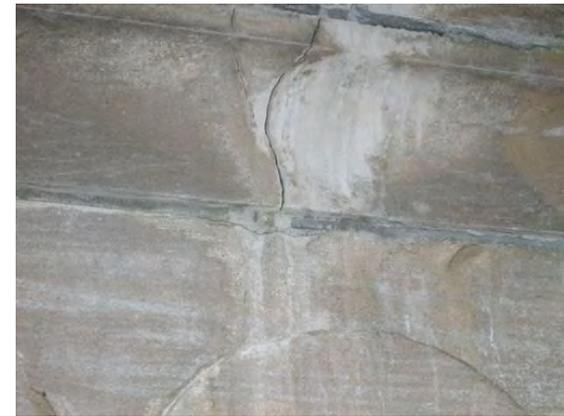
Fig. II-5.4(5): Cracked Beam End

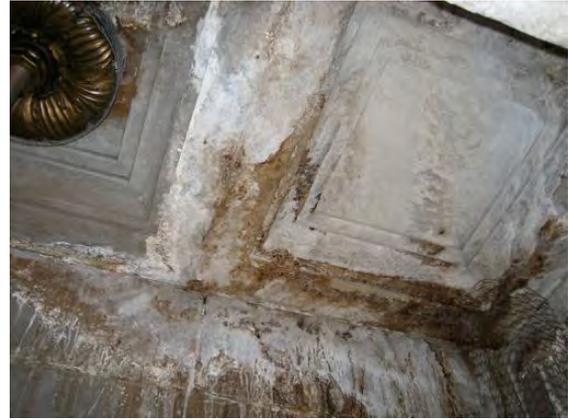
Fig. II-5.4(14): Ceiling Leakage

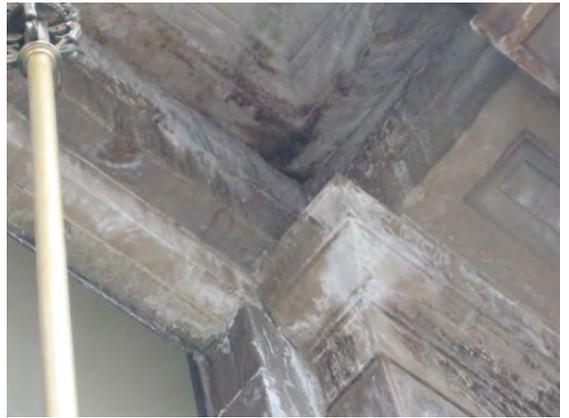
Fig. II-5.4(16): Ceiling Leakage

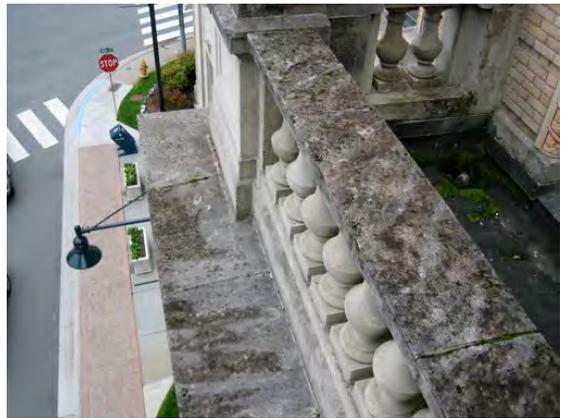
Fig. II-5.4(18): Water Table Degrad.

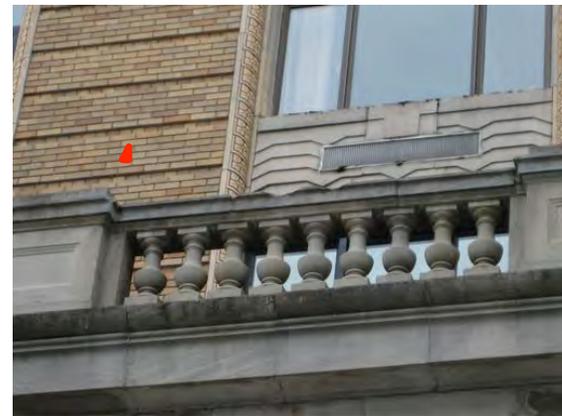
Fig. II-5.5(4): Railing Spalling

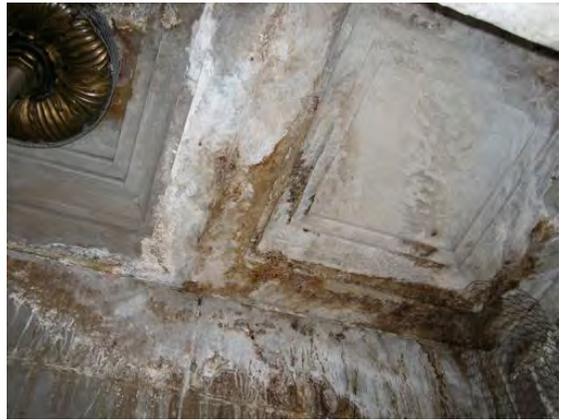
Fig. II-5.6(6): Ceiling Leakage
