SUMMARY EVALUATION,
CORRECTIVE OPTIONS,
AND ESTIMATED CORRECTIVE COSTS

ALASKA STATE
CAPITOL

Juneau, AK.

Date: 2/20/13

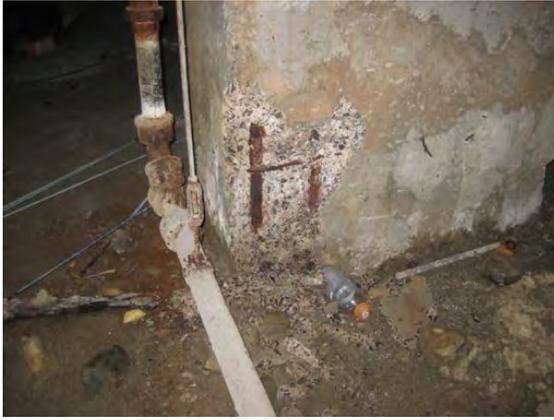
A cursory examination of accessible portions of the crawl space under the building revealed rather wet conditions, with a small but continuous stream running through this space. Consequently, the individual foundations displayed expected symptoms, including variable degrees of corrosive spalling and efflorescence, a powdery white crystalline substance that invariably indicates moisture passage through masonry materials.

Fig. II-2.2(1): Corrosive Concrete Spalling

The concrete spalling and efflorescence reflect degradation caused by moisture intrusion into the concrete. Some of the moisture enters the concrete from the damp atmosphere resulting from the running water within the crawl space. However, the specific pattern of the efflorescence on the concrete columns reveals that water also enters from the soils directly below the footings.

The corrosive spalling of the concrete results from corrosion of the embedded reinforcing. As steel corrodes, it experiences large volumetric expansion, thus popping concrete off the surface.

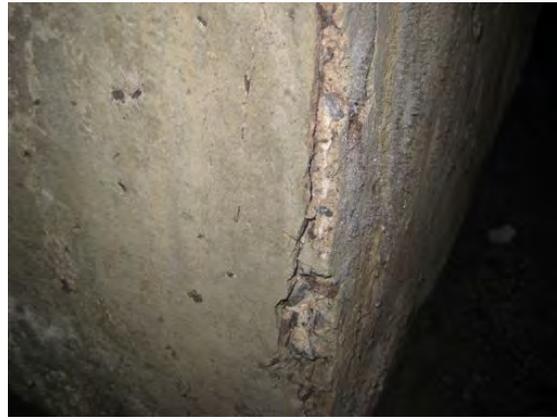
Fig. II-2.2(2): Concrete Spalling

The surface spalling located away from steel reinforcing can result from freezing expansion of embedded water as well as through concentrated recrystallization of salts. Both mechanisms appear plausible, even probable, in this case.

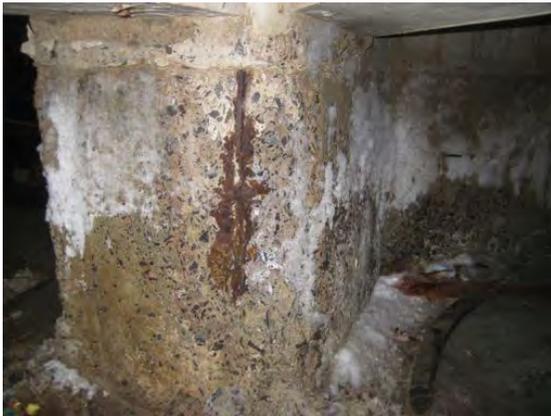
Fig. II-2.2(3): Spalling, Efflorescence

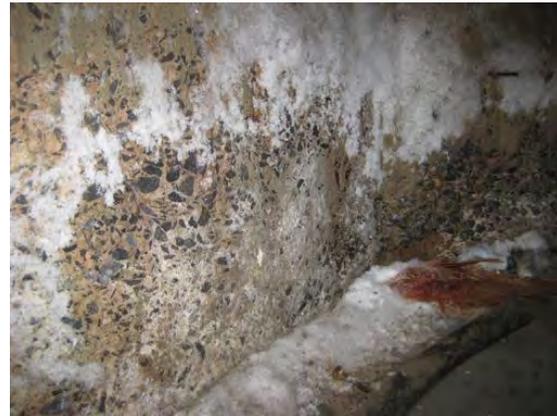
Fig. II-2.2(4): Efflorescence

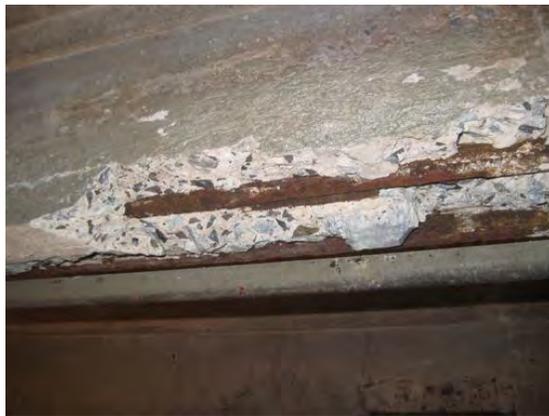
Examination of this floor framing from the crawl space revealed widespread and fairly serious corrosive spalling, which appeared to affect most of the integrally cast joists, particularly near their midspans. The bottoms of these joists had in most locations spalled off, exposing corroding reinforcing steel.

Fig. II-2.3(1): Spalling @ Joist Midspan

The concrete joist spalling reflects degradation caused by moisture intrusion. However, in contrast to the spalling affecting the foundations, the only moisture source reaching these joists consists of atmospheric humidity resulting from the wet crawl space.

The corrosive spalling of the concrete results from corrosion of the embedded reinforcing. As steel corrodes, it experiences large volumetric expansion, thus popping concrete off the surface.

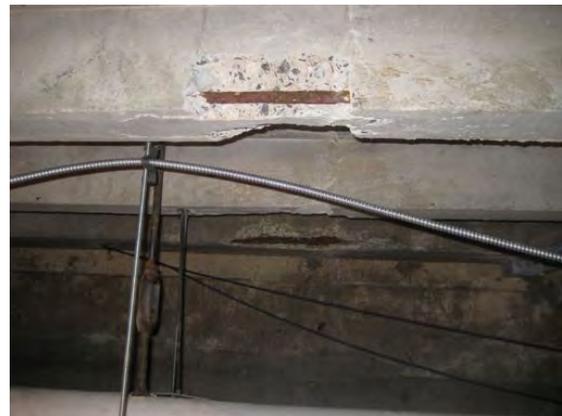
Fig. II-2.3(2): Spalling @ Jst. Bottoms

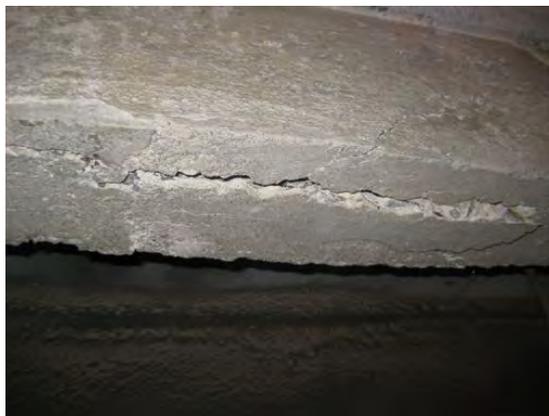
Fig. II-2.3(3): Spalling @ Joist Midspan

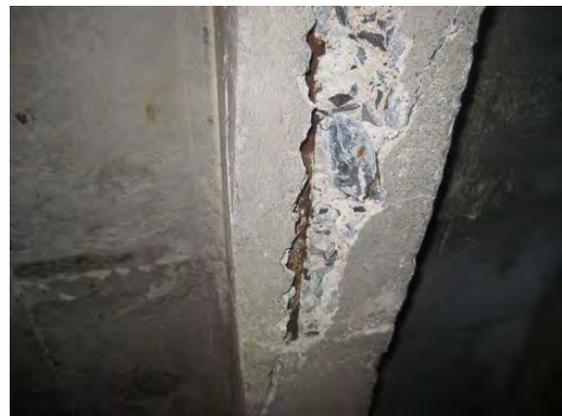
Fig. II-2.3(4): Spalling @ Jst. Bottom

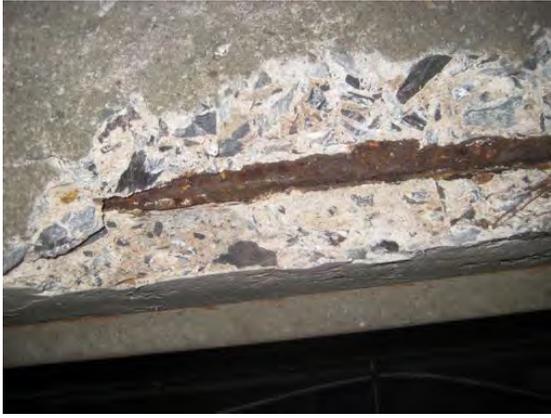
Fig. II-2.3(5): Spalling @ Joist Midspan

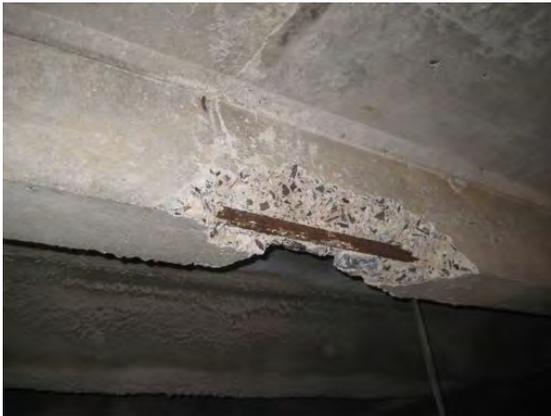
Fig. II-2.3(7): Spalling @ Joist Midspan

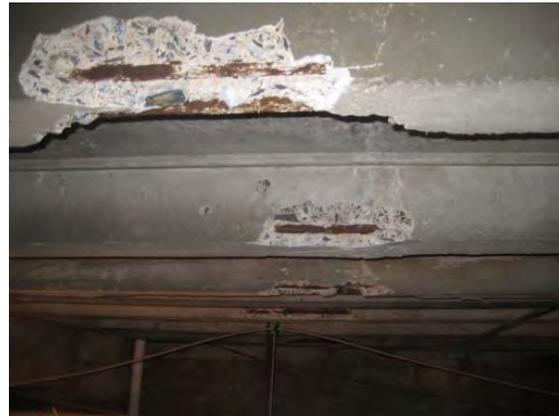
Fig. II-2.3(8): Spalling @ Jst. Bottoms

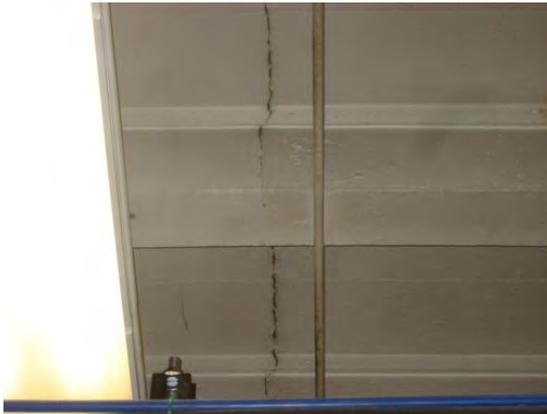
In addition, one continuous, completely straight crack was observed running a few feet south of the wall separating the boiler room from the shop. The crack parallels this wall, and runs across the entire width of the west wing.

Fig. II-2.4(1): Straight Crack in Floor Slab

The straight crack across the west wing most likely occurs along a pour joint, where curing shrinkage would be expected to create such a crack. However, this crack is wider than one would expect from shrinkage alone, and it appears probable that it has been exacerbated by subsequent seismic displacement.

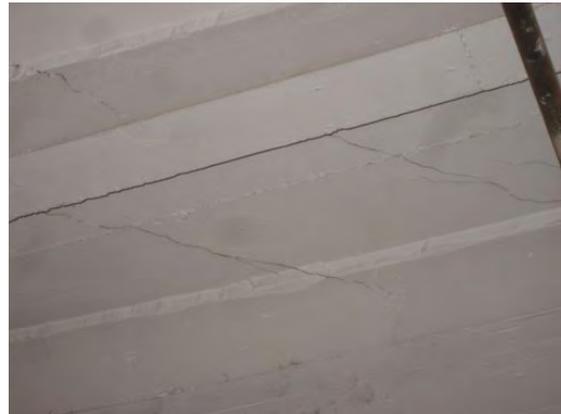
Where it was visible, significant cracking was observed very near the building's outer corners, where typically fairly wide, often closely spaced cracks were located.

Fig. II-2.4(2): Diagonal Cracks in Slab

The diagonal cracks near the outer building corners cannot reflect curing shrinkage restraint, as these cracks are also typically far too wide, and often occur in closely spaced pairs. Shrinkage cracks would not occur closely spaced, as the initial crack would relieve any tensile stress, thus precluding the second crack from occurring. Due to their size, locations, and spacing, these cracks appear seismically induced.

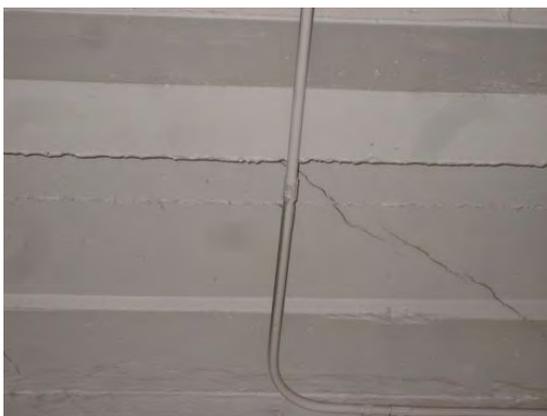
Fig. II-2.4(3): Diagonal Crack in Floor Slab

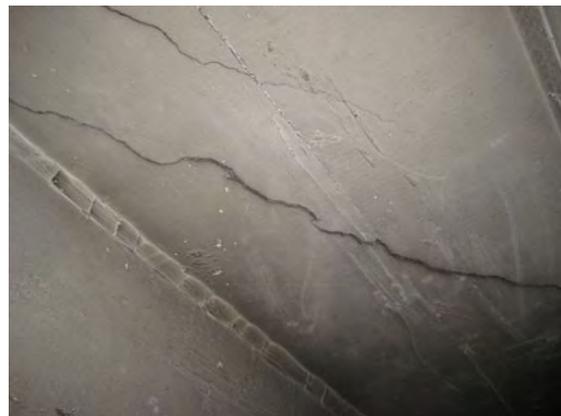
Fig. II-2.4(4): Diagonal Cracks in Slab

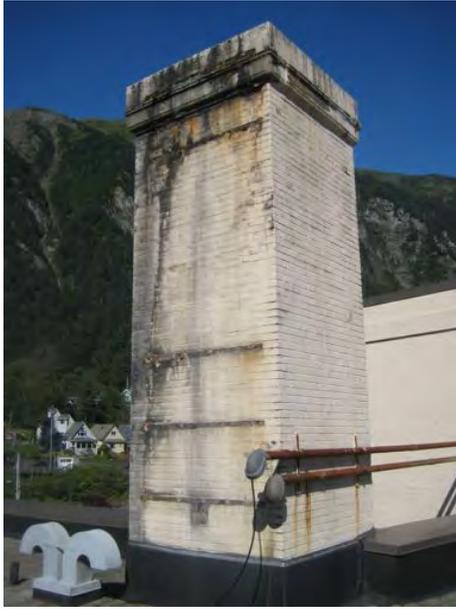
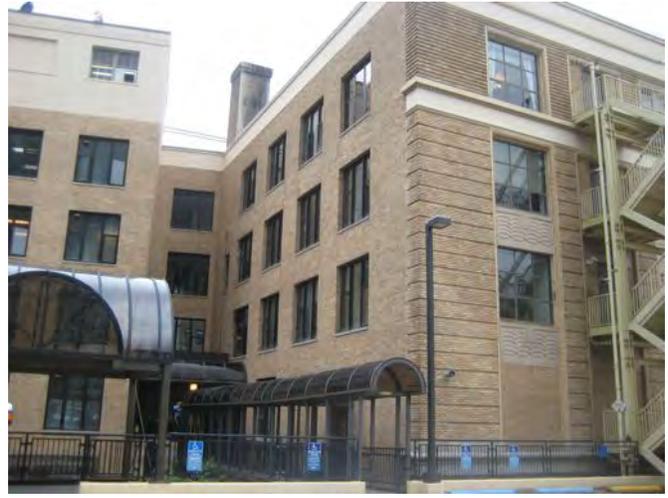
Fig. II-2.5(1): General Chimney View Fig. II-2.5(2): Chimney Location

The chimney brick and stone caps are largely painted with an elastomeric coating, apparently to limit moisture intrusion into the brickwork, which is fairly degraded, with extensive erosion of outer brick faces and mortar, mortar cracking, etc. The coating is delaminating in various locations, indicating moisture intrusion behind it.

Structural concerns relate to the chimney's overall stability as well as to securement of its stone cap elements. Based on the chimney's construction and height, it appears vulnerable to overturning failure in a seismic event. The absence of any mechanical securement of its heavy capstones to the primary chimney structure, combined with its degraded mortar, increase vulnerability of these capstones to seismic displacement. As the chimney occurs above one exit-way from the building, these issues represent a life-safety hazard to people existing the building in an earthquake.

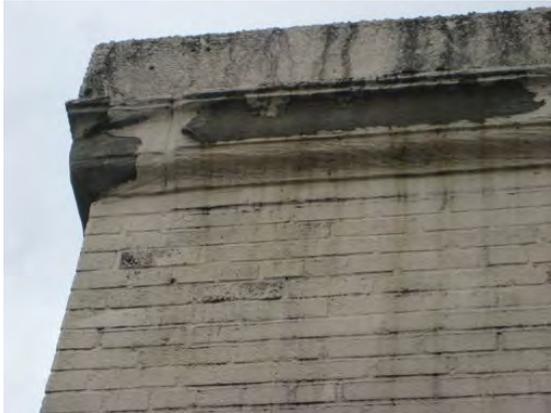
Fig. II-2.5(3): Coating Delamination

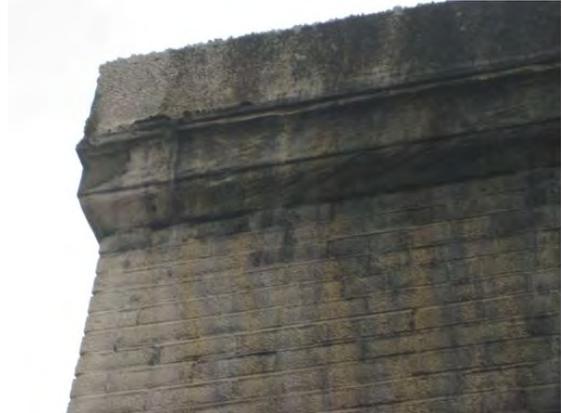
Fig. II-2.5(4): Coating & Brick Degr.

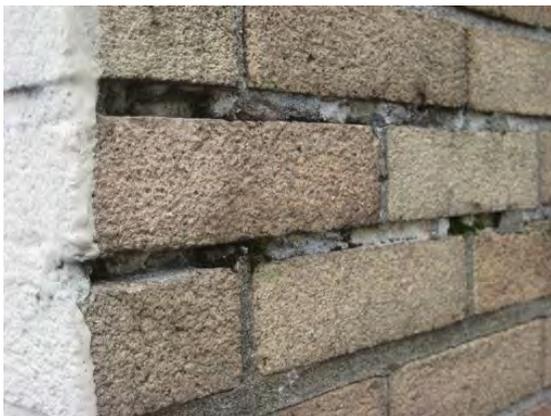
Fig. II-2.5(5): Brick & Mortar Degradation

As masonry is inherently absorbent, the absence of flashing caps greatly exacerbates moisture intrusion into the stone and brickwork. As Juneau's climate includes roughly 220 rainy days each year, and low temperatures drop below freezing through five months annually, this can greatly accelerate degradation, lead to freeze-spalling, mortar erosion, and similar symptoms, which are in fact evident.

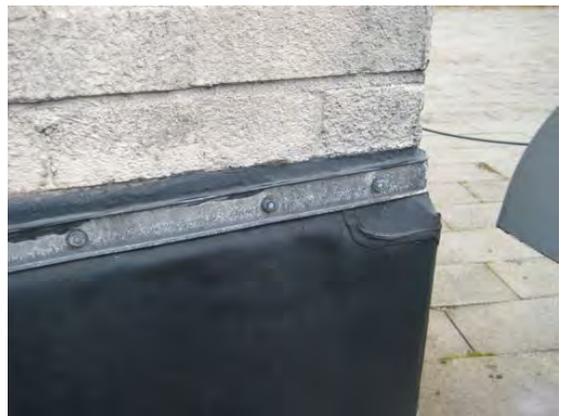
In addition, the chimney's junctures to the roof and parapets are not executed properly, in that the EPDM roof membrane and parapet flashings are sealed to the outer brick face, with no through-wall flashings to drain water out from behind the outer brick wythe.

Fig. II-2.5(6): Improper Roof Junct.

Along the chimney's base, its juncture to the roof membrane and parapets is improperly executed, as any water that permeates into and behind the outer brick drains downward into the roof assembly, posing a risk of interior leakage. The application of the elastomeric coating to the brickwork may in fact reflect an effort to limit interior moisture intrusion, although it may well exacerbate degradation by entrapping moisture. These junctures should have included continuous through-wall flashings above the roof membrane and flashing terminations to drain water harmlessly from behind the outer brick wythe and to preclude its drainage into construction elements below.

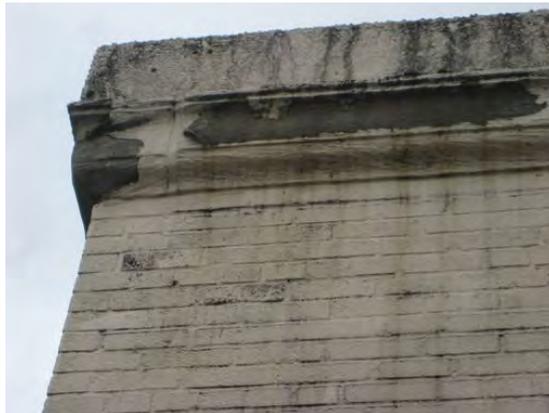
Large masonry elements which appear to lack any mechanical securement, other than mortar bond, include the chimney capstones, stone window sills, some portions of the stone railing atop the portico, the stone water table elements atop the portico, the stone portico ceiling elements, and probably some other elements. Similarly, the multi-wythe brick walls, which sit atop steel lintels and the concrete floor slabs and ledges, do not appear otherwise mechanically secured to the primary concrete structure. Further, my examination often revealed that the mortar bond securing these elements had degraded, and in some cases had become completely compromised. For example, I was able to freely, though with effort, move one very large stone cap atop the portico railing. Some of these elements had also become cracked, further compromising their securement. Figures II-2.6(1-6) depict a few of these un-secured elements.

Fig. II-2.6(1): Un-Secured Chimney Caps

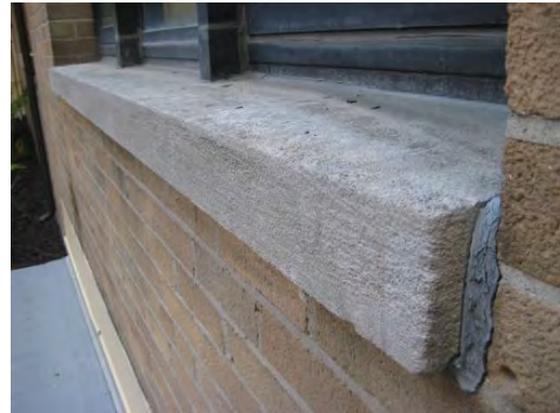
Fig. II-2.6(2): Un-Secured Stone Sill

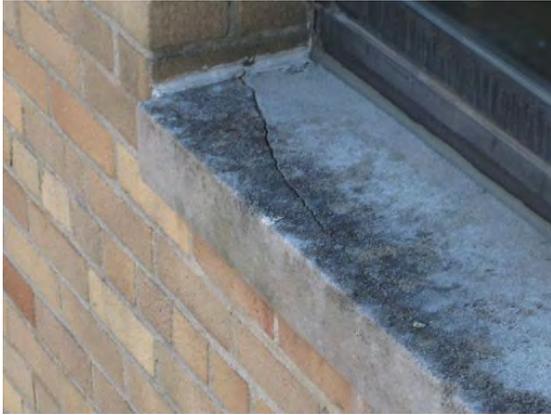
Fig. II-2.6(3): Un-Secured, Cracked St. Sill

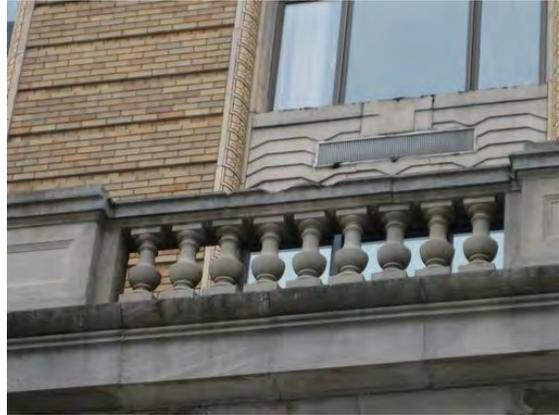
Fig. II-2.6(4): Un-Secrd. Stone Railing

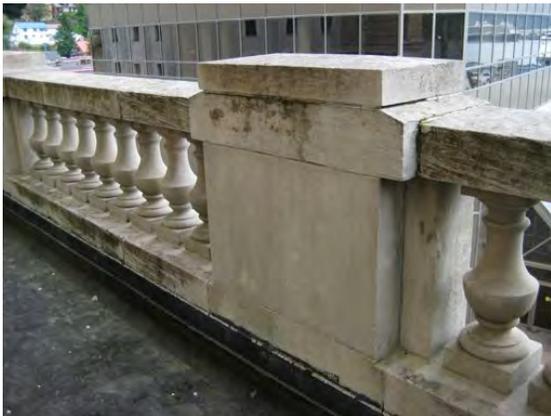
Fig. II-2.6(5): Un-Secured Stone Railing

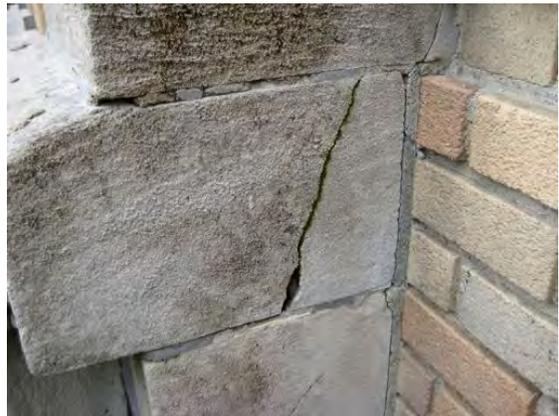
Fig. II-2.6(6): Un-Secrd. Cracked Ring.

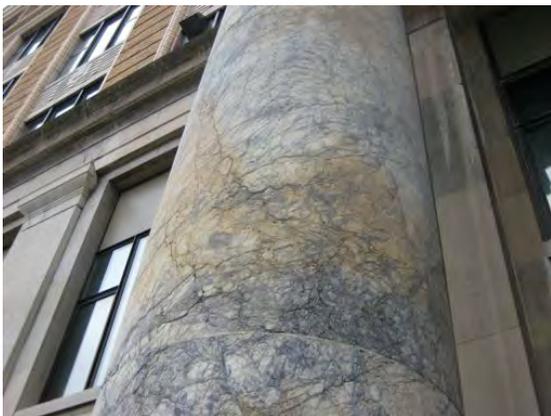
The tall stone columns supporting the portico roof also appear un-secured to the stone roof beams, and the very large column sections are not attached to each other in any way, having only very small, short “cube-dowels” between sections, which act more to center the sections relative to each other than to secure them. Some of these columns also display rust staining, which may indicate corrosion of these dowels, while others have seemingly significant cracks. See Figures II-2.6(7 & 8).

Fig. II-2.6(7): Un-Secrd., Rust-Stained Col.

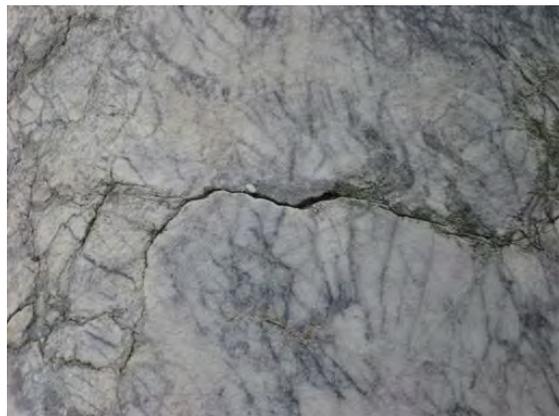
Fig. II-2.6(8): Cracked Column

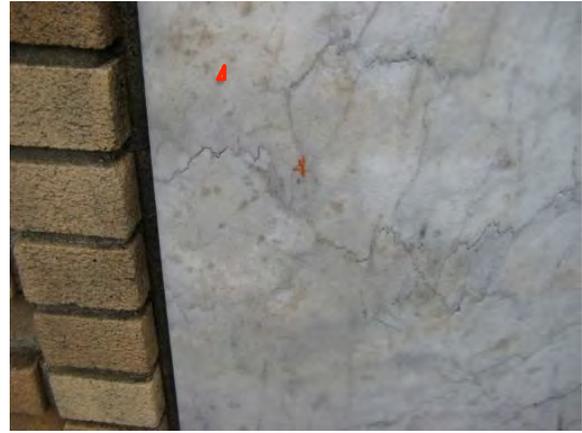
The large marble panels near the top of the south façade, directly above the portico, also do not appear to have any mechanical securement stipulated in the drawings, though some weak metal signals were detected in a few locations at some panels, indicating possible anchorage of some sort. Cracking observed at some panels may also indicate that these may be somewhat compromised. See Figures II-2.6(9 & 10).

Fig. II-2.6(9): Un-Secured, Marble Panels **Fig. II-2.6(10): Possible Small Anchor**

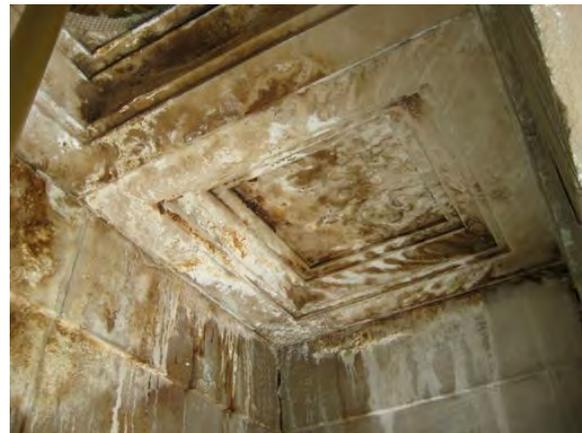
Some elements have a degree of mechanical securement, via steel dowels, straps, and similar methods, but such securement appears blatantly inadequate for holding these components in place under plausible seismic stresses. For example, the entire portico structure, which in totality weighs roughly 170 tons and consists of many individual stone elements, is secured to the primary structure with 7 or 8 small steel straps, each 2 ½” wide and ½” thick. These straps cannot resist lateral racking of the portico in the E-W direction, and the cracking pattern affecting the portico elements and the supporting stone cladding indicates that such racking had taken place. Further, though these straps, which are embedded within the portico ceiling, could not be examined, widespread staining on the portico ceiling indicates that these minimal straps have by now been largely compromised by corrosion. See Figures II-2.6(11-14).

Fig. II-2.6(11): Minimally Secured Portico **Fig. II-2.6(12): Water-Damaged Clg.**

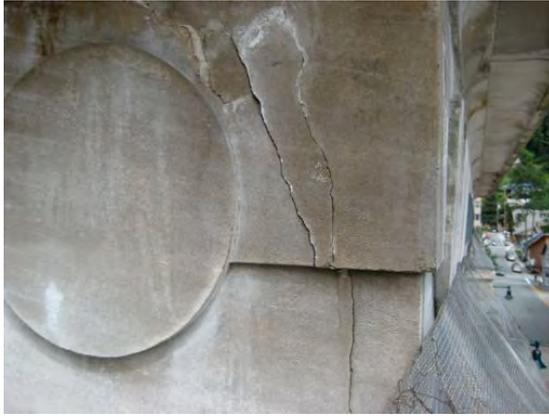
Fig. II-2.6(13): Cracked Portico Beams

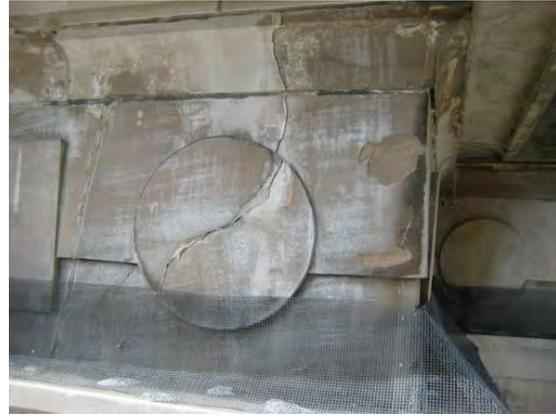
Fig. II-2.6(14): Cracked Prtco. Beams

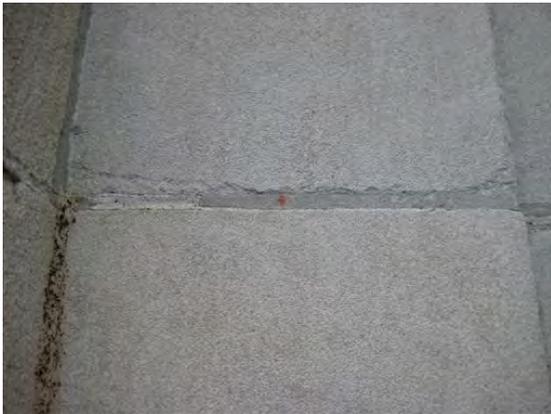
Similarly, the large stone cladding pieces along the bottom two levels of the south façade are secured with a single 3/8" \varnothing steel wire looped around the concrete columns and recessed into the stone about 2". In some cases, this yields a single point of marginal attachment for stones with a 13 SF face area, 20 CF volume, and over 3,000 lb. weight. The distribution of such anchors allows these stone pieces to rotate or buckle away from the building, and the cracking pattern in some of these elements under the portico indicates that such rotation had taken place, compromising these elements further. Also, though the drawings in a few locations call for "non-corroding" metal anchors, evidence of corroded anchors was observed in various locations. Figures II-2.6(15-18) illustrate these observations.

Fig. II-2.6(15): Minimal Anchor Location

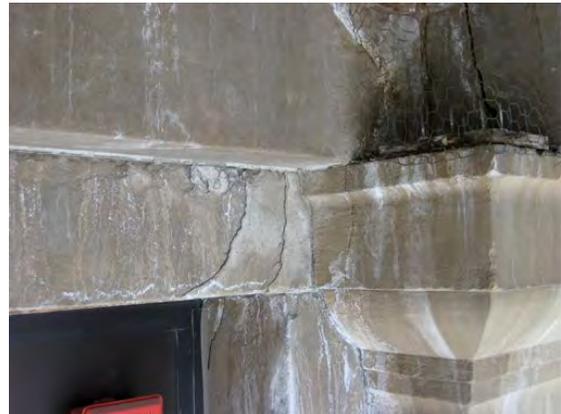
Fig. II-2.6(16): Cracked Stone Clng.

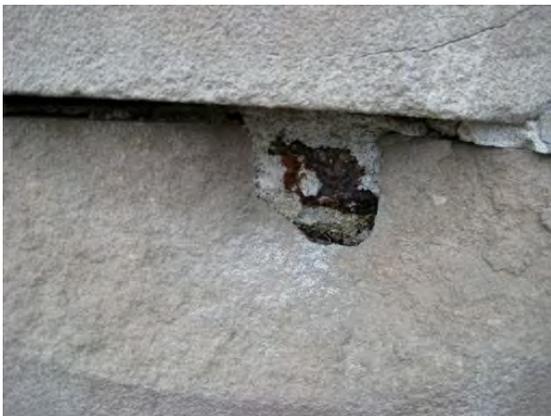
Fig. II-2.6(17): Corroding Anchor

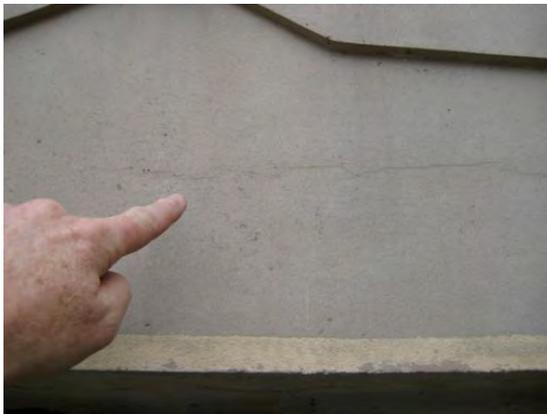
Securement of a few elements is more difficult to judge without specific analysis. For example, many of the terra-cotta elements, such as the upper water table, the spandrel panels between windows, and the window bay surrounds, as well as possibly the stone water table at level 2, appear to contain somewhat beefier securement via steel anchors. However, given the building's length of exposure to the wet Juneau climate, it appears probable that corrosion has begun to compromise these anchors, and some of the cracking observed in these elements coincides with locations of embedded steel, and resembles cracking one would expect of corrosive steel expansion. Figures II-2.6(19-22) illustrate these observations.

Fig. II-2.6(21): Crack Near Embedded Steel

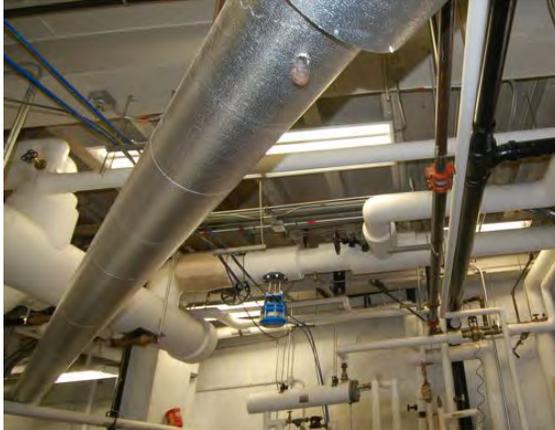
The building contains various large mechanical equipment units, such as the boiler, ductwork, piping, and similar elements that are not secured or braced in any fashion. Figures II-2.8(1 & 2) depict a couple of examples.

Fig. II-2.8(1): Un-Braced Piping & Ducts

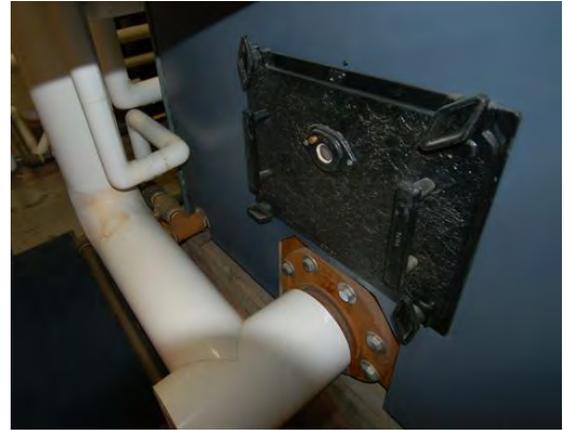
Fig. II-2.8(2): Un-Secured Boiler

These equipment elements are quite heavy, and as they are not secured or braced, they pose a risk of overturning or falling in earthquakes. This poses some risk to any people nearby, but further, it greatly exacerbates risk of damage to the equipment, which is typically much costlier to repair, compared to the cost of preventive bracing.

In their current configuration, these elements will remain vulnerable to seismic overturning or falling, posing a hazard to occupants.

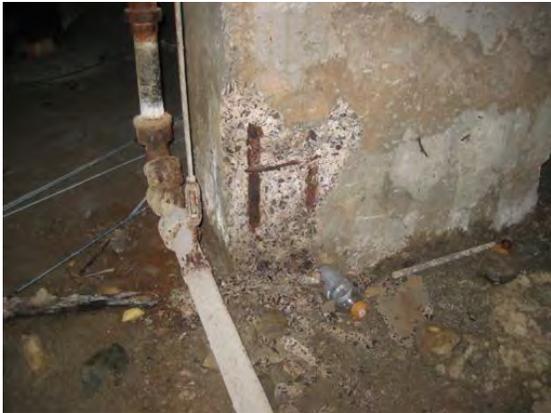
Fig. II-3.1(1): Fndtn. Spalling, Wet Soil

The exposed, water-saturated soils, which must characterize this crawl space year-round, are having a very visible, cumulative, and detrimental effect on the integrity of all exposed concrete within the space, especially where steel-reinforced. The corrosive spalling and efflorescence represent the smoking-gun evidence for this. Water is being absorbed directly from soil into the foundations, but atmospheric moisture alone is causing the concrete floor joists to spall.

Left uncorrected, the present degradation of the concrete and its steel reinforcing will continue, causing ongoing corrosion and spalling. This will eventually compromise the structural integrity of the entire floor system.

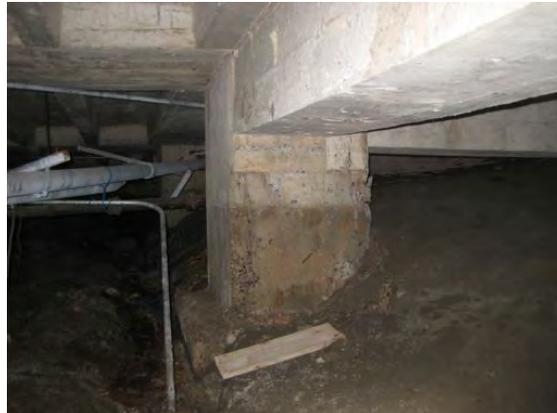
Fig. II-3.1(2): Sloping, Wet Soil

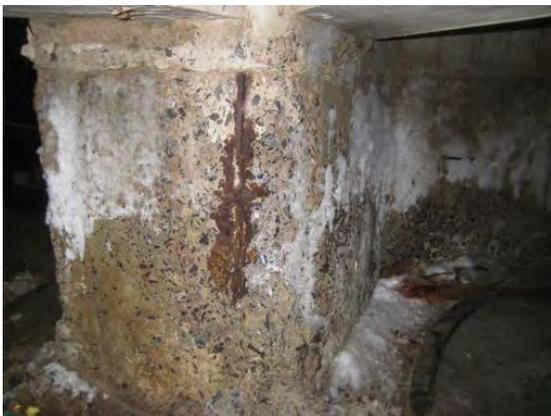
Fig. II-3.1(3): Fndtn. Spalling, Effloresc.

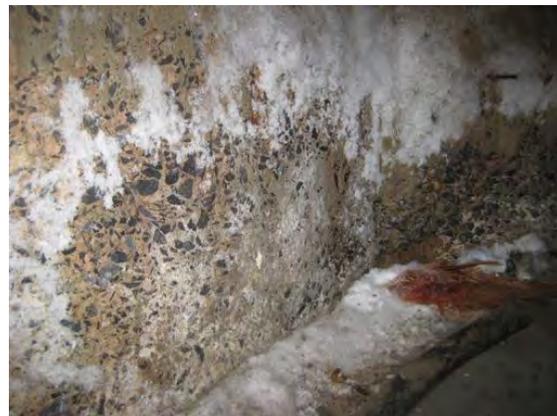
Fig. II-3.1(4): Fndtn. Efflorescence

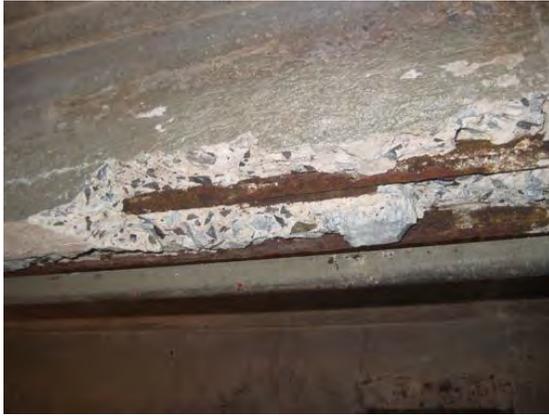
Fig. II-3.1(5): Spalling @ Joist Midspan

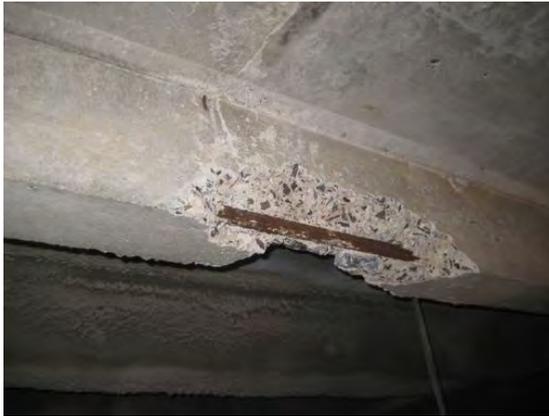
Fig. II-3.1(7): Spalling @ Joist Midspan

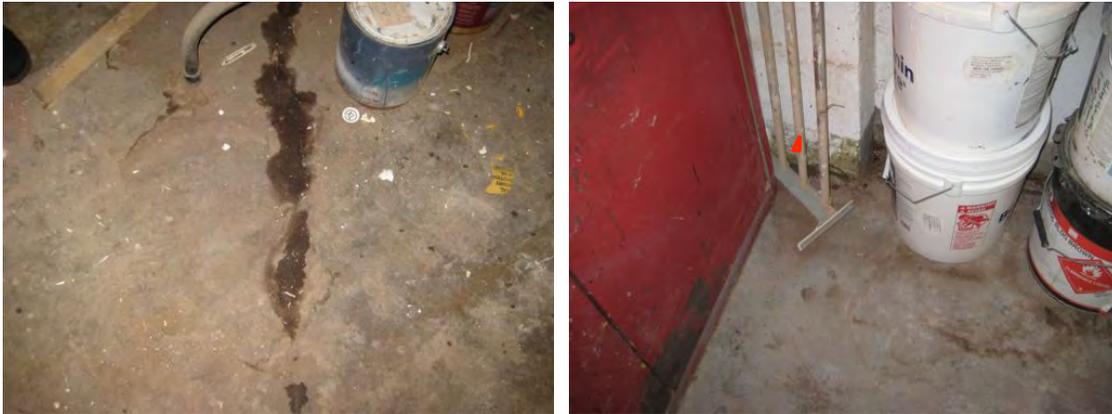
These floor slabs were examined only in the west wing. Random moisture readings at the shop area revealed elevated moisture levels within this slab, and occupant-staff reported occasional leakage via a crack in the slab and along the slab-floor juncture, both near the west wing's NW corner. No leakage was reported at the east-wing floor slab during a brief visit to this restricted-access space. Water and staining were visible along the floor crack and the floor-wall juncture where occasional leakage was reported. See Figures II-3.2(1 & 2).

Fig. II-3.2(1): Wet Concrete Along Fl. Crack Fig. II-3.2(2): Stained Floor Near Wall

It is evident that very wet soil lies beneath these floors. The drawings reveal that this moisture was a well-known design consideration, so while the multitude of conflicting foundation drawings raises some confusion, it is likely that the floor under the boiler room had been built as a waterproofed sandwich slab, that a simple perimeter sub-slab drainage system had been installed, and that the shop floor consists only of a floor slab with no waterproofing. This is also consistent with the observation that infiltration via the floor appears limited only to this shop area.

With regard to the floors alone, as a minimum, recurring infiltration via floor cracks and along floor-wall junctures will continue to be a nuisance. It would become problematic if any moisture-sensitive floor finishes, such as floor coatings, linoleum, vinyl tile, etc., were to be placed directly over these. Corrosive spalling may begin popping off the floor surface along reinforcing lines.

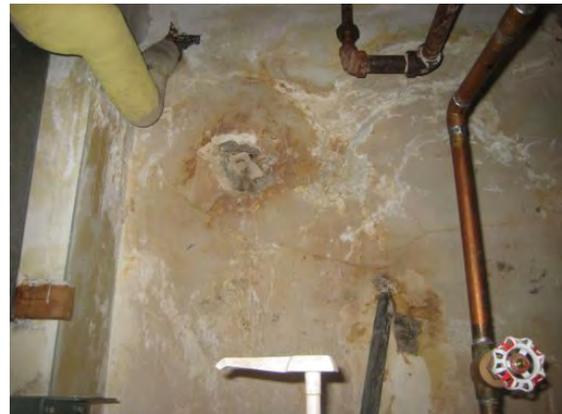
Fig. II-3.3(1): Fl. Stain, NW Corner, W. Wing **Fig. II-3.3(2): Plaster Dam., E. Wing**

In contrast, the east wing basement had been excavated after the building was in place. Although no leakage was reported in this space, the relatively ample leak symptoms imply otherwise. In view of this, it appears most prudent to assume that leakage is affecting these walls, most likely via shrinkage cracks, cold-joints, and possibly rock-pockets.

It appears probable that some leakage is occurring at the east wing, despite reports to the contrary. If so, this will continue to damage interior plaster, stain walls, etc. Over the long term, this could begin affecting the walls' integrity through reinforcing corrosion.

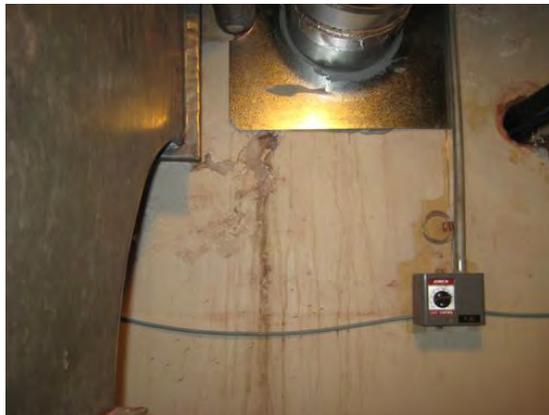
Fig. II-3.3(3): Streaks Bel. Duct, E. Wing **Fig. II-3.3(4): Streaks, E. Wing**

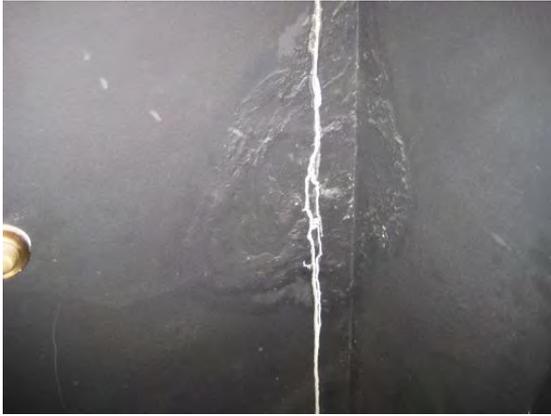
Fig. II-3.3(5): Streaks, Plstr. Dam., E. Wing

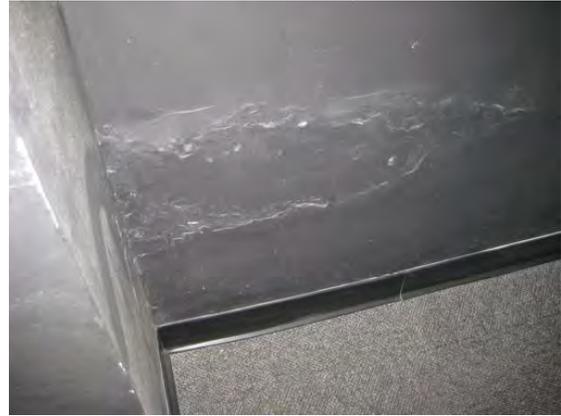
Fig. II-3.3(6): Plaster Dam., E. Wing

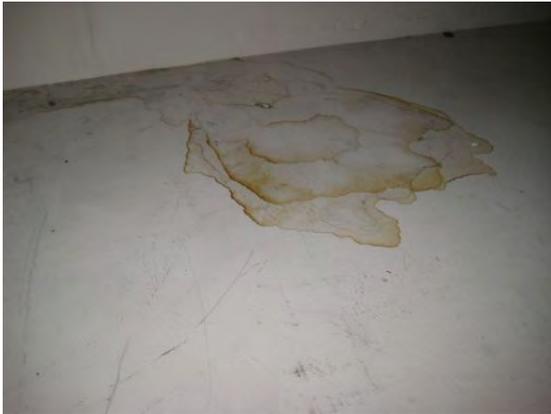
Fig. II-3.3(7): Stains Below Wall, E. Wing

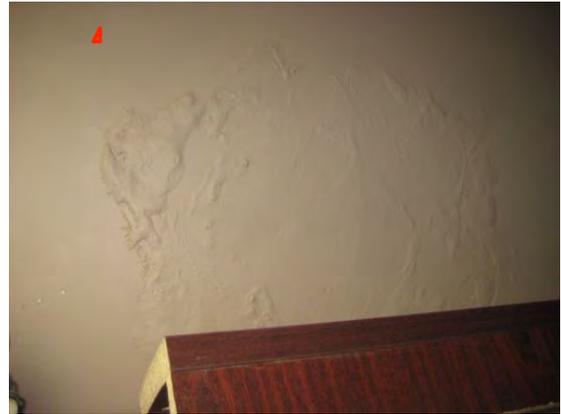
Fig. II-3.3(8): Plaster Dam., E. Wing

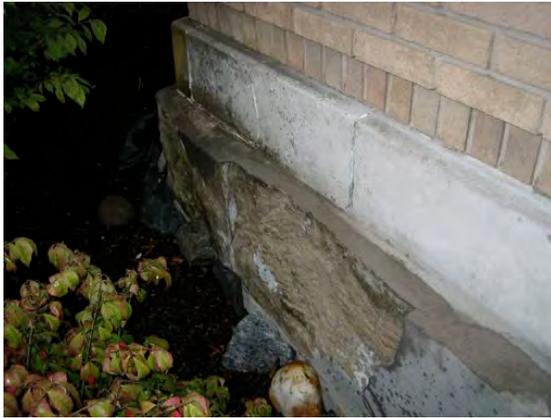
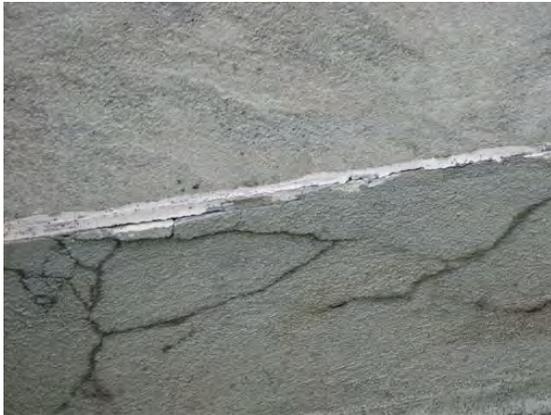
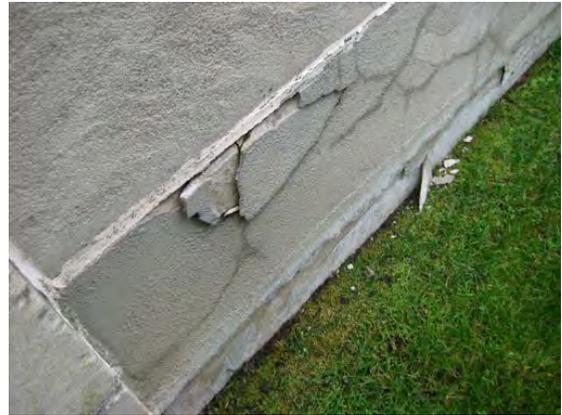
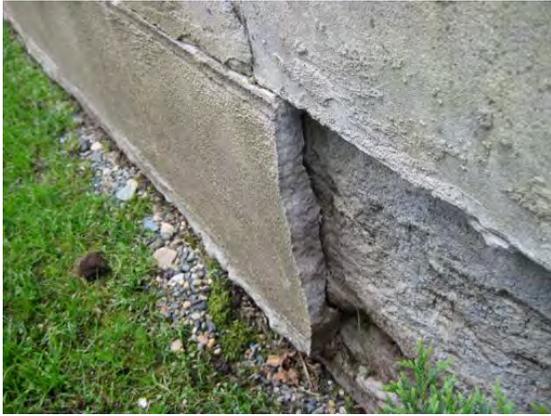
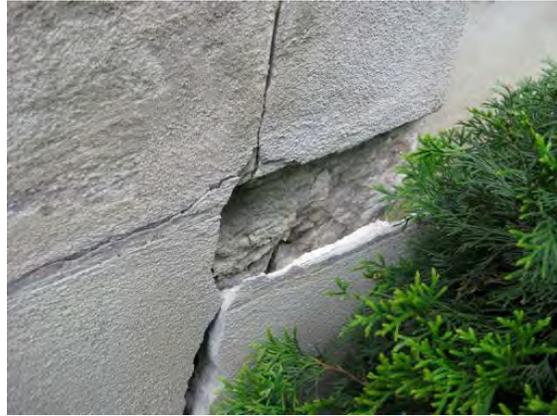
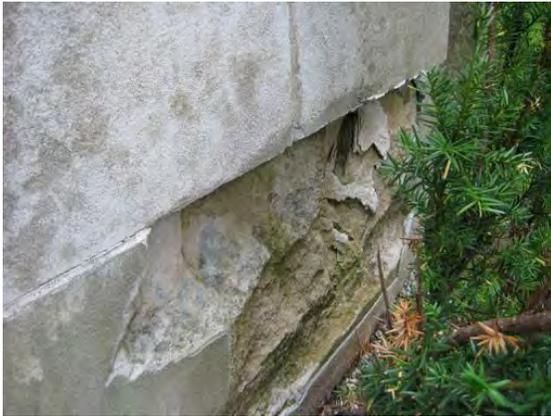
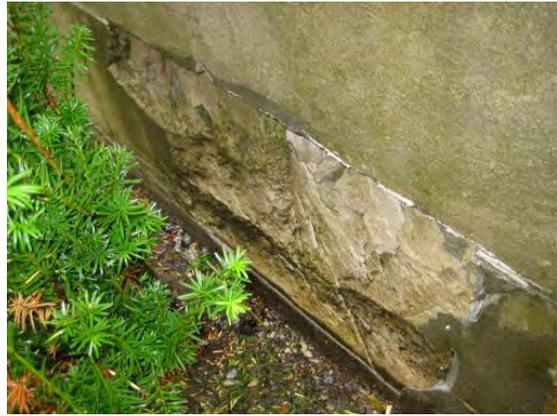
Fig. II-3.4(1): Spalled Stone Base

This stone base, particularly along the grade, has effectively been destroyed, largely through moisture absorption from the ground, followed by freeze-spalling. Sedimentary stone in general is poorly suited to such wet, often freezing conditions.

The steel wire anchors securing this base to the building are minimal to begin with, and it is highly probable that these have been further compromised by corrosion.

Left uncorrected, the current spalling will continue, and will eventually destroy the entire base portion.

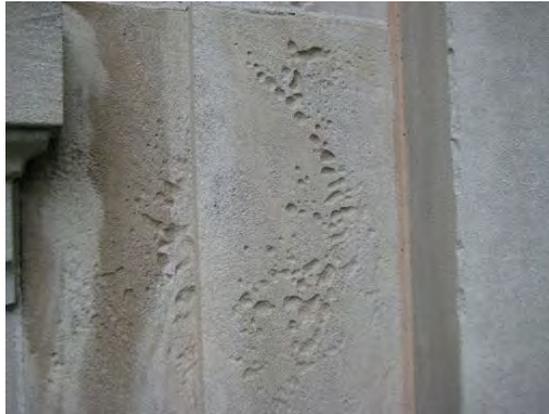
Fig. II-3.5(1): Stone Cladding Erosion

This leads to the second issue concerning the cladding's condition. The stone is moderately degraded, and displays scattered erosion, cracking, mortar delamination, etc. Though less visible, it also appears very likely that the metal anchorage has also been at least partly degraded by corrosion. The cracking of the stone sills appears to reflect seismic damage, and it further exacerbates moisture intrusion and anchor corrosion.

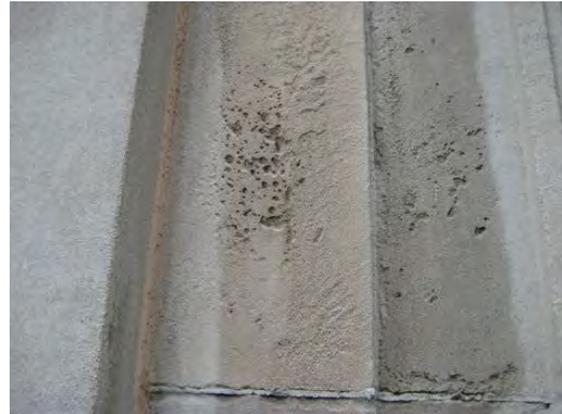
Fig. II-3.5(2): Stone Cladding Erosion

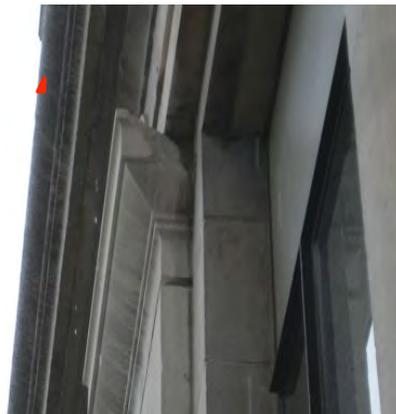
Fig. II-3.5(3): Spalled-Off Stone Capital

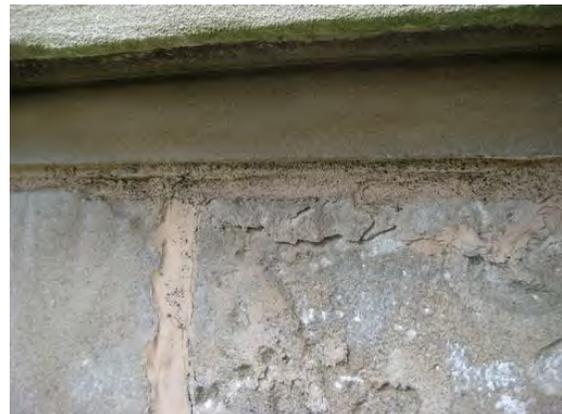
Fig. II-3.5(4): Stone Cladding Spalling

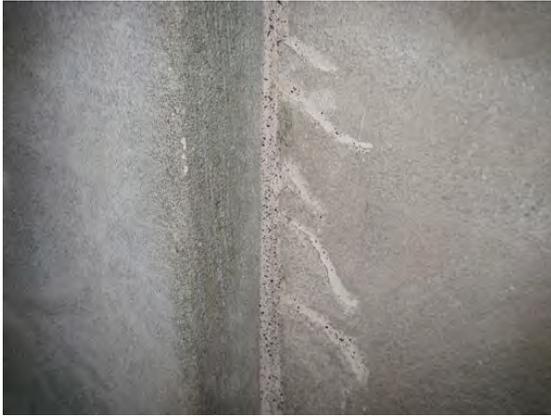
Fig. II-3.5(5): Surface Cracking of Stone

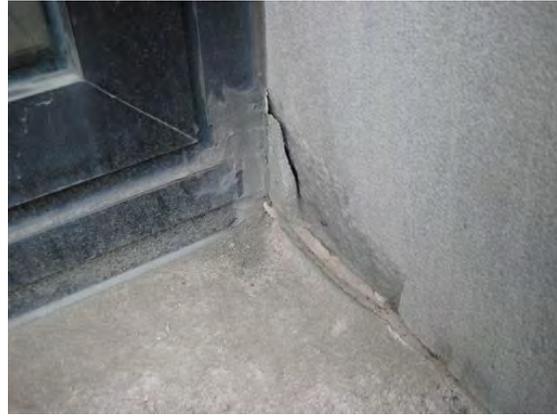
Fig. II-3.5(6): Stone Cracking

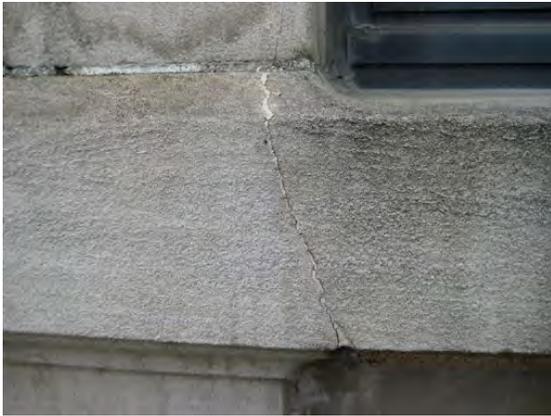
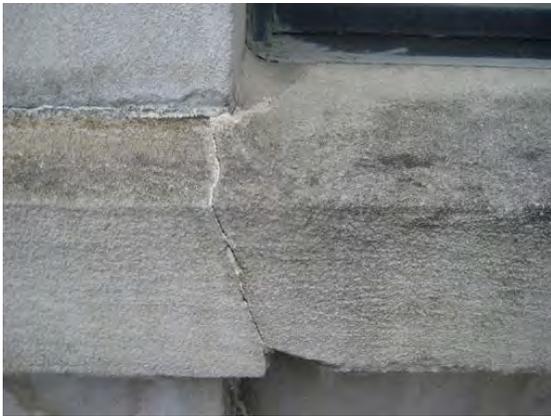
A related interesting observation is that all ground-level stone sills within this cladding are cracked at one side, and all sills located west of the central entry are cracked at their west ends, while all sills located east of the entry are cracked at their east ends. See Figures II-3.5(7-10).

Fig. II-3.5(7): W. Sill Cracked @ W. End

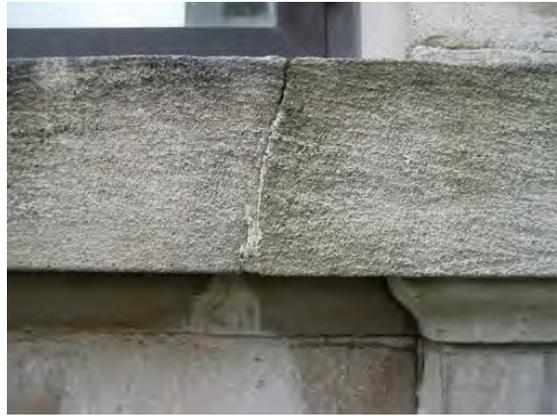
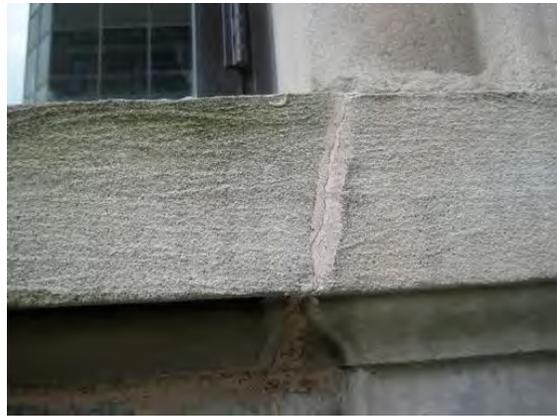
Fig. II-3.5(8): E. Sill Cracked @ E. End

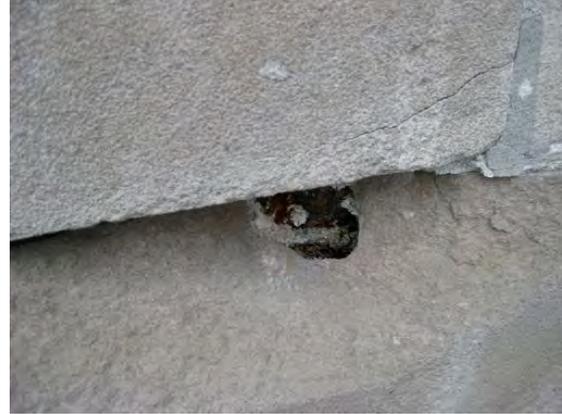
Fig. II-3.5(12): Corroded Wire Anchor

The anchorage of the stone cladding to the structure was insufficient to begin with, and this inadequacy has been further exacerbated by anchor corrosion. Many of the stone elements weigh several thousand pounds each, and anchorage failure would cause these, and the supported brick above, to fall off the building.

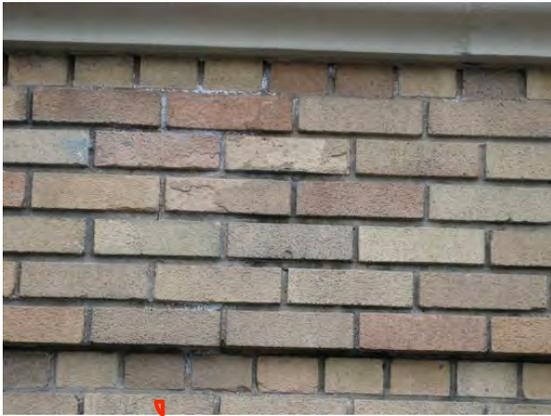
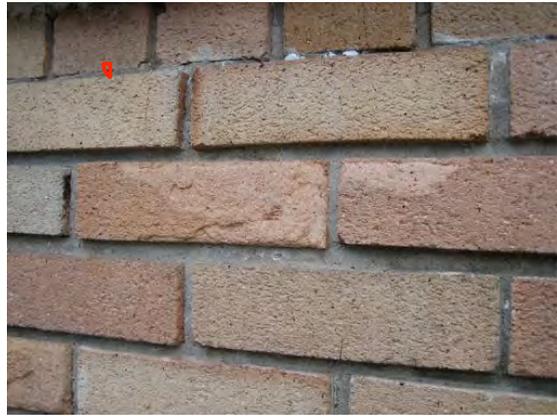
General design considerations can be divided into several sub-categories. First, the composition of these walls varies appreciably between where these occur over the concrete columns and between the columns. Where these occur over the concrete columns, which represents the majority of locations, the brick walls consist of double-wythe brick placed outward of the concrete columns. Between columns, such as above and below some windows as well as adjacent to some windows, the brick walls contain 3 brick wythes. In all cases, the brick wythes contain interlocking header or rowlock courses, wherein the brick is turned 90 degrees to span across two adjacent wythes to secure them together. Figures II-3.6(1 & 2) depict this header coursing.

Fig. II-3.6(1): Recessed Header Coursing

Fig. II-3.6(2): Recessed Hdr. Course

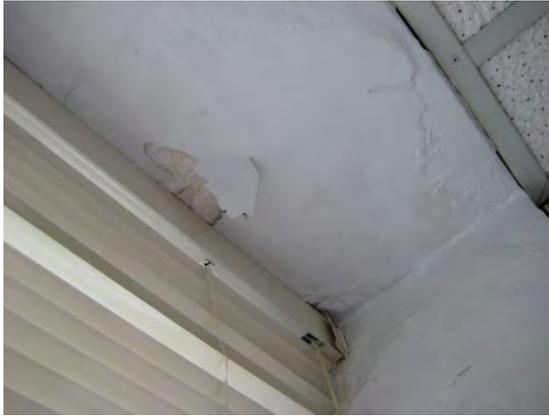
Further, none of these brick walls incorporate any flashings or weep holes to help drain any water back out of the brickwork. Consequently, expected symptoms of infiltration are scattered around the building, such as interior plaster damage near windows, elevated moisture levels within the stone cladding below these brick walls, extreme infiltration into the portico roof structure and stone cladding below, etc. Absence of flashings above steel lintels that support the brick above some windows has also contributed to variable degrees of lintel corrosion, even at some sheltered locations. Figures II-3.6(3-10) illustrate some examples of observed symptoms.

Fig. II-3.6(3): Interior Plaster Damage
