SUMMARY EVALUATION,
CORRECTIVE OPTIONS,
AND ESTIMATED CORRECTIVE COSTS

ALASKA STATE
CAPITOL

Juneau, AK.

Date: 2/20/13

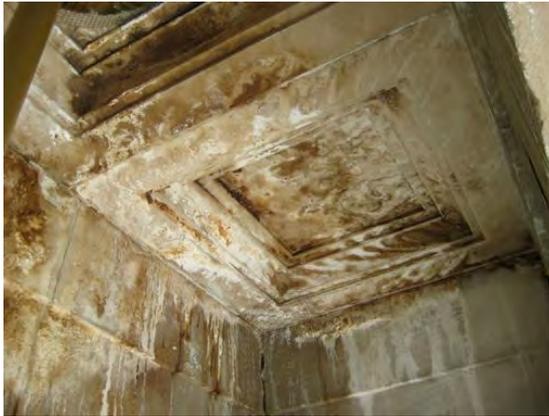
Further, none of these brick walls incorporate any flashings or weep holes to help drain any water back out of the brickwork. Consequently, expected symptoms of infiltration are scattered around the building, such as interior plaster damage near windows, elevated moisture levels within the stone cladding below these brick walls, extreme infiltration into the portico roof structure and stone cladding below, etc. Absence of flashings above steel lintels that support the brick above some windows has also contributed to variable degrees of lintel corrosion, even at some sheltered locations. Figures II-3.6(3-10) illustrate some examples of observed symptoms.

Fig. II-3.6(5): Portico Ceiling Damage

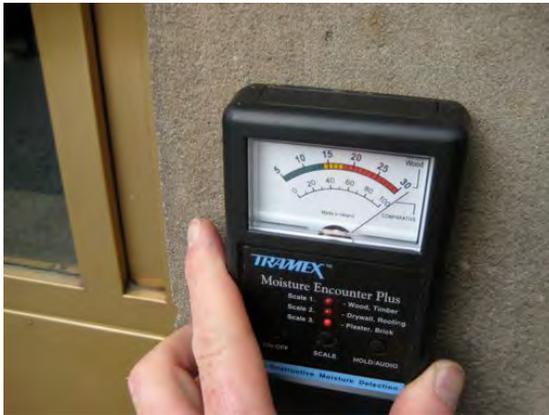
Fig. II-3.6(7): High Moisture in Stone Bel.

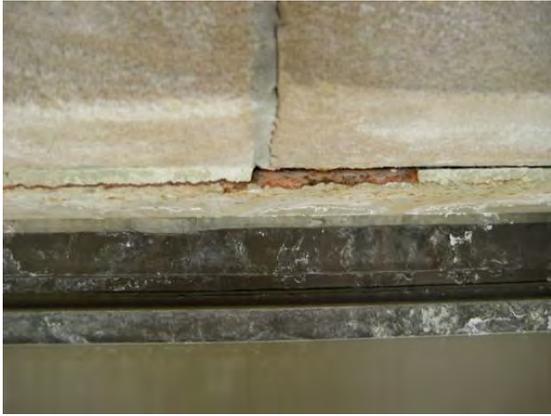
Fig. II-3.6(9): Lintel Corrosion

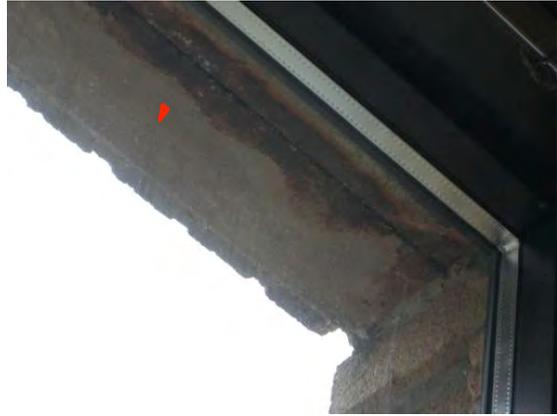
Fig. II-3.6(10): Lintel Corrosion

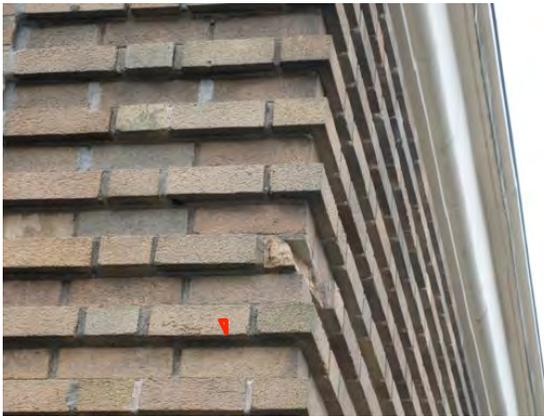
Although the specific bond pattern varies between different levels, all of the visible brickwork is similar in that it is characterized by typically recessed header courses and deeply raked mortar joints. Both of these factors increase the brickwork's weather-exposed surface area, and create many water-catching ledges throughout the exterior brick surface. This design approach, though adding visual interest, greatly increases moisture intrusion and associated degradation of the brick and mortar, and widespread spalling and surface erosion affects the brickwork, especially at highly exposed locations. Figures II-3.6(11-18) illustrate some of these observations.

Fig. II-3.6(11): Brick Spalling

Unfortunately, the specific configuration of the brickwork, combined with the already advanced erosion of the outermost brick faces, will lead to ongoing spalling, which can be slowed down, but cannot be effectively stopped, by treating with consolidating agents.

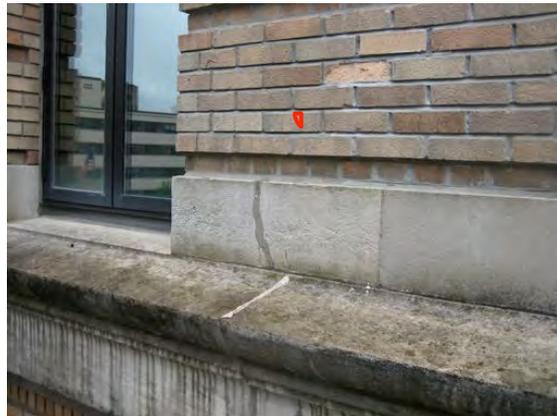
Fig. II-3.6(12): Brick Spalling

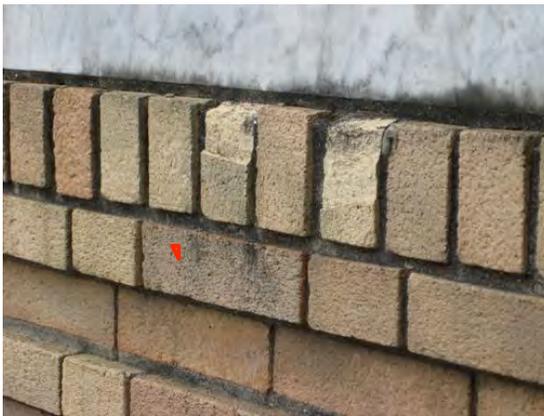
Fig. II-3.6(13): Brick Spalling

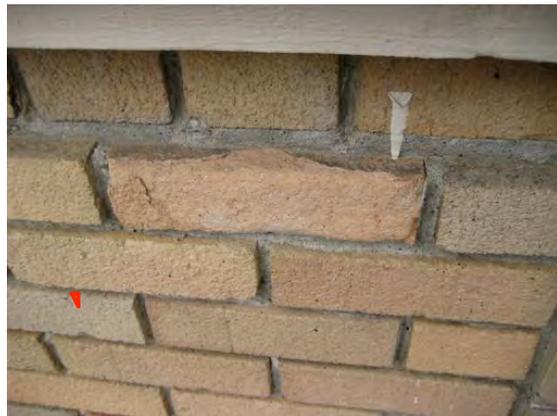
Fig. II-3.6(14): Brick Spalling

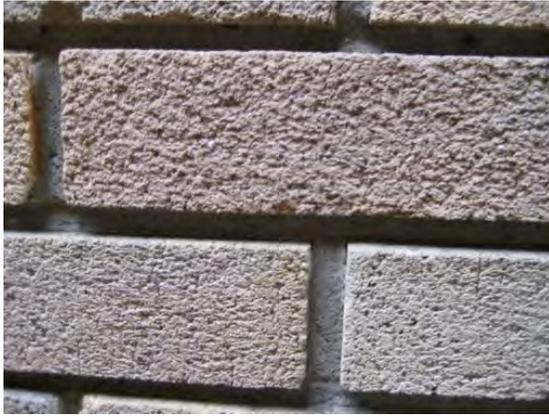
Fig. II-3.6(15): Brick Surface Erosion

Though I have only observed comparable levels of surface erosion on similarly-aged brick which had been actively sandblasted for cleaning, my recent observation that the serious erosion does not appear to affect more sheltered exposures could indicate that in this case, Mother Nature alone may have caused this. The marble columns, for example, also display serious erosion on their SW, SE, and NE faces, while their NW exposures retain much of their original polish, implying that severe weather hits this building from the southeast.

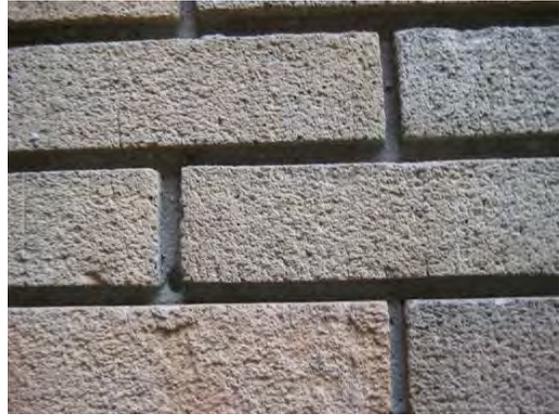
Fig. II-3.6(16): Brick Surface Erosion

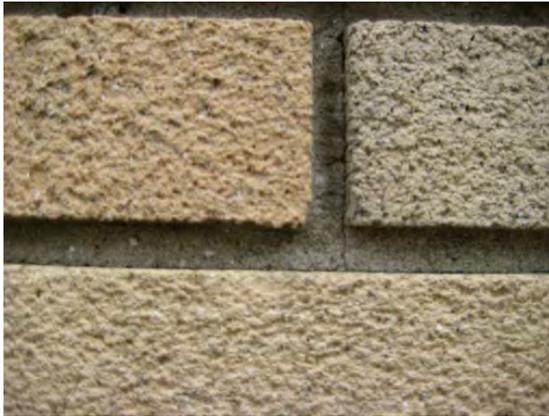
Fig. II-3.6(17): Brick Surface Erosion

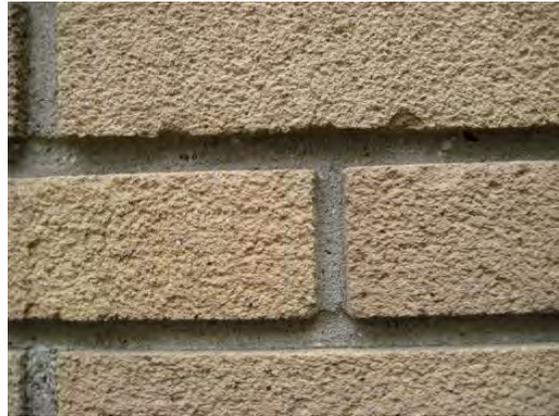
Fig. II-3.6(18): Brick Surface Erosion

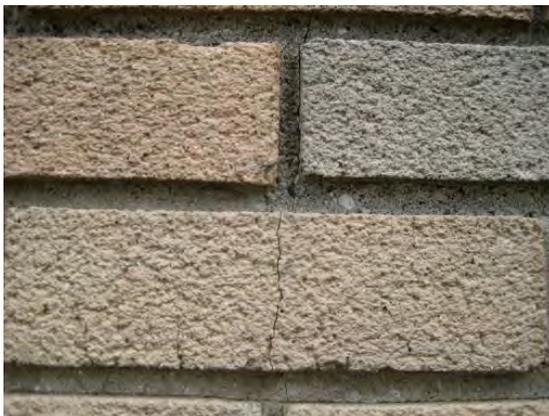
In addition to widespread spalling, the brickwork also displays scattered cracks through both the brickwork and mortar. Figures II-3.6(19-24) illustrate some of these observations.

Fig. II-3.6(19): Brick & Mortar Crack

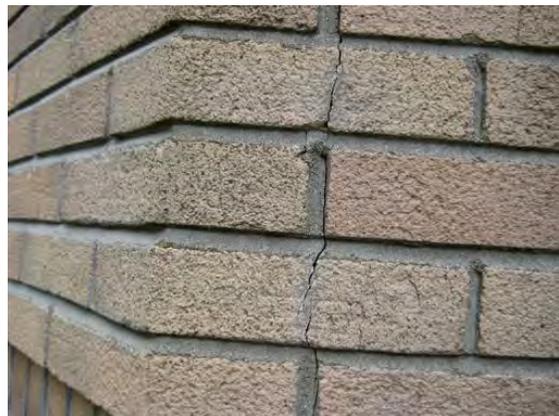
Fig. II-3.6(20): Brick & Mortar Crack

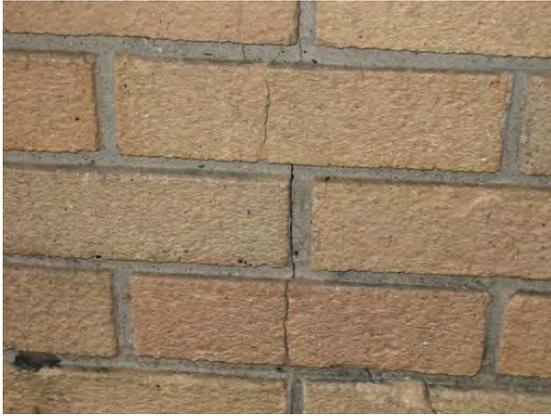
Fig. II-3.6(21): Brick & Mortar Crack

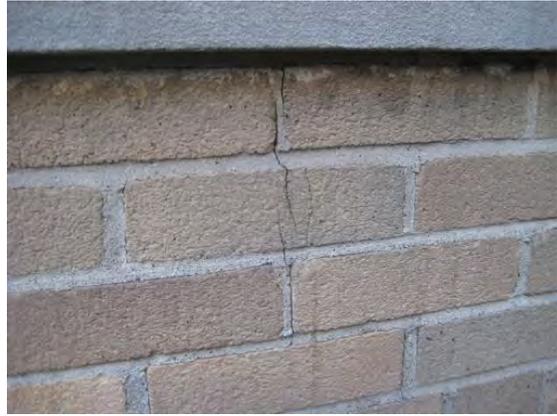
Fig. II-3.6(22): Brick & Mortar Crack

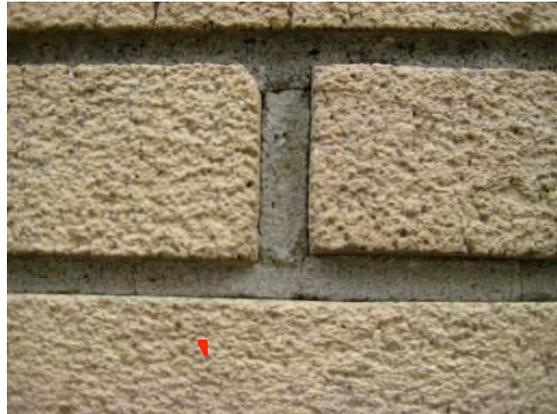
Fig. II-3.6(24): Mrtr. Crck. & Delamin.

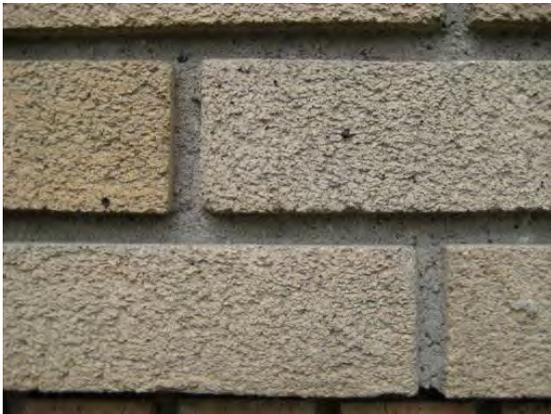
The mortar condition varies greatly between locations, with some areas displaying largely sound, well-bonded mortar, while eroded, cracked, and delaminated mortar typifies other locations. Figures II-3.6(25 & 26) illustrate this variation.

Fig. II-3.6(25): Well-Bonded Mortar

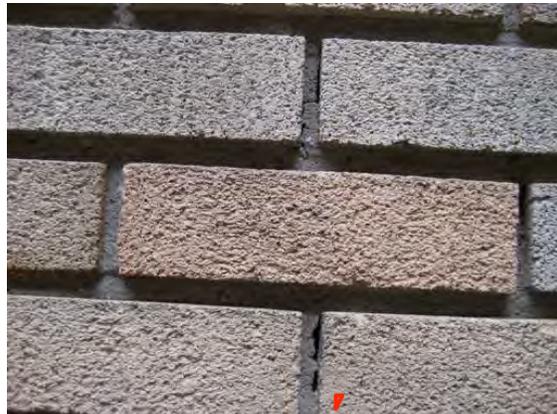
Fig. II-3.6(26): Mrtr. Crck. & Delamin.

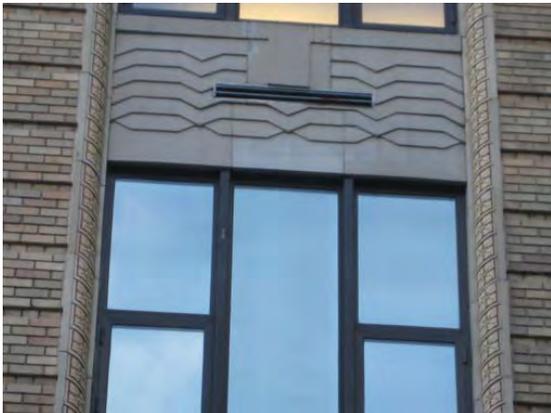
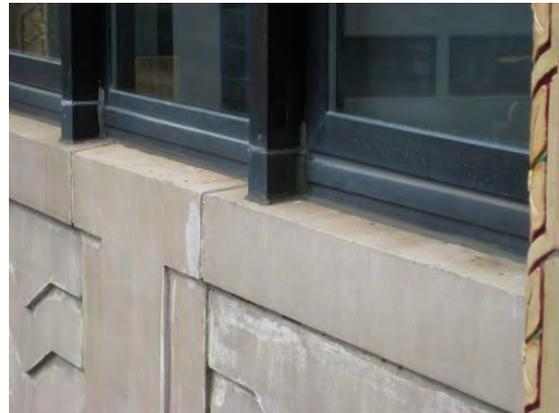
Each of these terra-cotta spandrel panels consists of six individual terra-cotta pieces, which are secured to the back-up brick walls with steel anchors. The apparent condition of these elements varies appreciably between different locations. Many appear to still be in reasonably good condition, with minor surface spalling.

Fig. II-3.7(1): Moderate Degr. of T-C Panel **Fig. II-3.7(2): Mod. Degr. of T-C Panel**

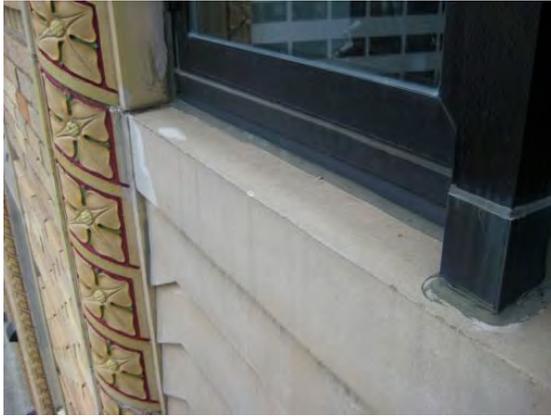
Fig. II-3.7(3): Minor Degr. of T-C Panel

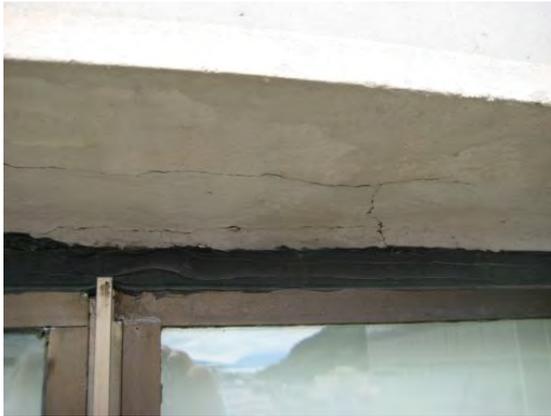
However, the design of these elements lacks any drainage provisions, as is typical of all masonry elements on this building, and as was typical of masonry in general during this building's construction. Consequently the bottoms of many panels in weather-exposed locations are degrading, with spalling and efflorescence evident.

Fig. II-3.7(5): Serious Degr. of T-C Pnl. Bot.

The absence of flashing caps significantly increases infiltration into these panels, and the fairly advanced degradation along the bottoms of some panels confirms this. The panel-bottom damage is appreciably accelerated by the absence of drainage provisions. Removal of the roof cornice in the past further increased exposure.

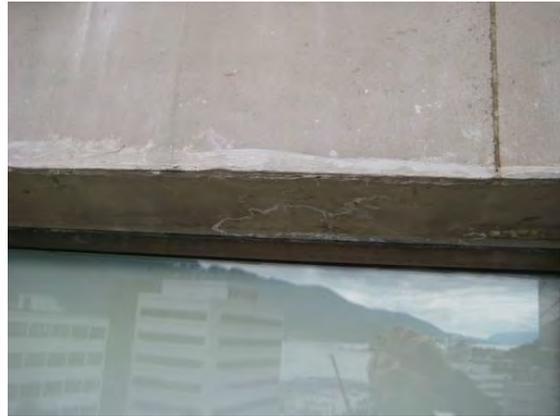
Fig. II-3.7(6): Serious Spalling @ Bot.

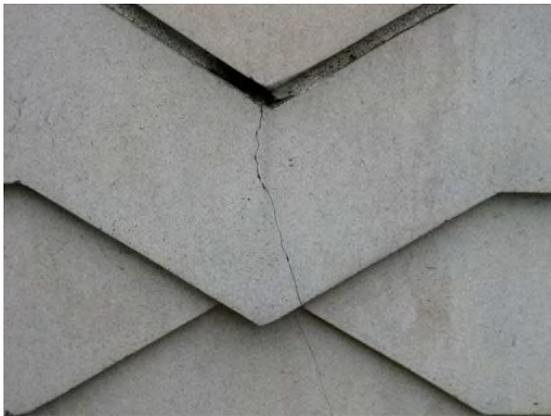
In addition, various panels display both vertical and horizontal cracking, which often coincides with locations of embedded steel, and can be an early indication of corrosion of embedded steel.

Fig. II-3.7(7): Vertical Cracking in T-C Pnl.

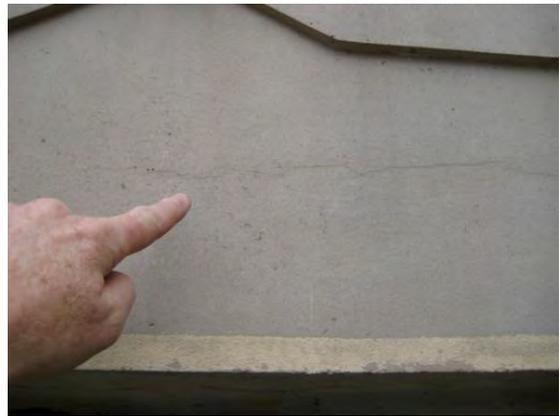
Fig. II-3.7(8): Horiz. Crack in T-C Pnl.

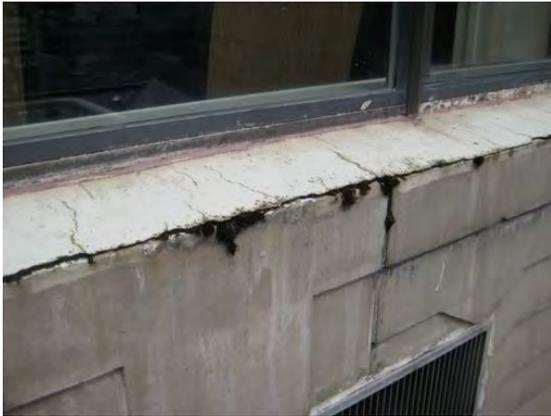
Above the entry portico, several of these panels have sloping mortar-wash sills, which are degrading seriously. Several panels in the same general location also have some grille penetrations with moss growth. Figures II-3.7(1-12) illustrate examples of these observations.

Fig. II-3.7(11): Sill Degradation

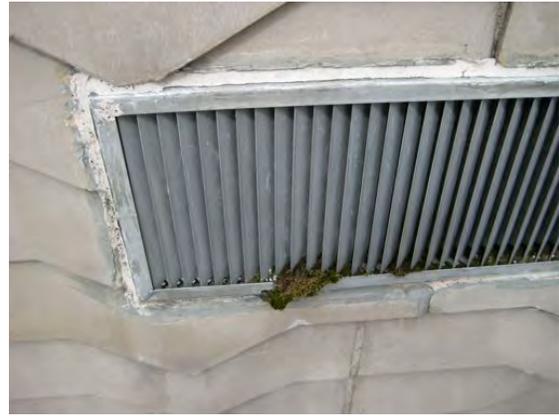
Fig. II-3.7(12): Grille Penetration

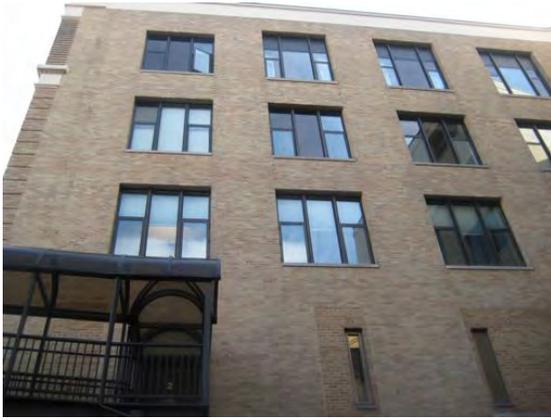
Fig. II-3.8(1): Utility-Grade Design

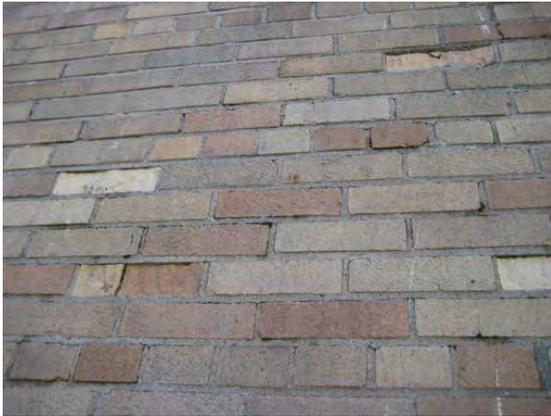
Fig. II-3.8(3): Spalling, E-Facing Wall

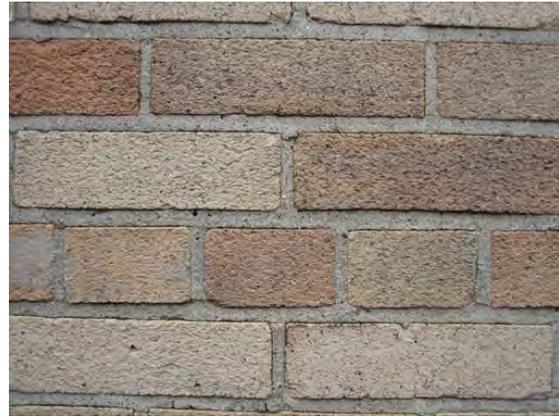
Fig. II-3.8(4): Erosion, E-Facing Wall

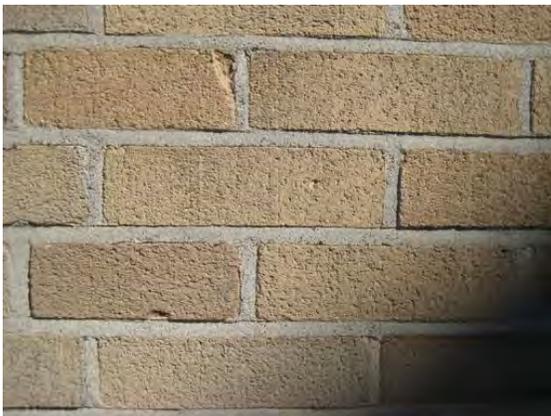
Fig. II-3.8(5): Better Cond., W-Facing Wall

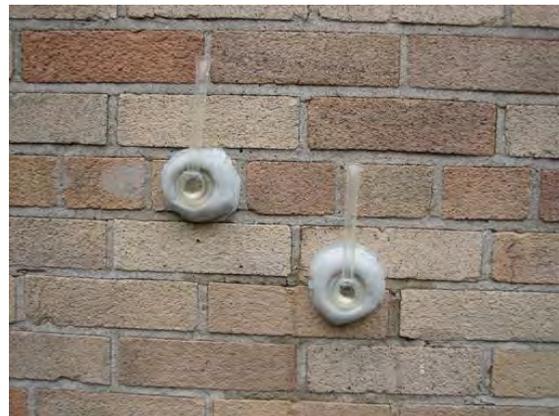
Fig. II-3.8(6): Absorption Test, E. WI.

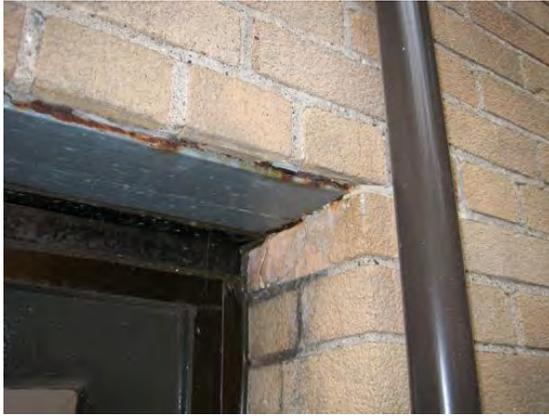
With regard to “design and weathering” considerations, these walls are also similar to the more public ones. For example, they also lack flashings or weep holes to drain water out of the brickwork, or above steel window-head lintels, which display variable, and in a few locations moderately-advanced, corrosion.

Fig. II-3.8(7): Lintel Corr., E-Wall, Bottom

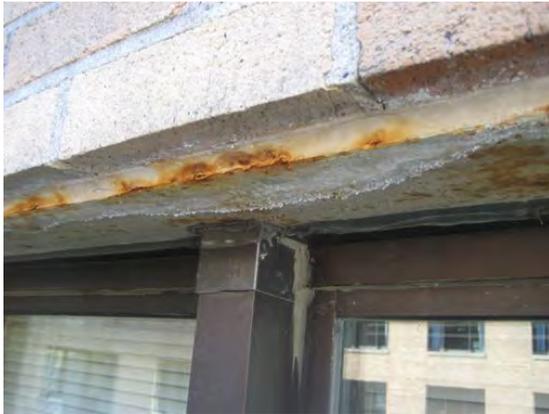
Fig. II-3.8(9): Lintel Corr., E-Wall, Top

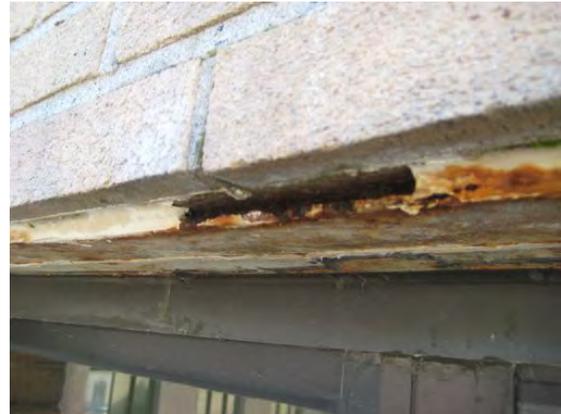
Fig. II-3.8(10): Lintel Corrosion, E.

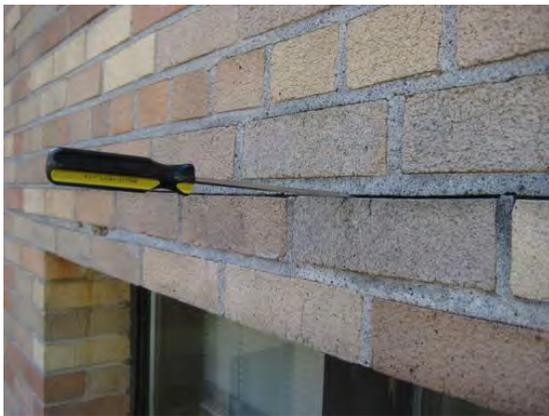
The east-facing wall also displays cracking in the brick as well as in one pre-cast concrete window sill. Further, it appears that the steel window-head lintel above an upper-level window has sagged, causing a long and significant delamination crack in the brick header above.

Fig. II-3.8(11): Sagging Head., E-Wall, Top

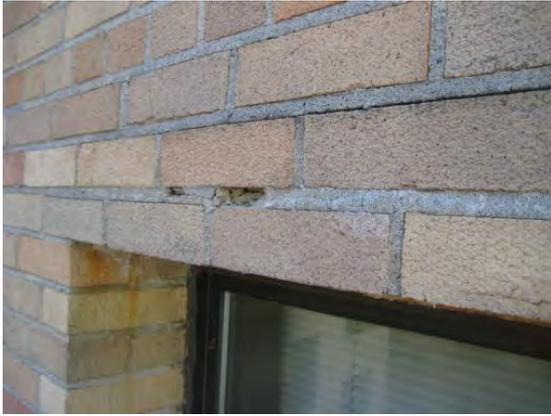
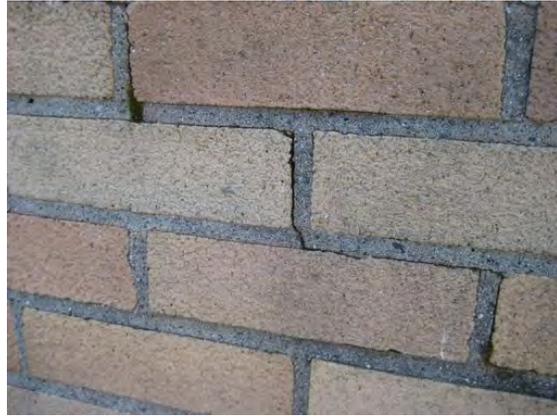
Fig. II-3.8(13): Sagging Head., E-Wall, Top **Fig. II-3.8(14): Crack @ E. Wall, Top**

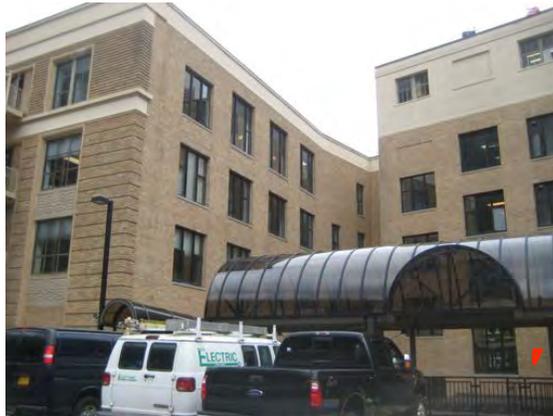
With regard to their construction, these walls are effectively identical to the other courtyard walls, differing primarily in being taller, protruding a floor level above the roof line, with this upper portion over-clad with directly adhered stucco. The east and west stairwell walls consist of triple-wythe brickwork, while the north wall consists almost entirely of concrete columns wrapped with a single brick wythe. The south wall, which occurs only above the roof, consists of double-wythe brick coated with stucco. The upper stucco band, as well as the entire height of the east-facing wall, is painted with an elastomeric coating. Figures II-3.9(1 & 2) illustrate these observations.

Fig. II-3.9(1): Stairwell's North Wall

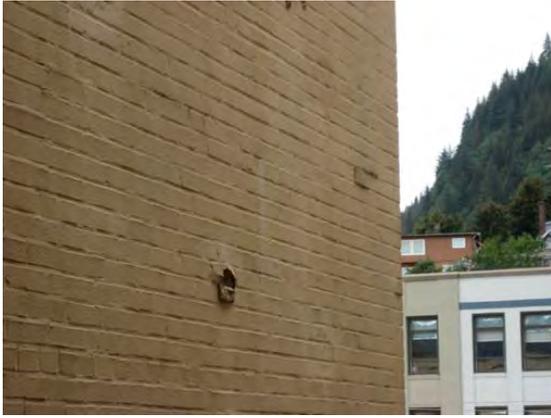
The east-facing wall suffers significant brick spalling, though partly concealed by the elastomeric coating, which has clearly been applied to address infiltration. The coating has not proved successful in fully precluding moisture entry, and spalling continues, with brick chunks in places hanging by only the coating. The north and west-facing walls are in notably better condition. See Figures II-3.9(3-5).

Fig. II-3.9(5): Post-Coating Spalling., East

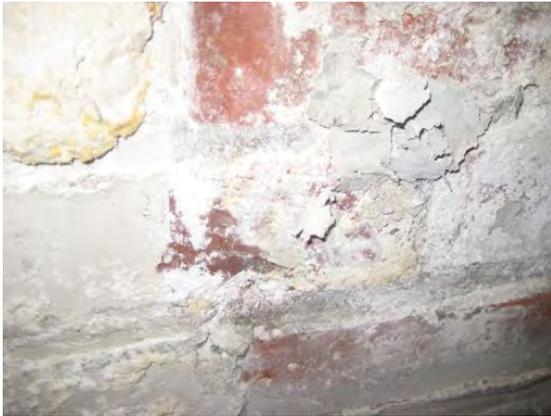
Indications of ongoing infiltration are also evident at the south-facing wall, whose innermost face manifests the surface pulverization, brick flaking, and white salt deposition characteristic of deep infiltration, as already explained in greater detail in subsection II-3.6.2. See Figures II-3.9(6-8).

Fig. II-3.9(7): Flaking @ Interior, S. Wall

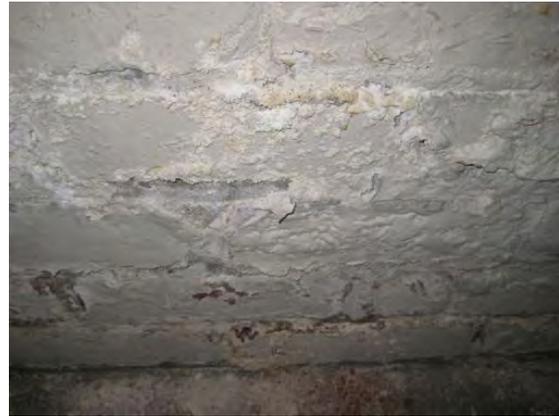
Fig. II-3.9(8): Flaking @ Int., S. Wall

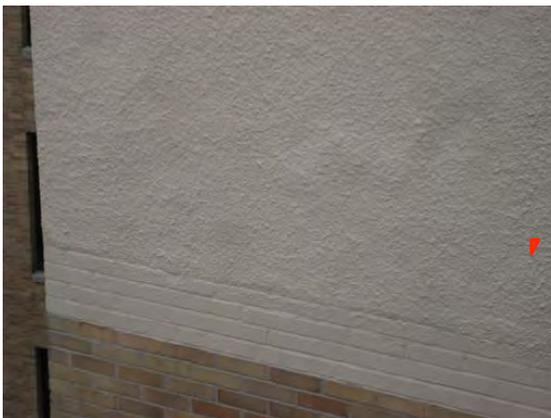
The upper stucco band appears directly adhered to the brick. In places, it bulges outward, and some coating blisters indicate moisture intrusion behind the coating. The stucco's bottom merges into the brick face below, and the elastomeric coating spans across the juncture, precluding any opportunity for drainage. Similarly, the stucco joins the abutting parapets and roof in a non-draining fashion, wherein any water behind the stucco would drain into the roof assembly. See Figures II-3.9(9-12).

Fig. II-3.9(9): Stucco Bulging, W. Wall

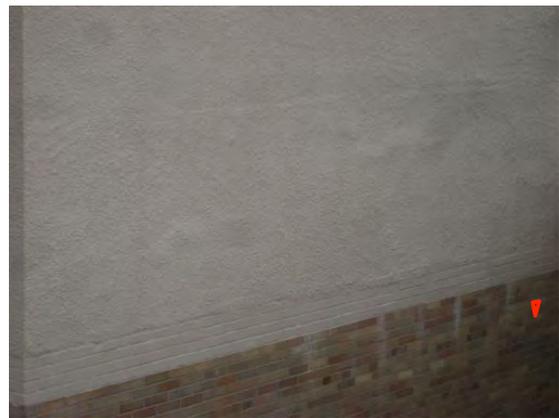
Fig. II-3.9(10): Coating Over Junct.

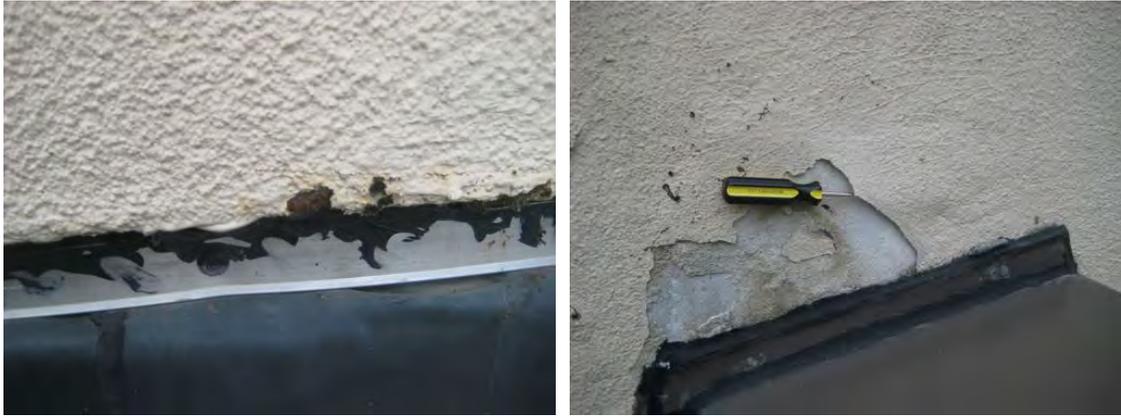
Fig. II-3.9(11): Non-Dr. Stucco-Roof Junct. Fig. II-3.9(12): Blistered Coating

Similarly, improper, non-draining junctures of the stucco cladding to the parapets and roof along the south side pose inherent risk of interior leakage and damage to the roof.

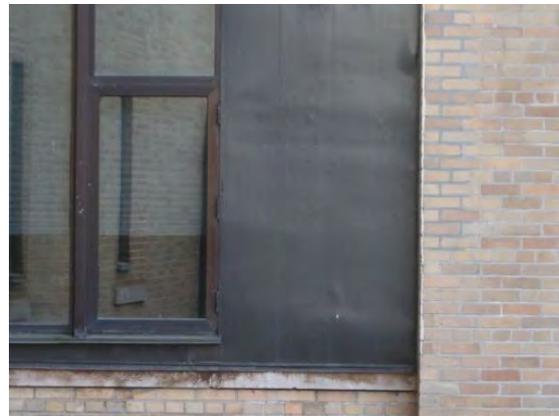
These two newer, small walls are reported to consist of standard light-gage steel framing, with steel studs, gypsum exterior sheathing, probably building paper, an exterior metal cladding, and windows and doors. Examination with binoculars did not reveal any drainage provisions along the metal cladding’s base. The cladding is lightly warped. Figures II-3.11(1 & 2) show the eastern wall.

Fig. II-3.11(1): N-Facing, Metal-Clad Wall

Fig. II-3.11(2): Metal Cladding

Absence of cladding drainage provisions, if confirmed, would exacerbate risk of interior leakage and water damage to the lower portions of these walls. This concern is appreciably minimized by the sheltered orientation of both walls.

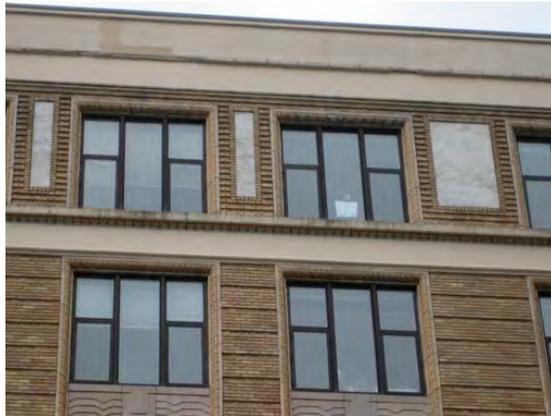
Fig. II-3.12(1): Typ. Window Configuration

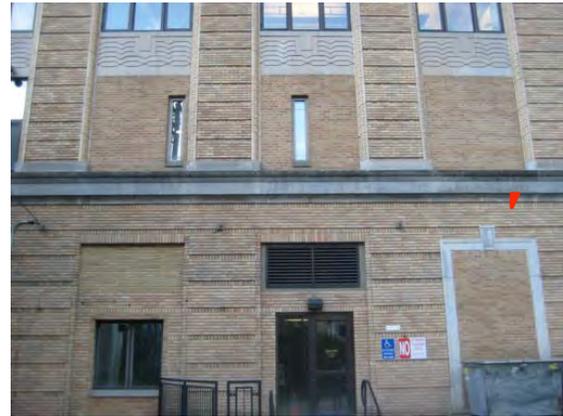
Fig. II-3.12(2): Atypical Narrow Units

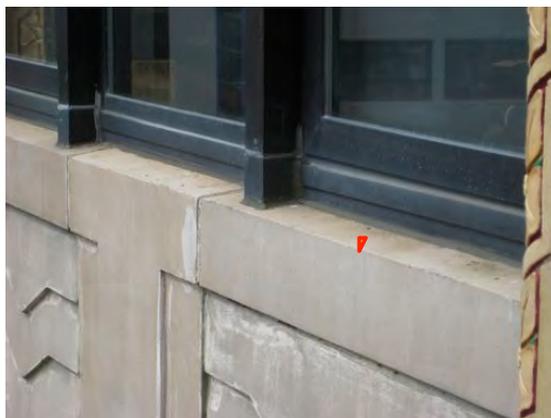
Fig. II-3.12(3): Typ. Wide-Mullion Config.

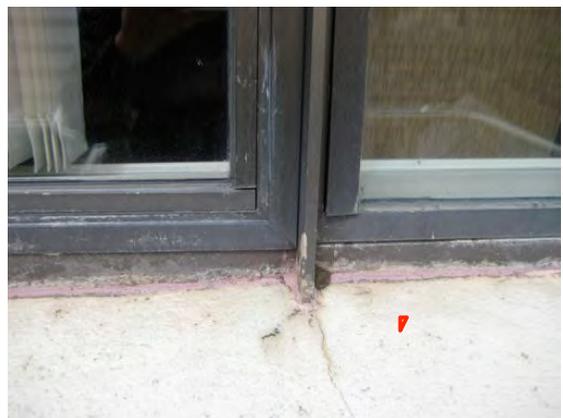
Fig. II-3.12(4): Atypical Narrow Mulls.

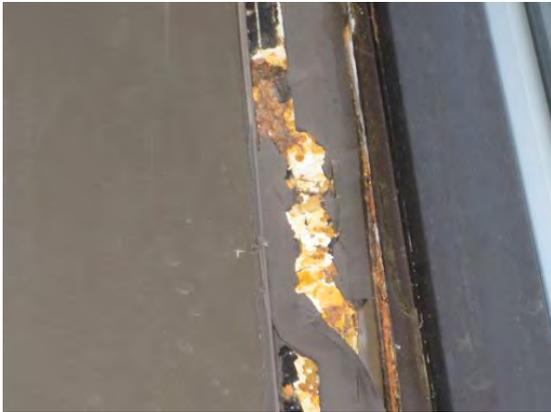
A few loose and deflected window frames revealed that the new aluminum windows had been installed over the original steel frames, which were corroding. See Figures II-3.12(5 & 6).

Fig. II-3.12(5): Corroding Steel Frame

The severely corroded steel frames behind the aluminum extrusions appear to reflect electrolytic corrosion, wherein fastening of the aluminum and steel elements together greatly accelerated corrosion. Water intrusion and condensation within the frames may have exacerbated this effect.

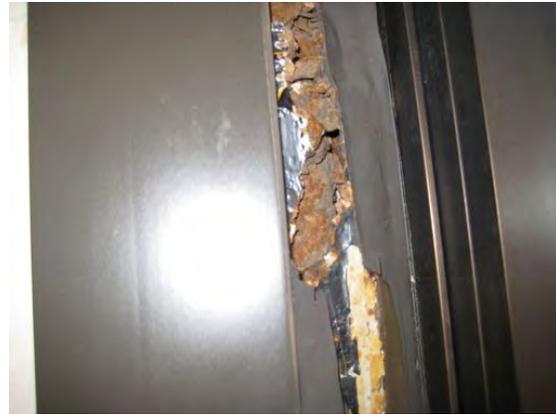
Fig. II-3.12(6): Corroding St. Frame

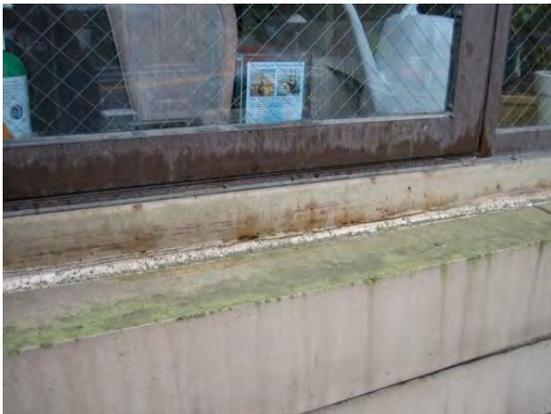
Although the original steel-sash windows contain rudimentary drainage provisions, such as notches to preclude damming, the newer aluminum units lack any integral drainage. Raised dams along outer sill edges block drainage from the sub-sash channels, whose various screw penetrations and holes clearly allow water into the frame extrusions, but sealant applied along all exterior junctures precludes outward drainage from the frames. The application of sealant over all joints is extremely unusual, and typically, such measures reflect ill-fated efforts to stop leakage. See Figures II-3.12(7-11).

Fig. II-3.12(7): Original Steel-Sash Window

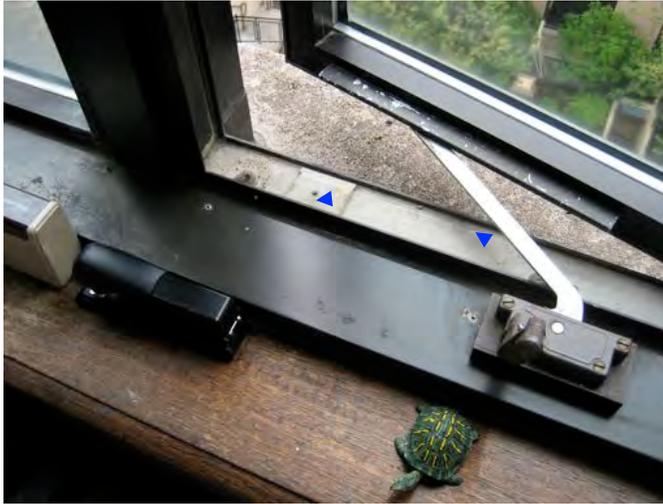
- Raised inner sill dam precludes inward spillage of water off sill below operable sash.

- Continuous raised outer lip lacks any notches or holes to allow water atop sill to drain back out.

Figure II-3.12(9): Absence of Drainage Notches or Weeps in Outer Sill Lip

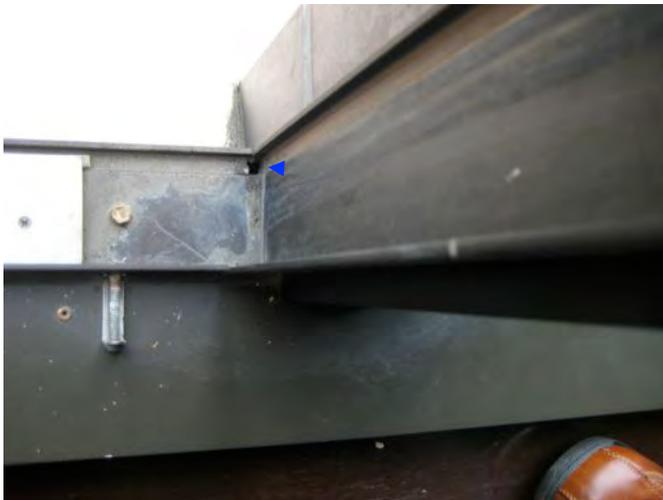
- Hole in sill extrusion drains water off sill into sill extrusion, which appears to be fully sealed and unable to drain.

Figure II-3.12(10): Hole at Sill/Jamb Juncture Allows Water Into Sill Extrusion

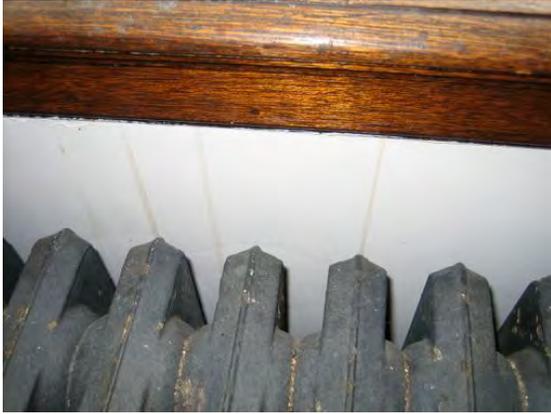
Not surprisingly, my examination also revealed relatively widespread evidence of previous leakage, such as blistered plaster around and below windows, white deposits at many interior joints, elevated moisture content below some window sills, streaks on plaster below sills, and similar manifestations. In a couple of locations, some sort of oily streaks occur on interior mullion faces. While many such symptoms reflect leakage via masonry above these windows, others, such as those below midspans of interior sills and along joints in the aluminum extrusions, are more likely to reflect leakage via the windows themselves. Sealant along interior window frame joints, which is quite unusual, may also reflect an effort to stop leakage. Figures II-3.12(12-23) show some examples of these observed symptoms.

Fig. II-3.12(12): Streaks Bel. Window Sill

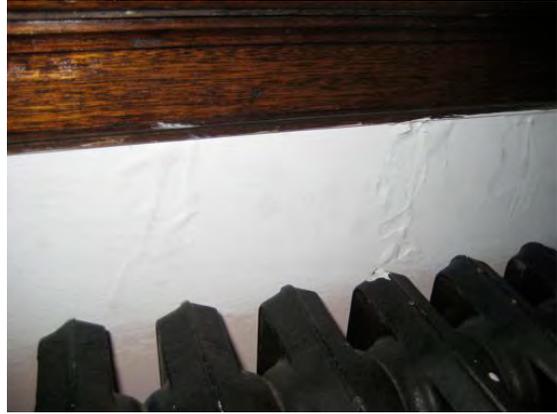
Fig. II-3.12(13): Plstr. Dam. Bel. Sill

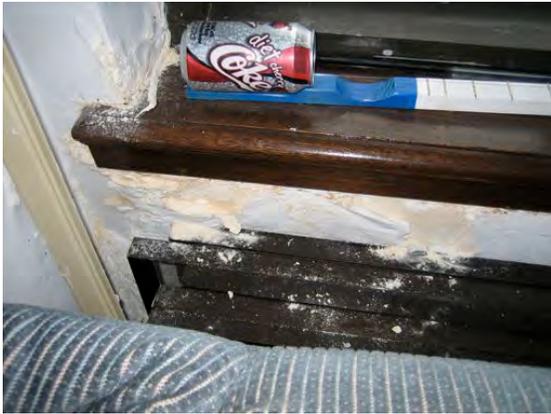
Fig. II-3.12(14): Plaster Damage Below Sill

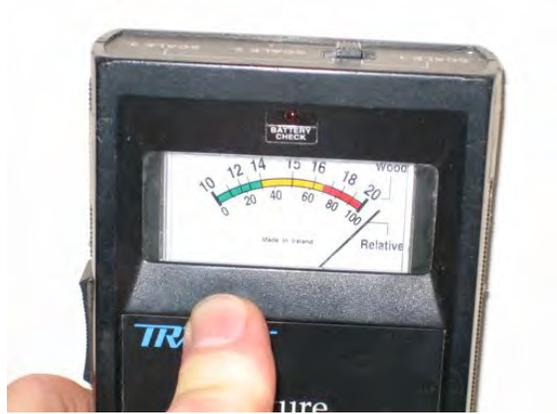
Fig. II-3.12(15): Elev. Moist. Bel. Sill

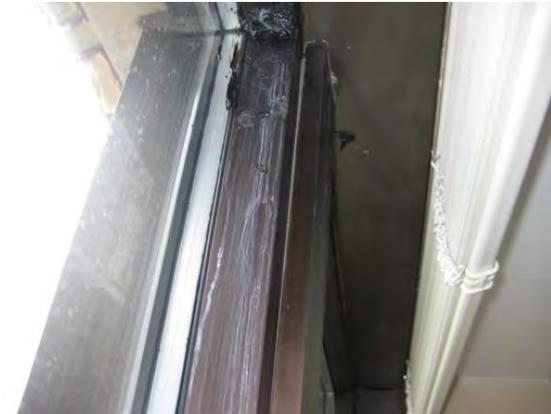
Fig. II-3.12(16): Streaks Bel. Window Head

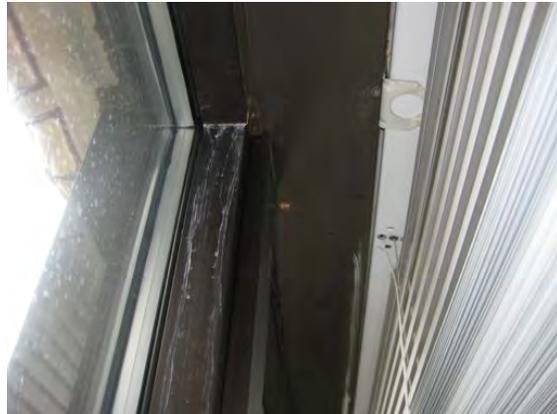
Fig. II-3.12(17): Streaks on Mullion

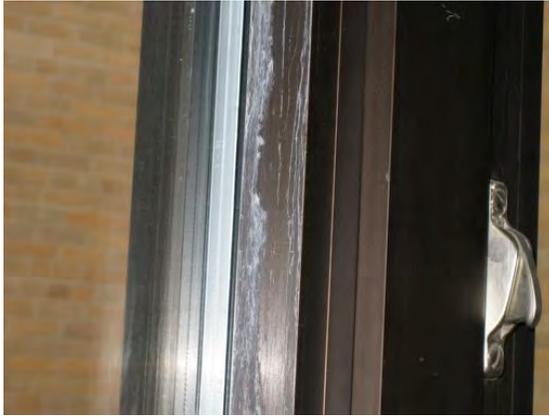
Fig. II-3.12(18): Streaks On Mullion

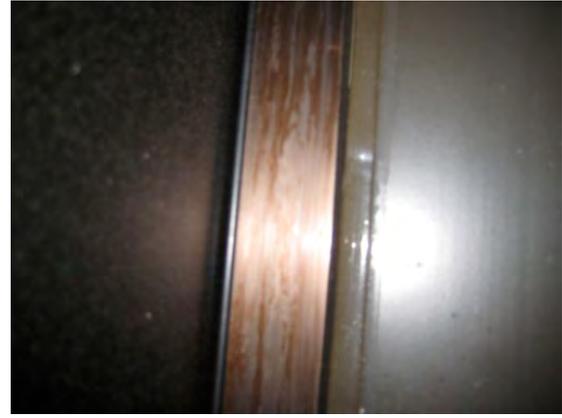
Fig. II-3.12(19): Oily Streaks on Mull.

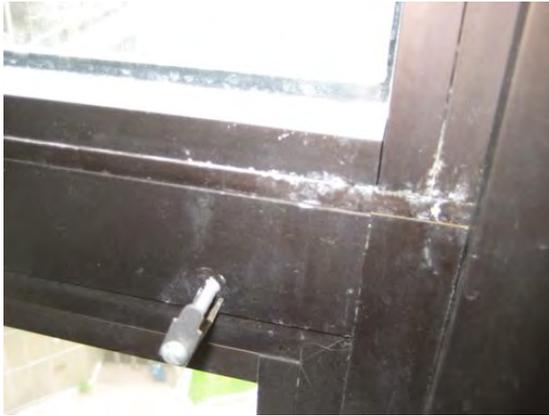
Fig. II-3.12(20): White Dep. At Frame Jts.

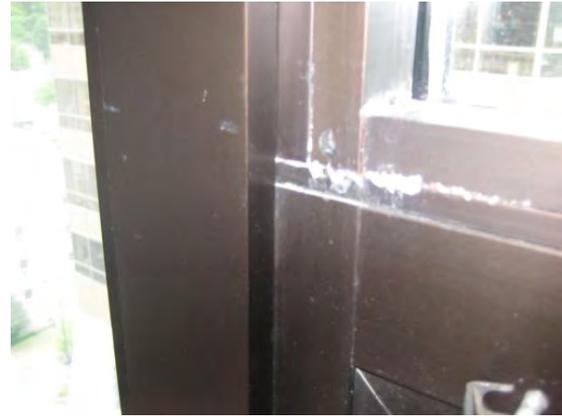
Fig. II-3.12(21): White Dep. At Joints

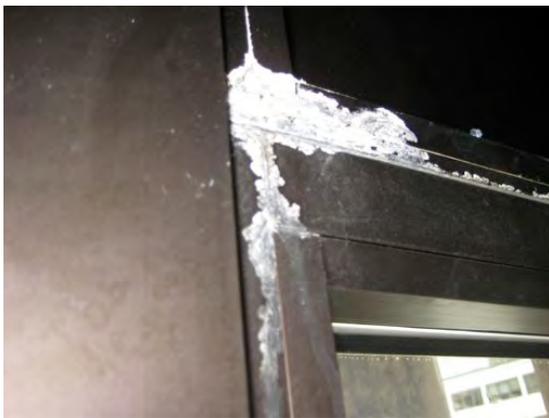
Fig. II-3.12(22): White Dep. At Frame Jts.

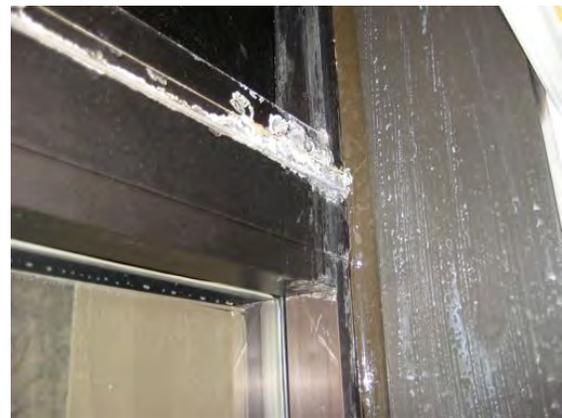
Fig. II-3.12(23): White Dep. At Joints

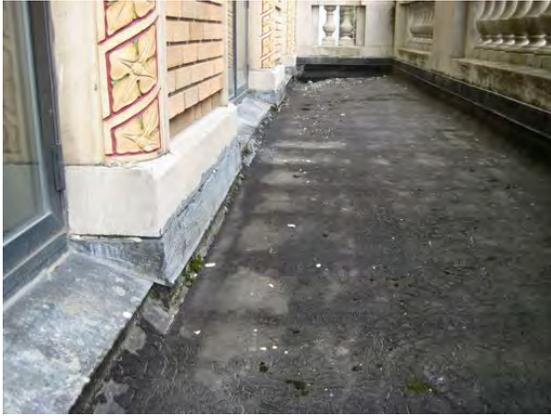
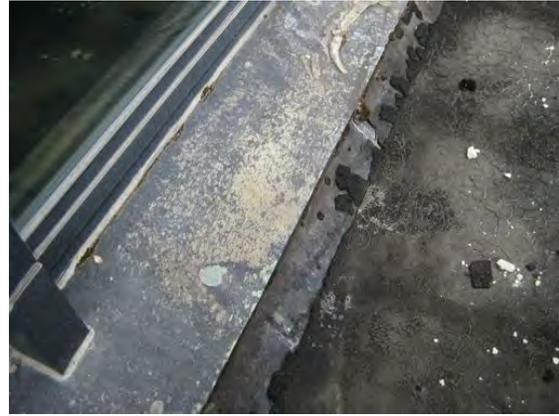
In addition, the sills of the three windows above the portico occur quite close to the roof, and occasionally become buried in snow, increasing leak risk. These sills are capped with asphalt-coated copper sill flashings, which could lead to corrosion if copper-aluminum contact occurs. All joints in these windows are also sealed with sealant. See Figures II-3.12(24 & 25).

Fig. II-3.12(24): Sills Near Portico Roof

Fig. II-3.12(25): Cpr. Flshgs. Bel. Al.

Placement of three windows only a few inches above the portico roof also increases leak risk, particularly during periods of wet snow accumulation.

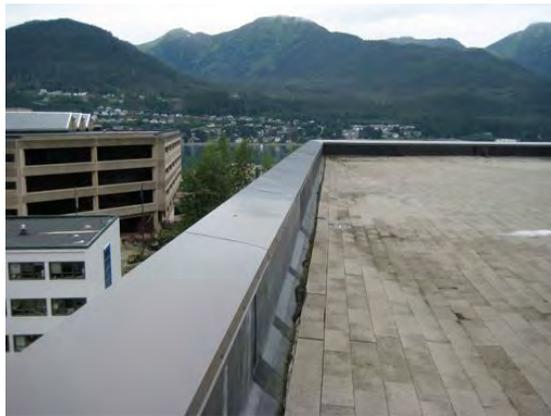
Fig. II-3.13(1): Paver-Capped Main Roof

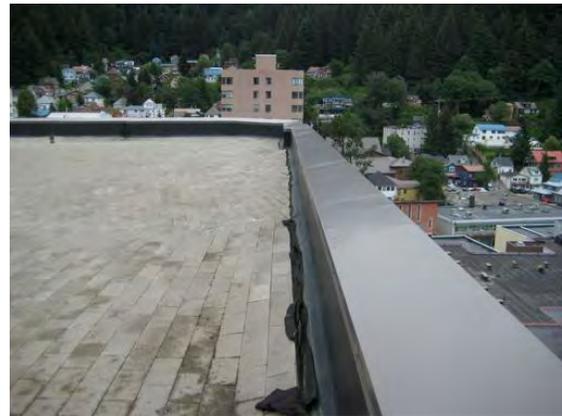
Fig. II-3.13(2): Paver-Capped Main Rf.

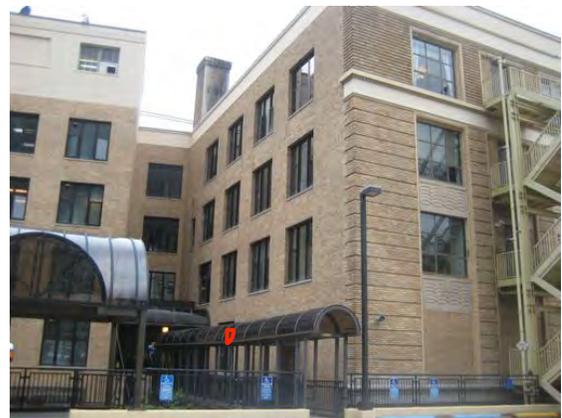
Fig. II-3.13(4): Paver-Capped Low Rf.

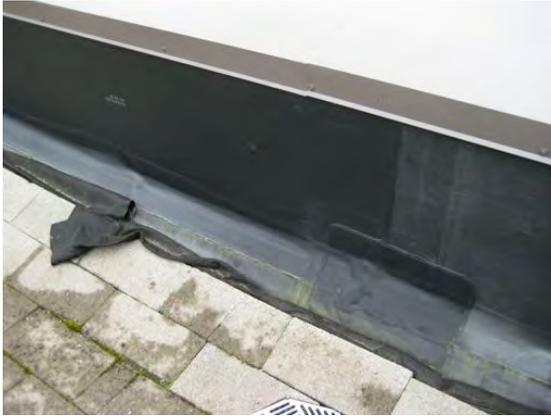
Fig. II-3.13(5): EPDM Roof w/IRMA Config.

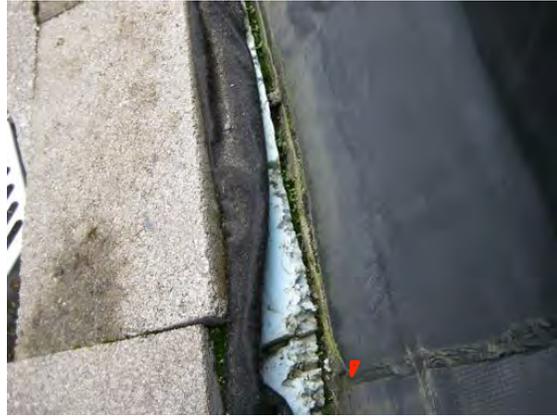
Fig. II-3.13(6): Insul. Atop Rf. Membr.

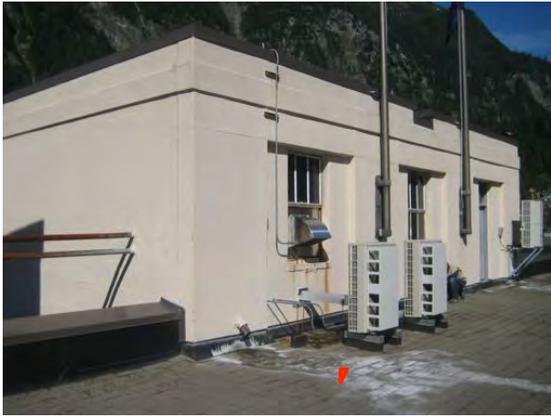
A second major observation relates to all conditions where the roof membrane joins higher masonry walls above, such as along the base of the brick chimney, where the main roof joins the stair-tower walls and parapets, and where the two lower roofs abut the brick-clad walls. The roof membrane top edges at these junctures are secured with continuous termination bars, with sealant above the bars, but with no through-wall flashings to allow drainage from the masonry or stucco above.

Fig. II-3.13(7): Non-Drain. Roof-Wall Junct.

The non-draining junctures of the roof membrane to abutting walls are quite improper, and substantially increase risk of leakage below such transitions. This may be one reason why the stairwell's east-facing brick wall, as well as several chimney walls, had been painted with an elastomeric coating, probably reflecting an effort to stop infiltration below.

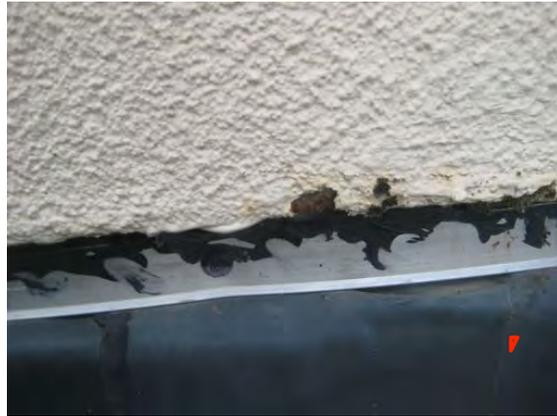
Fig. II-3.13(8): Sealed Roof-Wall Jct.

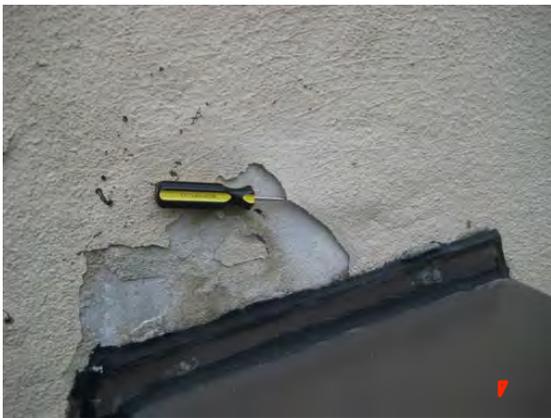
Fig. II-3.13(9): Non-Drain. Prpt.-Wall Junct.

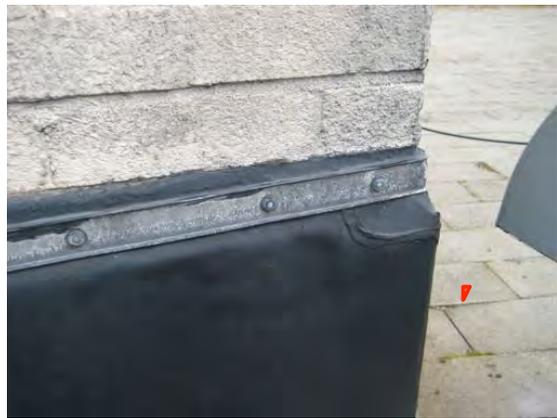
Fig. II-3.13(10): Sealed Roof-Wall Jt.
