SUMMARY EVALUATION,
CORRECTIVE OPTIONS,
AND ESTIMATED CORRECTIVE COSTS

ALASKA STATE
CAPITOL

Juneau, AK.

Date: 2/20/13

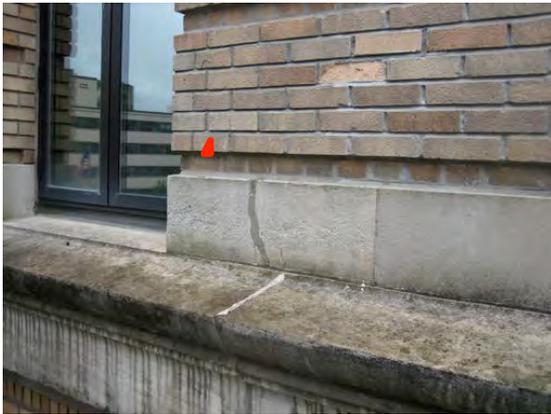
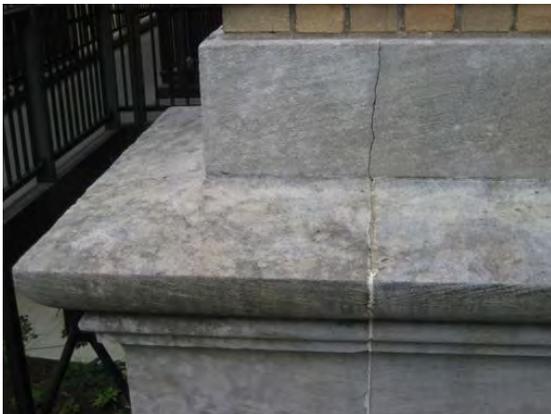
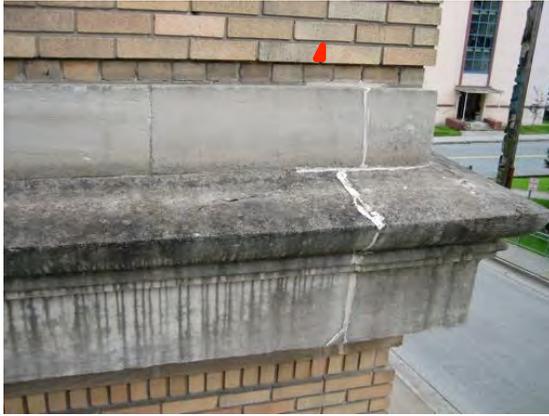
With regard to design, this water table lacks any flashings on top or under it, allowing permeation into the water table and the masonry below. Consequently, it displays appreciable degradation, erosion, cracking, and exfoliation. A large portion east of the south entry has spalled off between my 2006 and 2010 visits, and other sections are in process of spalling. See Figures II-4.1(1-14).

Fig. II-4.1(1): Cracking in Band Abv. W.T.

Fig. II-4.1(3): Cracking in Band Abv. W.T.

Fig. II-4.1(5): Cracking in Band Abv. W.T.

Absence of flashings atop and below the water table allows infiltration into the water table and masonry below, greatly accelerating degradation, spalling, and risk of interior leakage. However, the current degradation does not yet appear to have irretrievably damaged this water table.

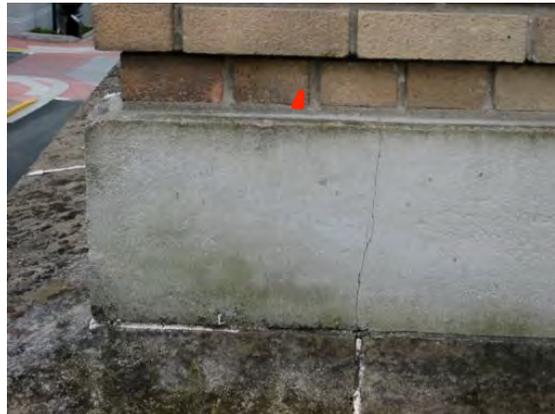
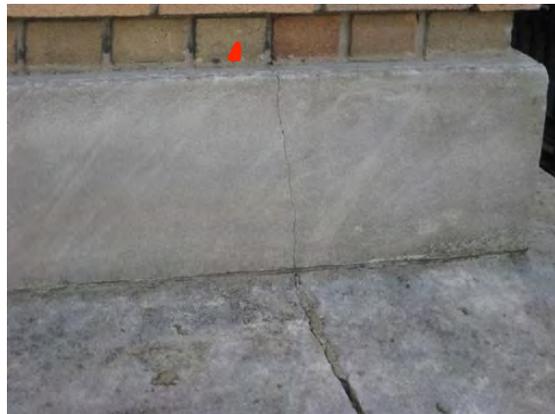
Fig. II-4.1(2): Crack Above Wtr. Tbl.

Fig. II-4.1(4): Crack Above Wtr. Tbl.

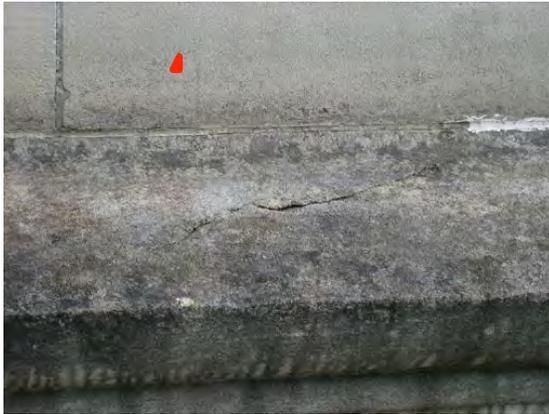
Fig. II-4.1(7): In-Progress Spalling of W.T.

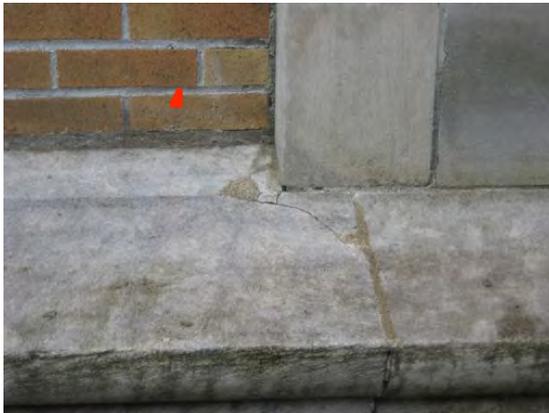
Fig. II-4.1(9): Spalling Near Steel Anchor

The water table's securement at the windows appears inadequate to resist lateral loads, though it seems notably beefier where it runs past embedded concrete columns. It is probable that the anchors have begun to corrode, compromising securement to variable degrees, depending on weather exposure.

The water table's securement may pose some risk to pedestrians below in case of earthquake. Continued corrosion of these anchors will compromise securement further, and will contribute to localized spalling near the water table top, which may have already begun.

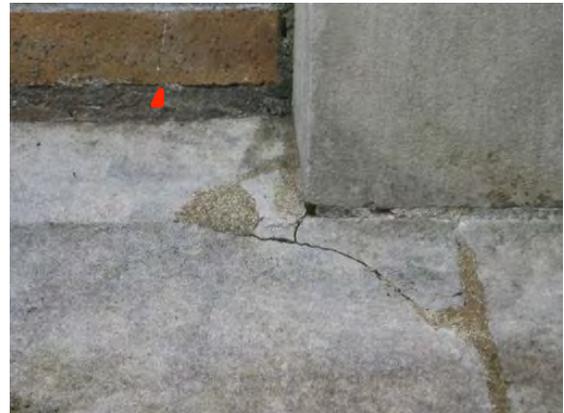
Fig. II-4.1(10): Spalling Near Anchor

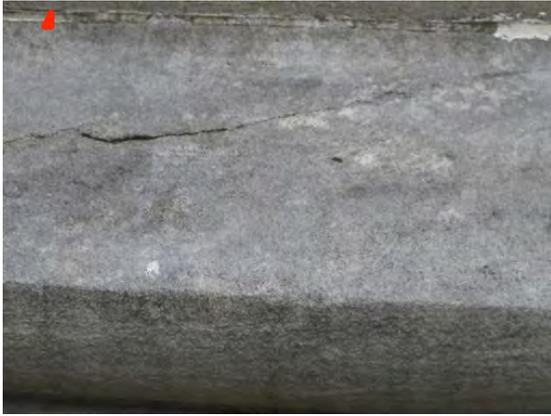
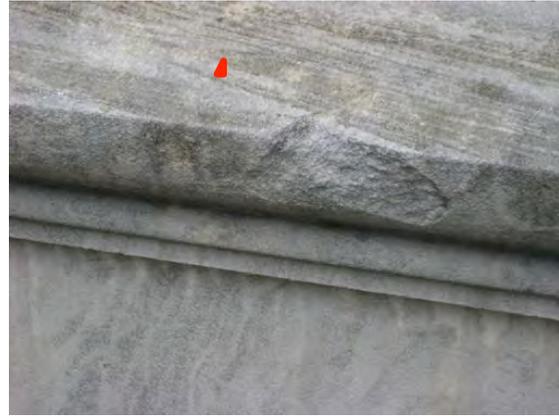
Fig. II-4.1(11): In-Progress Spalling of W.T. **Fig. II-4.1(12): Edge Spalling**

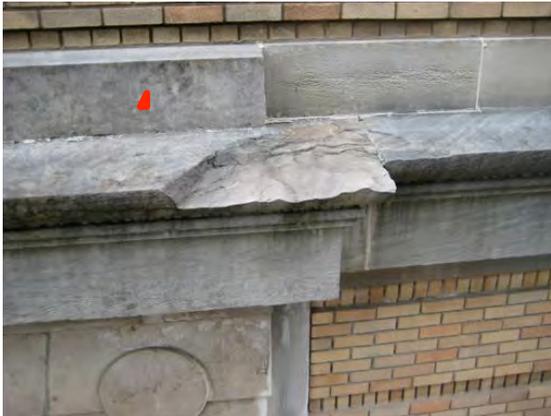
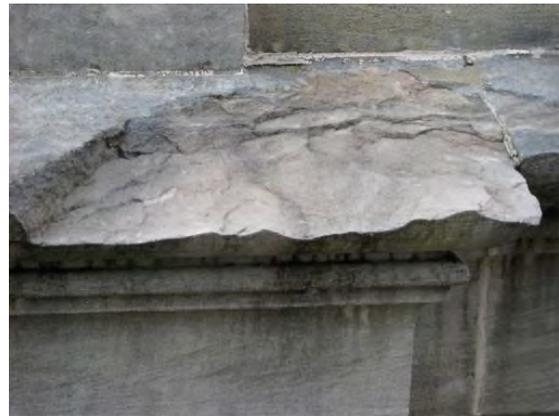
Fig. II-4.1(13): Spalled Water Table Top **Fig. II-4.1(14): Spalled W.T. Top**

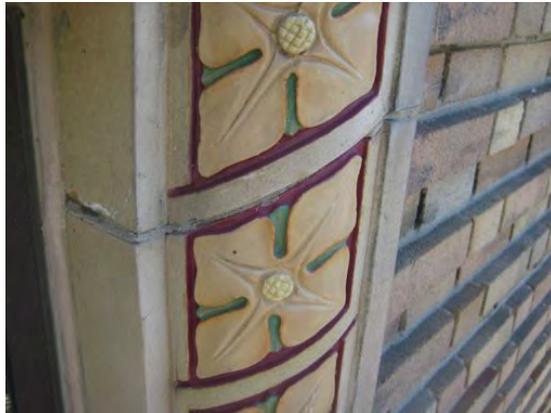
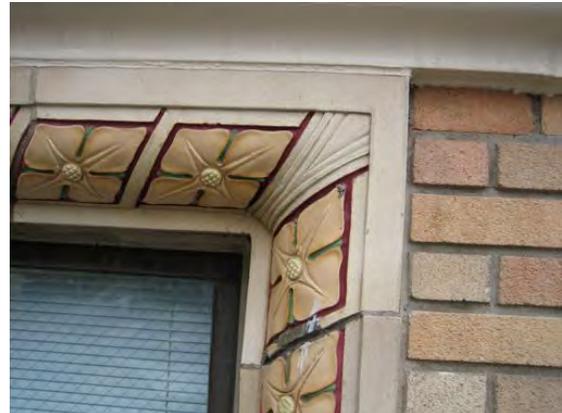
The condition of these terra-cotta elements varies greatly around the building. In many locations, these elements appear to still be in generally good condition, with no visible weathering symptoms, other than some color fading. See Figures II-4.2(1 & 2).

Fig. II-4.2(1): Terra-Cotta in Good Condition Fig. II-4.2(2): T.-C. in Good Condition

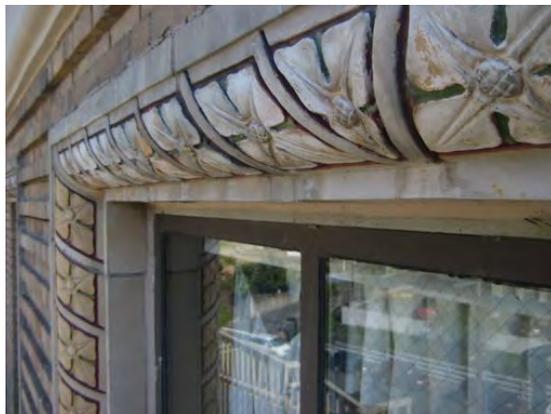
Elsewhere, many pieces are discolored by what appears to be lime. See Figures II-4.2(3-6).

Fig. II-4.2(3): Terra-Cotta Discoloration

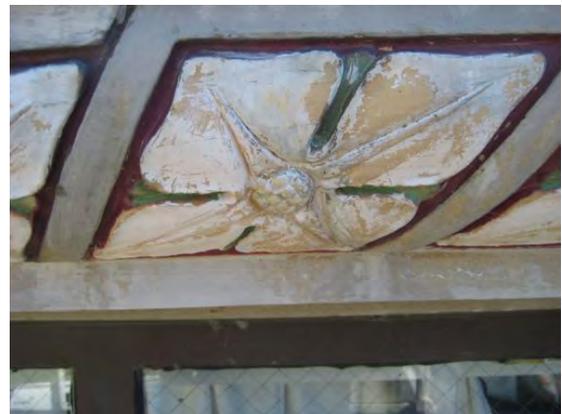
Fig. II-4.2(4): T.-C. Discoloration

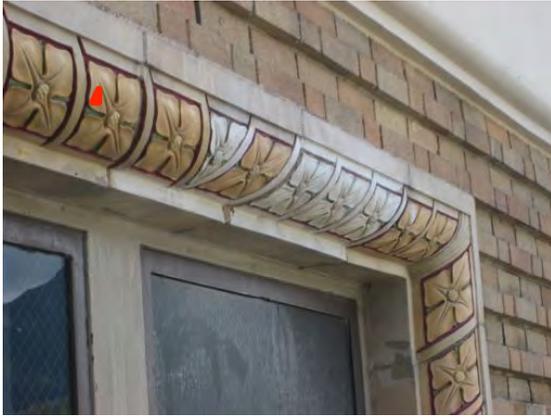
Fig. II-4.2(5): Terra-Cotta Discoloration

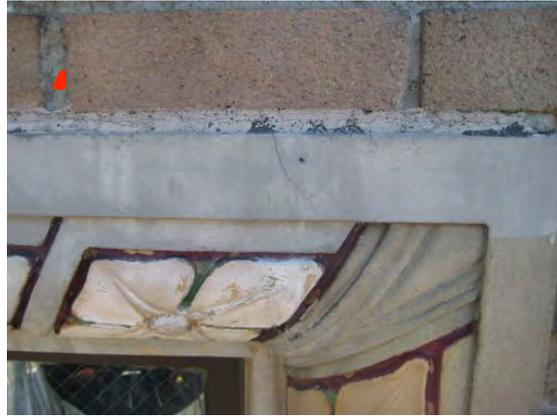
Fig. II-4.2(6): Discoloration, Cracking

Proceeding up the damage scale, a still fairly limited number of pieces have begun to show cracking and spalling of their outer faces, ranging from minor short cracks to complete face spalling. Figures II-4.2(6-12) illustrate the range of this type of damage.

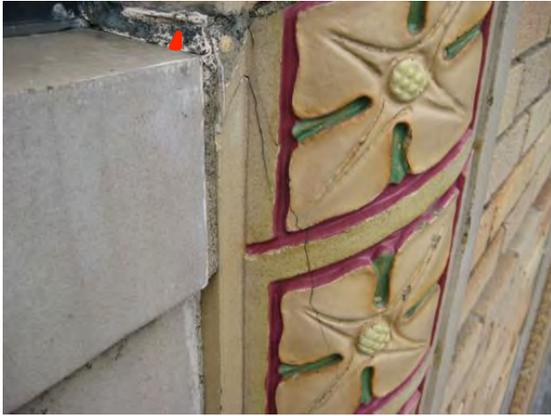
Fig. II-4.2(7): Terra-Cotta Cracking

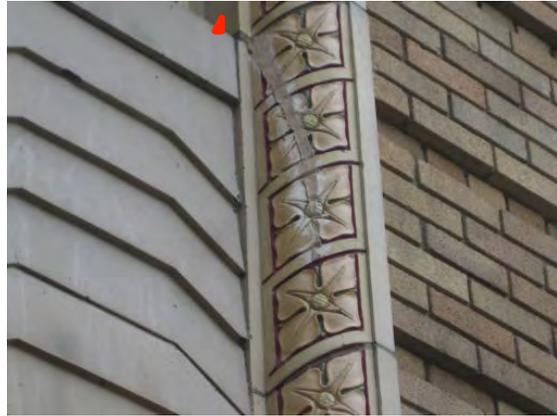
Fig. II-4.2(8): Terra-Cotta Cracking

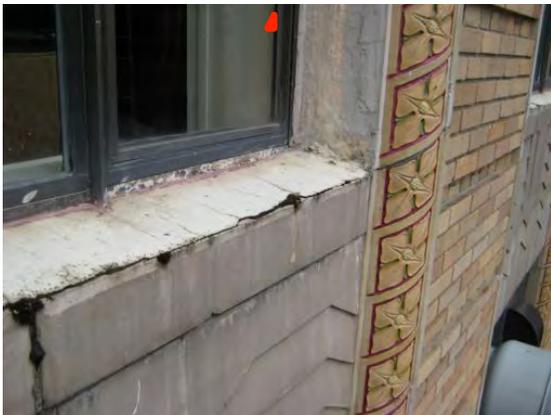
Fig. II-4.2(9): Terra-Cotta Face-Spalling

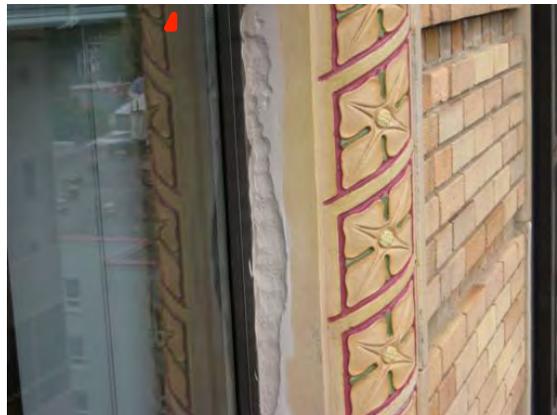
Fig. II-4.2(10): T.-C. Face-Spalling

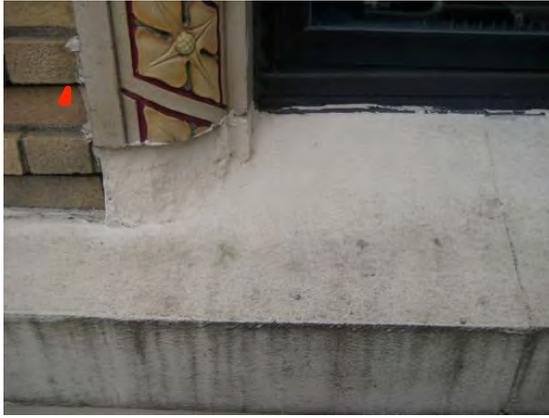
Fig. II-4.2(11): Terra-Cotta Face-Spalling

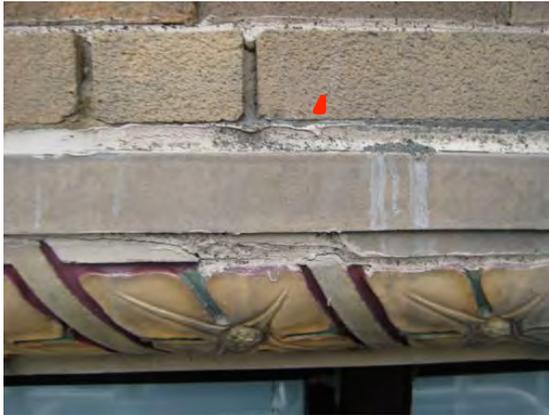
Let me return to the non-draining masonry above the terra-cotta window heads. As noted, the joints directly above these heads had typically been sealed with sealant, precluding drainage from behind the brickwork above. Lime staining below these joints, and moss growth in some mortar joints directly above them, as well as spalling and efflorescence on the underside of these heads clearly indicate that water is trying to drain out of the masonry above the heads. See Figures II-4.2(13 & 14).

Fig. II-4.2(13): Lime Streaks Bel. Sealed Jt.

A primary design flaw affecting these terra-cotta surrounds concerns the non-draining brickwork above the heads. As a consequence of the absence of drainage provisions above these heads, water within the brickwork drains directly into the terra-cotta heads, which then direct this water down the terra-cotta jamb surrounds. When the water freezes and expands, it rips the terra-cotta pieces, causing the observed cracking and spalling.

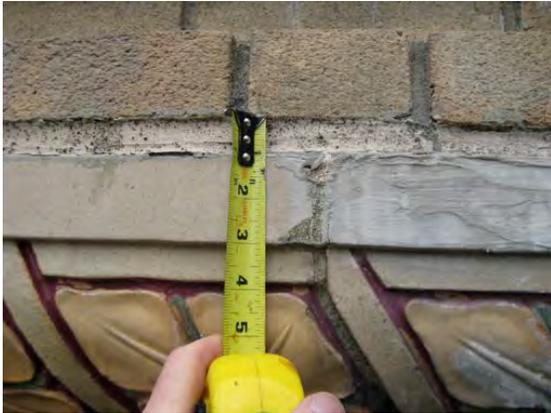
Some of these sealed joints near the top of the south elevation had become widened to roughly an inch from their original 1/2" width. In many such widened locations, the terra-cotta directly below has become cracked, in places quite badly. Such symptoms often indicate corrosive expansion of embedded steel. However, examination of the steel lintel in the location of the worst apparent damage revealed a deeply embedded, non-galvanized, non-flashed steel lintel with very minimal corrosion. This indicates that the observed damage is resulting from freeze-spalling. See Figures II-4.2(15-20).

Fig. II-4.2(15): Widened Joint Abv. T.-C.

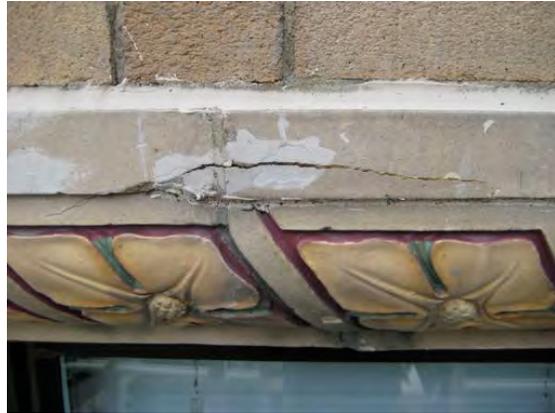
Fig. II-4.2(16): T.-C. Cracking Bel. Jt.

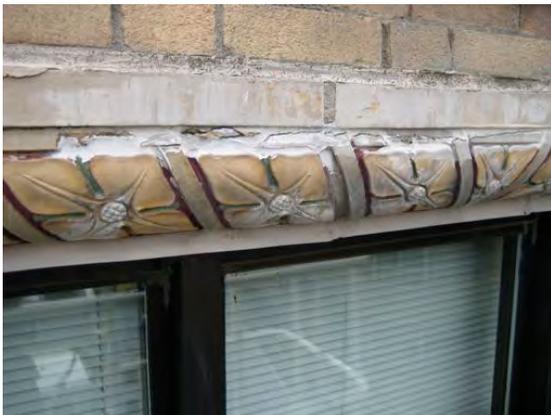
Fig. II-4.2(17): Cracking Bel. Sealed Joint

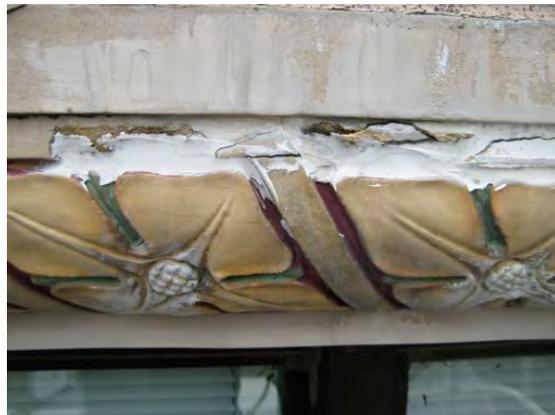
Fig. II-4.2(18): T.-C. Cracking Bel. Jt.

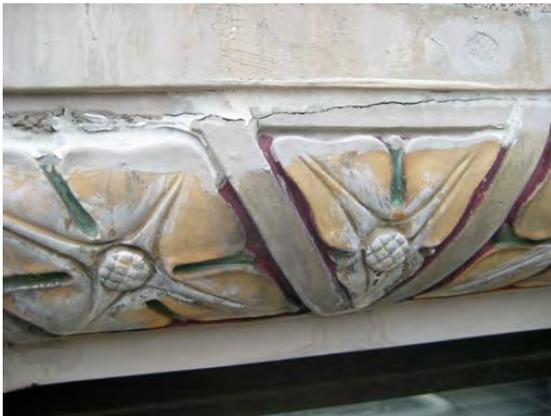
Fig. II-4.2(19): Cracking Bel. Sealed Joint

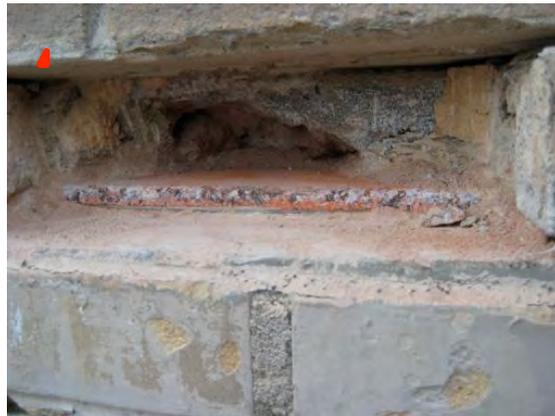
Fig. II-4.2(20): Minor Lintel Corrosion

This infiltration is also likely to lead to corrosion of the steel lintels, and probably of the wire hooks securing the terra-cotta heads, although such corrosion does not yet appear to be a significant factor, probably reflecting the fact that the cornice, which had since been removed, had afforded appreciable protection for these heads, and also due to the apparently deep embedment of the lintels.

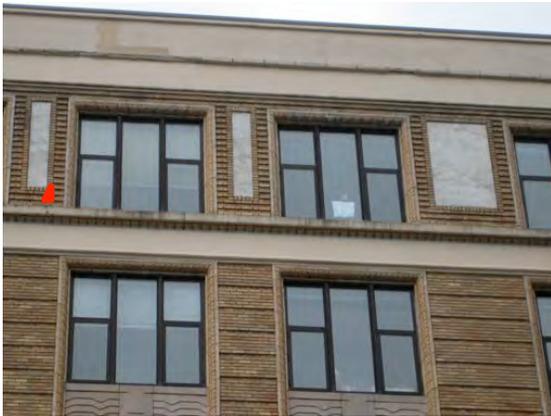
This observation provides a good introduction to a discussion of this band’s condition, which, though variable, ranges up to seriously degraded in many locations. For example, the uppermost projecting water table band in places appears in reasonably good condition, to the extent one can discern through the elastomeric coating. Elsewhere, in-progress spalling can be seen through the coating on this band, and in various other places, the spalling of this upper band is quite advanced, with chunks of the surface gone. Figures II-4.3(1-16) illustrate these observations.

Fig. II-4.3(1): 3-Part Terra-Cotta Band

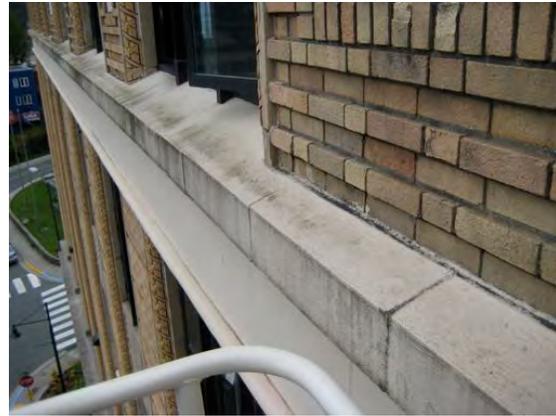
Fig. II-4.3(2): Minor Degradation

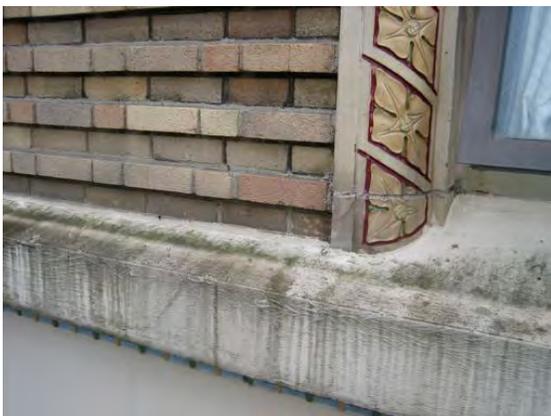
Fig. II-4.3(3): Minor Degr. of Top W.T. Band

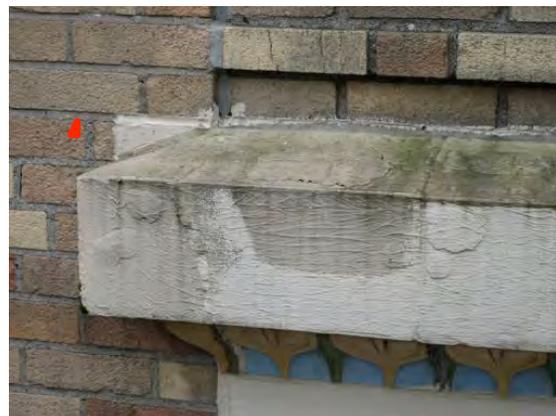
Fig. II-4.3(4): Incipient Spalling

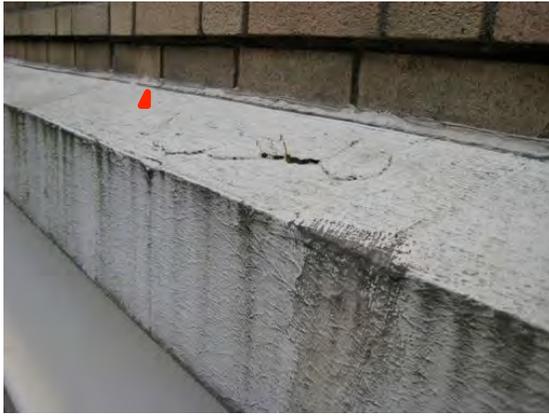
Fig. II-4.3(5): In-Progress Spalling

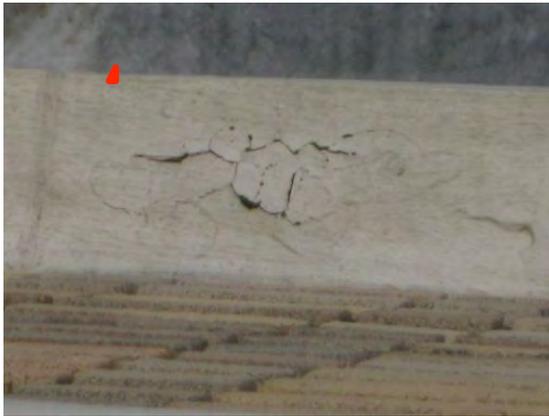
Fig. II-4.3(7): In-Progress Spalling

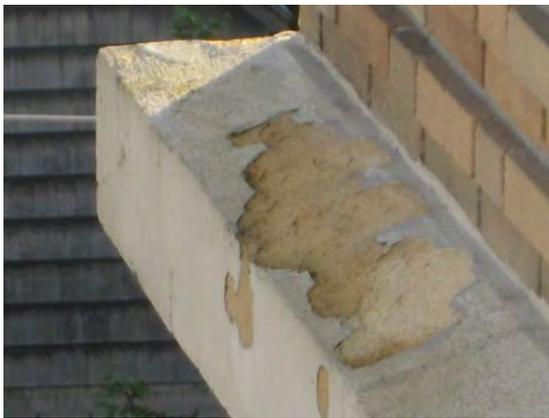
Fig. II-4.3(9): Serious Spalling of Top Band

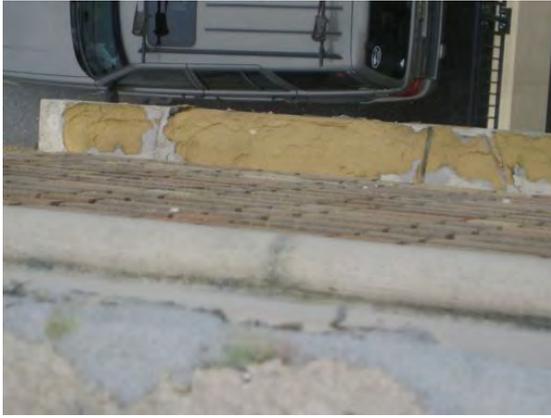
Fig. II-4.3(11): Serious Spalling of Top Band Fig. II-4.3(12): Serious Spalling

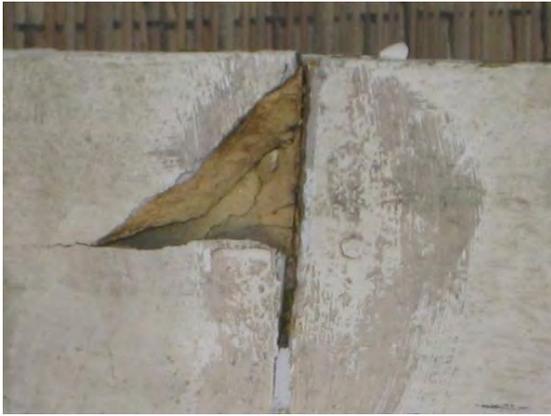
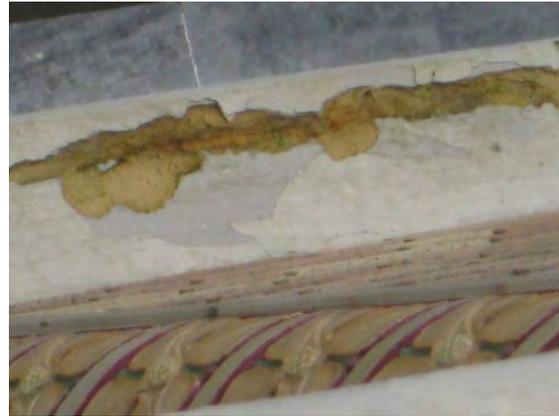
Fig. II-4.3(13): Serious Spalling of Top Band Fig. II-4.3(14): Serious Spalling

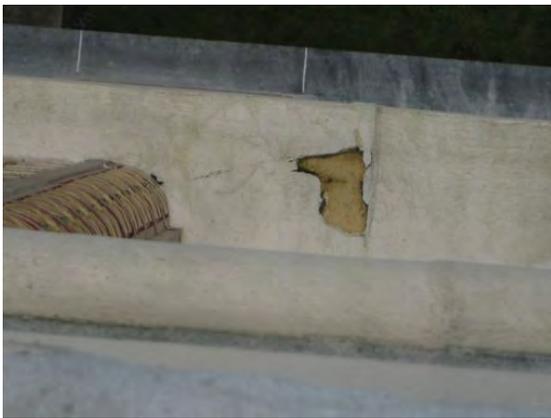
Fig. II-4.3(15): Serious Spalling of Top Band Fig. II-4.3(16): Serious Spalling

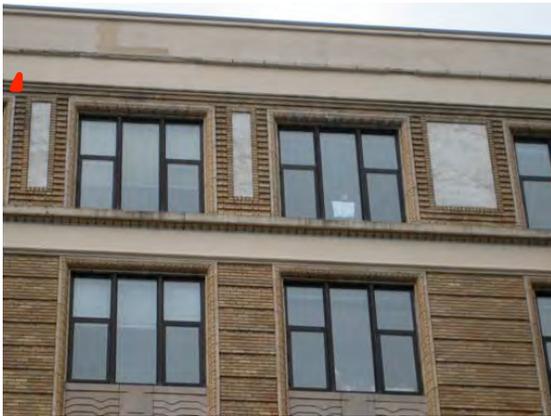
The outer surfaces of these panels are quite rough and eroded, indicating fairly heavy sandblasting, which appears to reflect natural and serious weathering. Some of the marble's veins appear to be possibly cracked. The panel bottom edges are stained dark, resembling mildew staining. Figures II-4.4(1-6) depict these observations.

Fig. II-4.4(1): Marble Panels

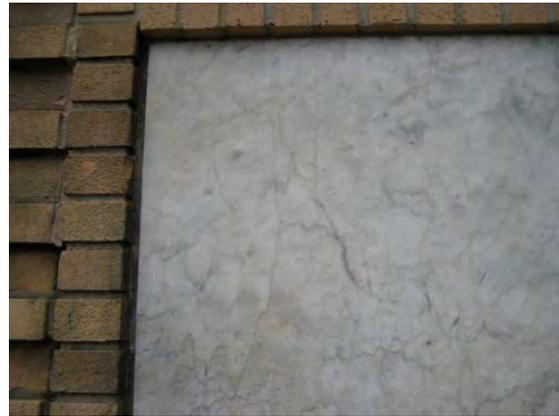
Fig. II-4.4(2): Surface Erosion

The weathering degradation is largely a visual distraction, and not much of that, since these panels are so high above any viewing point that the surface erosion is not apparent. The surface erosion may tend to increase moisture absorption, but this can be largely addressed with application of appropriate penetrating repellents. The possible short cracks along veins can also exacerbate infiltration and subsequent freeze-spalling, so this could be a more serious consideration.

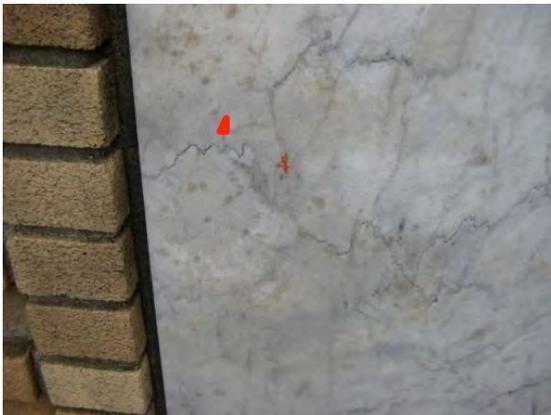
Fig. II-4.4(3): Poss. Anchor Loc., Erosion

Though these panels are affected both by weathering and possibly inadequate anchorage, it appears that at least at this stage, the questionable securement represents the primary possible concern.

The questionable securement could pose a risk to pedestrians below in case of earthquake, as well as possibly due to freeze-spalling.

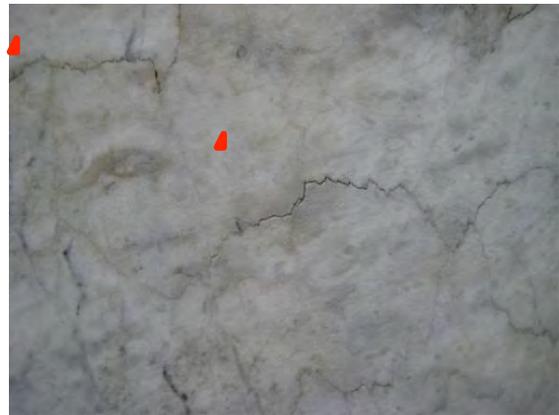
Fig. II-4.4(4): Erosion, Poss. Cracking

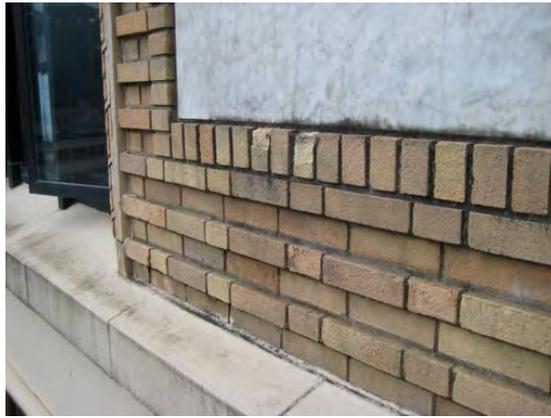
Fig. II-4.4(5): Black Staining at Panel Bott. Fig. II-4.4(6): Staining, Spalled Brick

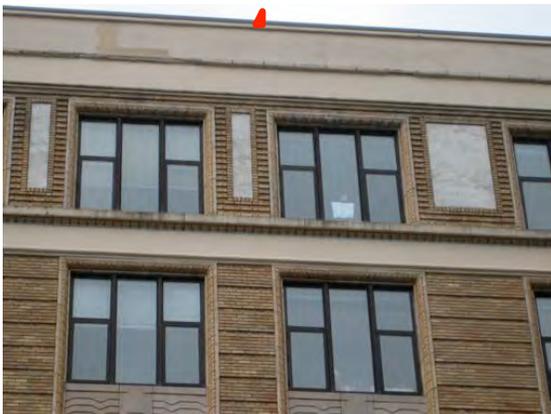
Three primary considerations apply to this band. First, the current configuration does not reflect the building's design or original construction, in that the design included a significant, protruding terra-cotta cornice, which was built, but as a consequence of its ill-advised design, was removed after about three decades due to its degradation.

Fig. II-4.5(1): Cornice-Parapet Band

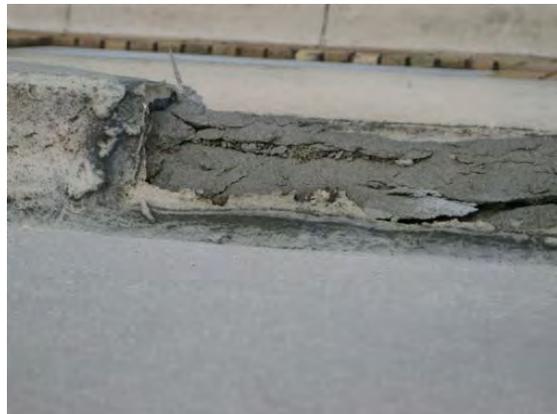
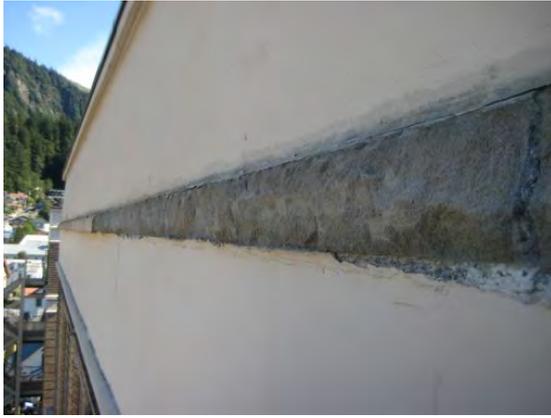
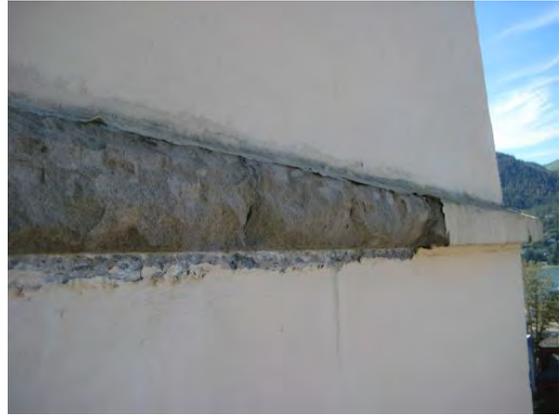
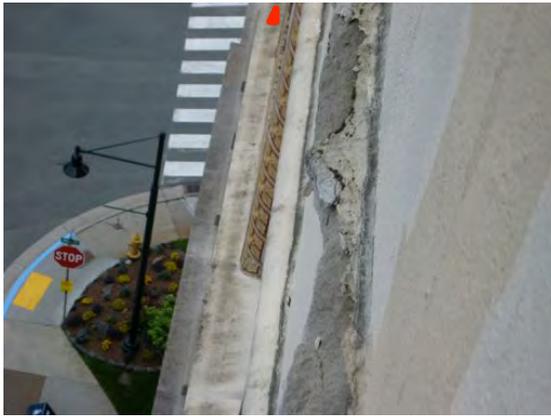
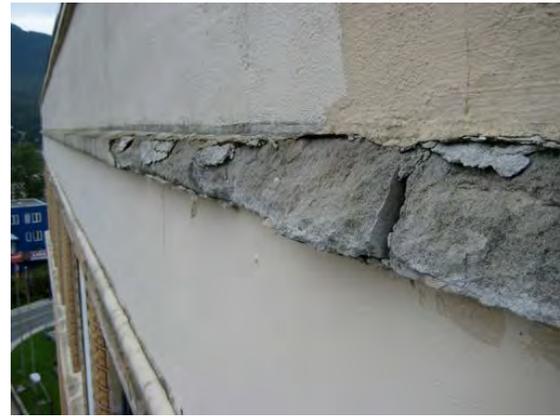
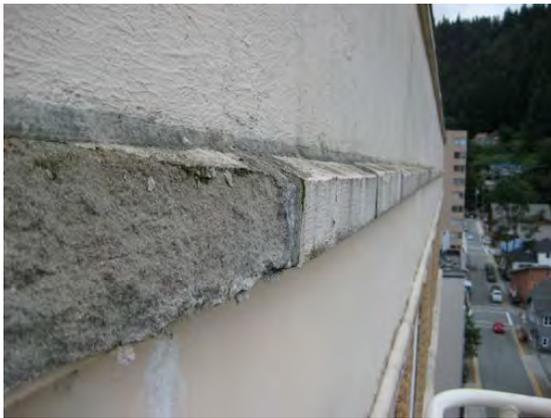
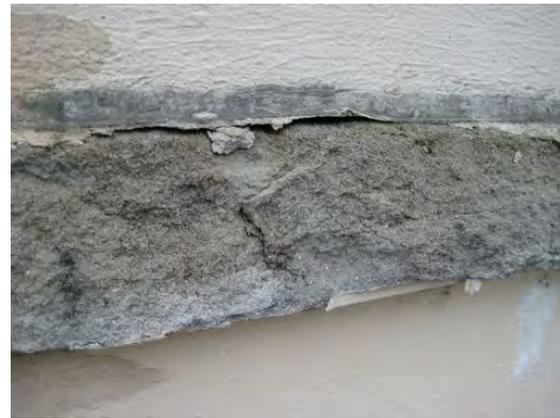
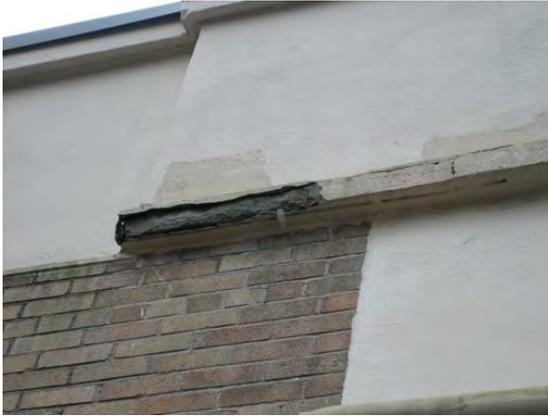
The third consideration relates to the condition of this band, most notably to the protruding band about 3 feet from the wall top, which is in extremely poor condition. It is in fact disintegrating, dropping up to fist-sized chunks onto the portico roof and ground below. During one visit to the roof, I personally observed one such chunk fall off and shatter on the portico roof below.

Fig. II-4.5(2): Disintegration

The most obvious relates to the severe degradation of its protruding mid-band, which will continue to seemingly randomly shed stone chunks ranging up to about fist-sized, posing an ongoing and immediate risk to pedestrians. During my most recent 2012 visit, I pointed out some “ready-to-go” pieces directly above a walkway on the building’s north side, which were removed the next day. However, ongoing degradation will continue to produce possibly dangerous chunks, so ongoing vigilance and removal of loose pieces are critically important.

The severe degradation of the protruding mid-band will continue to pose a hazard to pedestrians below.

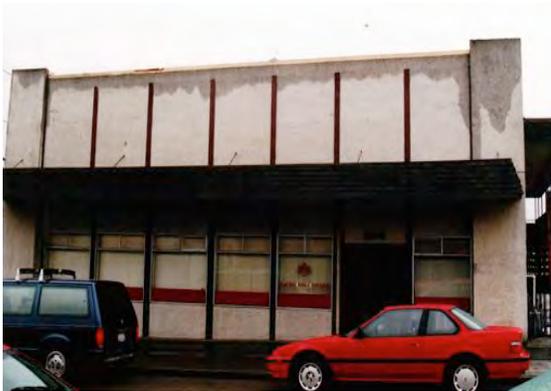
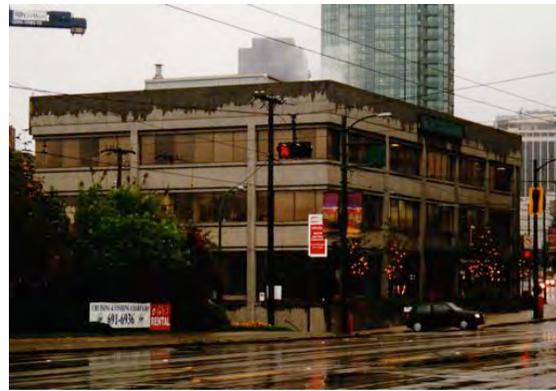
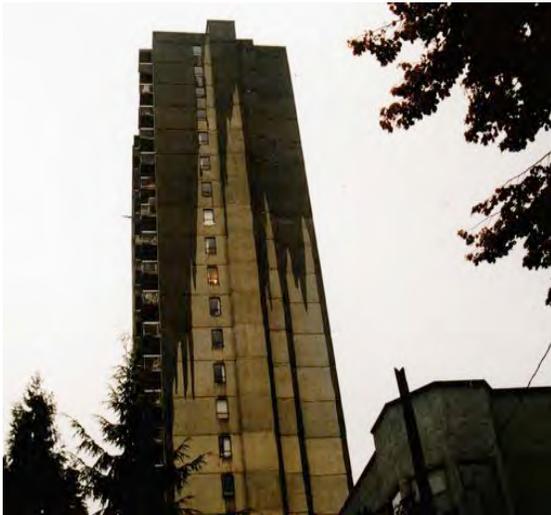
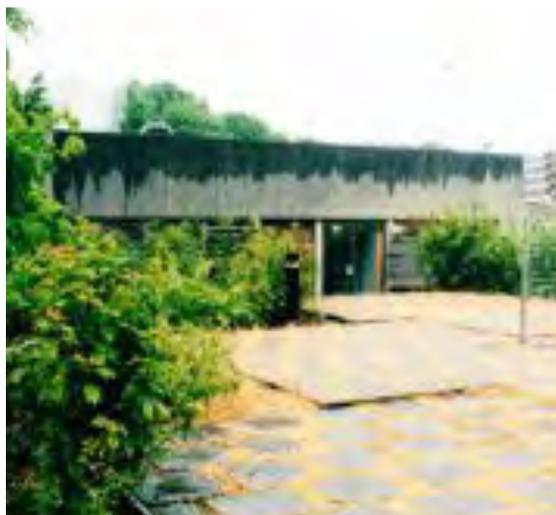
Fig. II-4.5(13): Wetting Pattern on Lee Side

Fig. II-4.5(14): 3rd Rain Day Wetting

Fig. II-4.5(15): 3rd Rain Day Wetting Pattern

Fig. II-4.5(16): 3rd Rain Day Wetting

The absence of a protective cornice substantially increases the frequency, duration, and severity of wetting of the exterior masonry. This, combined with the many ledges and absorption surfaces resulting from the recessed brick headers and mortar joints, Juneau's destructive climate, among other factors, will continue to subject this building's masonry to appreciably accelerated weathering degradation.

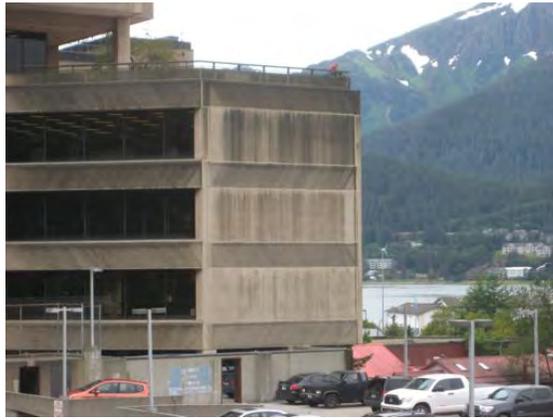
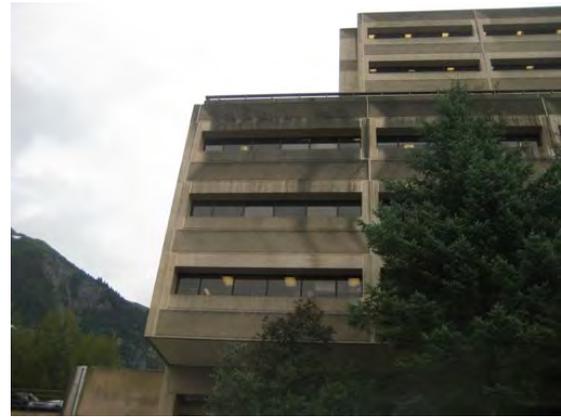
Fig. II-4.5(17): Stain Pattern, Juneau

Fig. II-4.5(18): Stain Pattern, Juneau

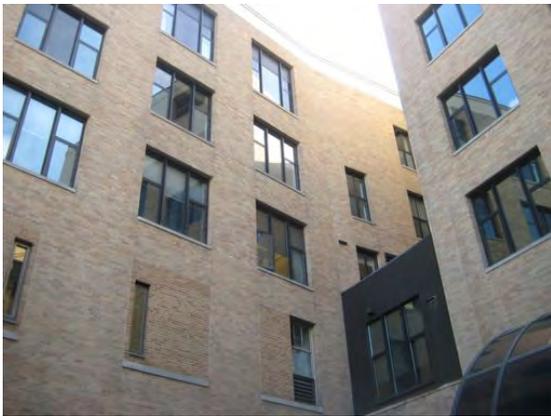
With regard to securement, these sills appear to rely entirely on mortar bond, with no mechanical anchors. Further, the mortar under most of these sills is degraded and largely delaminated. Thus, these sills appear to be held in place primarily via friction.

With regard to design, these sills, like essentially all other elements on this building, lack any flashings under them or flashing caps atop them. Some interior plaster damage below window sills may indicate infiltration via these un-flashed sills.

Fig. II-4.6(1): Stone Sills, Courtyard Area

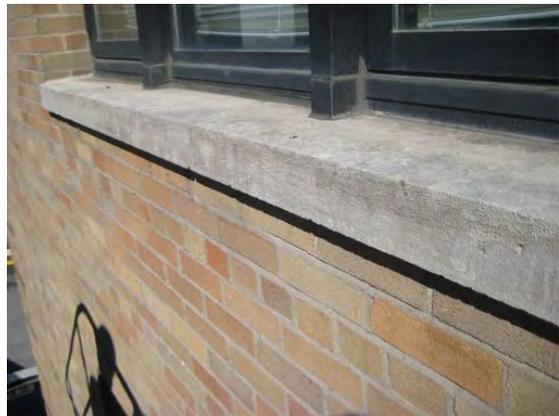
Fig. II-4.6(2): Sill in Good Condition

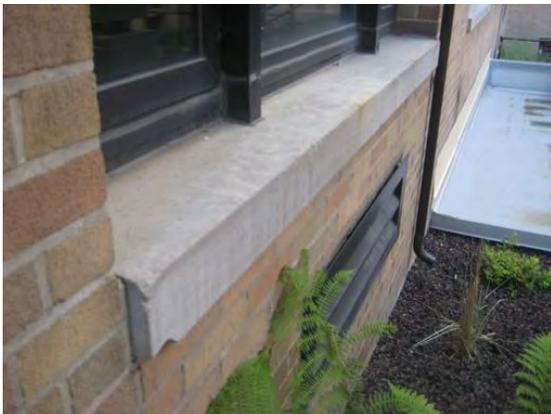
In general, the condition of these sills is variable, but for the most part degradation is limited. Various sills have chipped corners and edges, some surface erosion, and one sill on the east face of the west wing is seismically cracked.

Fig. II-4.6(3): Minor Chipping & Erosion

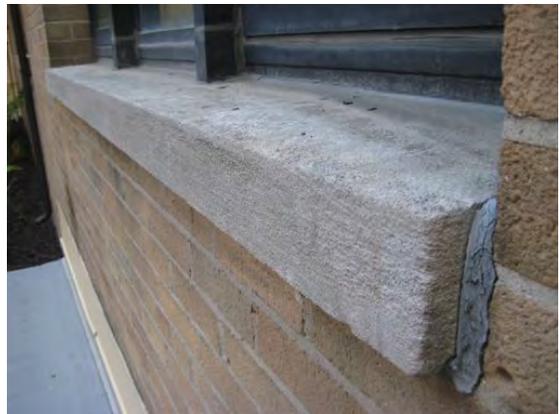
Fig. II-4.6(4): Minor Surface Erosion

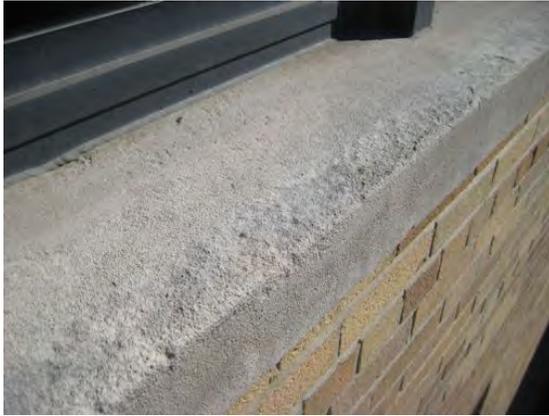
Fig. II-4.6(5): Moderate Surface Erosion

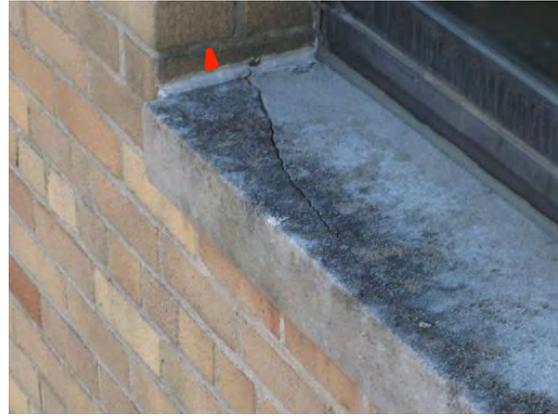
Fig. II-4.6(6): Cracked Stone Sill

First, lack of mechanical securement poses some increased risk of dislocation during earthquakes, which may present a hazard to pedestrians below. However, compared to similar risks posed by several other elements, this appears to be a relatively moderate risk at most. The one cracked sill on the east side of the west wing poses increased risk, as its outer portion is fully cracked-off.

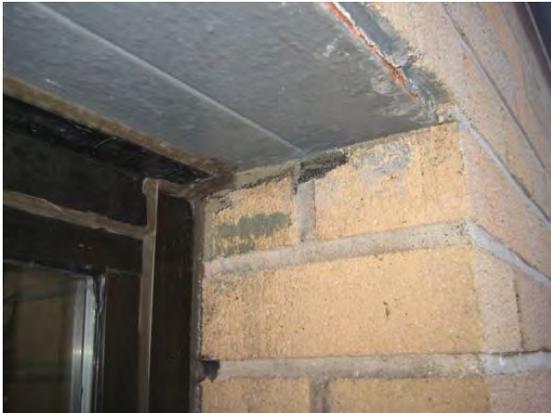
These design-related flaws have resulted in the expected symptoms. The lintels display varying degrees of corrosion. Many in relatively sheltered locations, such as those near wall bases, or located on the west face of the east wing, are still in good condition, with only minor surface corrosion. In contrast, lintels in more exposed locations, such as those at the building's SE corner or on the east face of the west wing, display more advanced corrosion, which, however, still appears moderate and is less advanced than one might expect, given the building's age and climate. Some elevated moisture readings and interior plaster damage near window heads may also relate to the absence of lintel flashings. Figures II-4.7(1-10) illustrate these observations.

Fig. II-4.7(1): Very Minor Lintel Corrosion

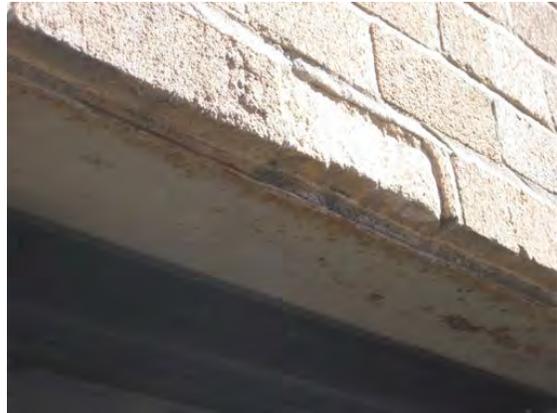
Fig. II-4.7(2): Minor Lintel Corrosion

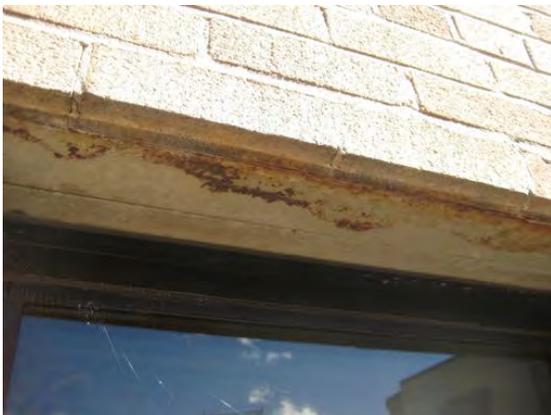
Fig. II-4.7(3): Moderate Lintel Corrosion

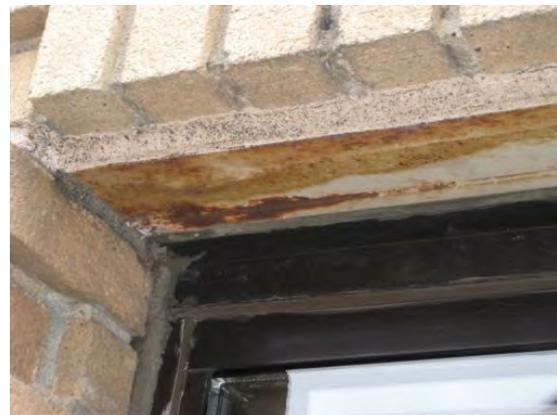
With regard to design, these lintels typically consist of doubled-up steel angles that support the brickwork above. They are plagued by several flaws that may be ascribed to design. First, like essentially all other elements, they lack any flashings. Many are also sealed to the brickwork directly above them, thus precluding drainage. Further, these lintels consist of standard steel.

Fig. II-4.7(4): Sealed Gap Abv. Lintel

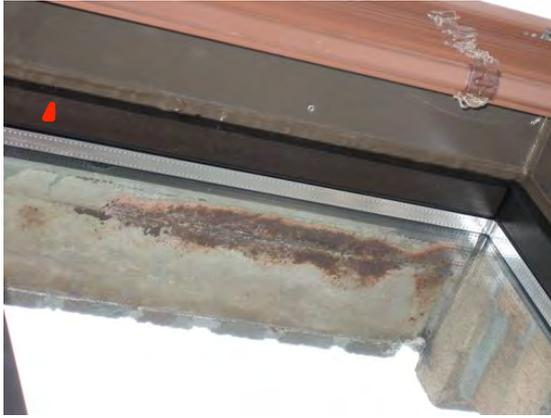
Fig. II-4.7(5): Moderate Lintel Corrosion

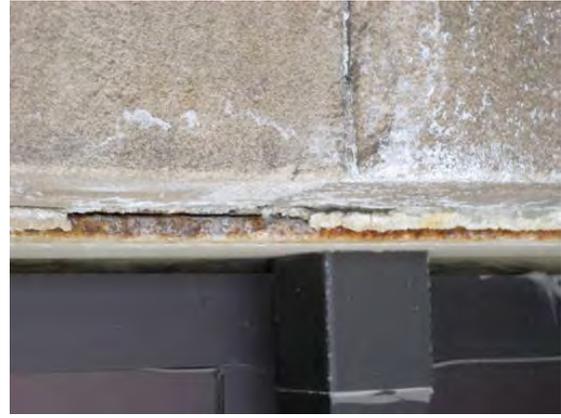
Fig. II-4.7(6): Moderate Corrosion

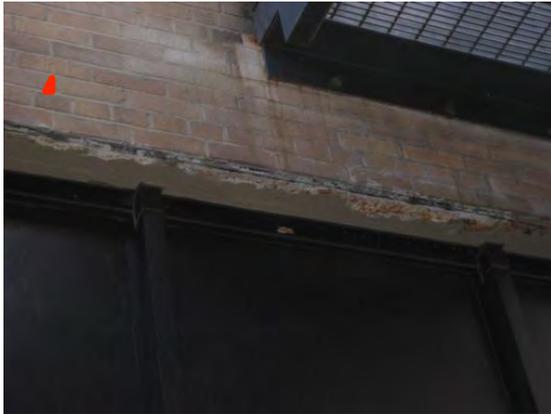
Fig. II-4.7(7): Moderate Lintel Corrosion

The absence of end-dammed flashings atop these lintels contributes to lintel corrosion and also to some of the interior plaster damage near window heads.

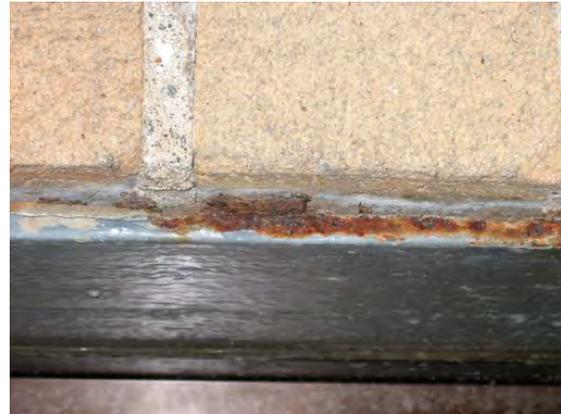
Fig. II-4.7(8): Moderate Corrosion

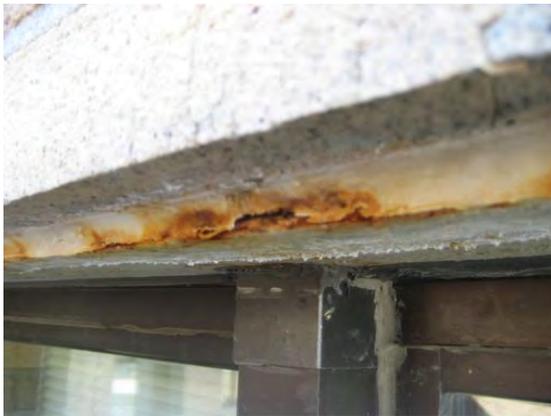
Fig. II-4.7(9): Corrosion Stain on Sealant

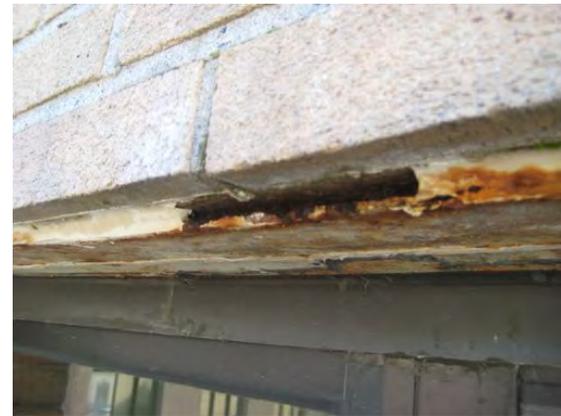
Fig. II-4.7(10): Moderate Corrosion

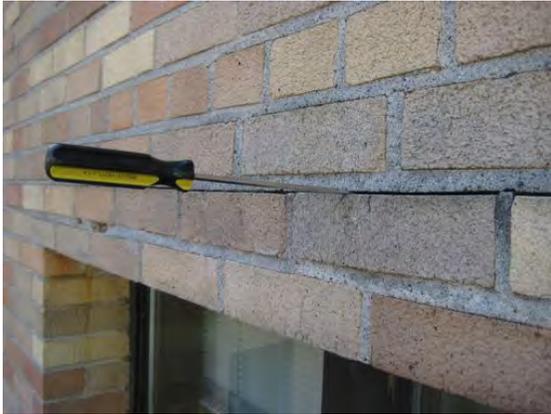
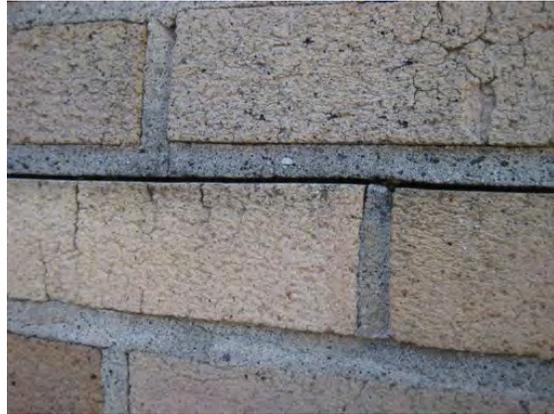
In addition, one lintel on the east face of the west wing appears to have sagged, as have the two brick courses above this lintel, causing a relatively wide gap and mortar delamination above the full width of the window. The lintel at this location is among the most corroded on the building. See Figures II-4.7(11 & 12).

Fig. II-4.7(11): Sagging Brick Above Lintel **Fig. II-4.7(12): Gap Abv. Sag. Lintel**

The one sagging lintel may be beginning to fail due to corrosion.

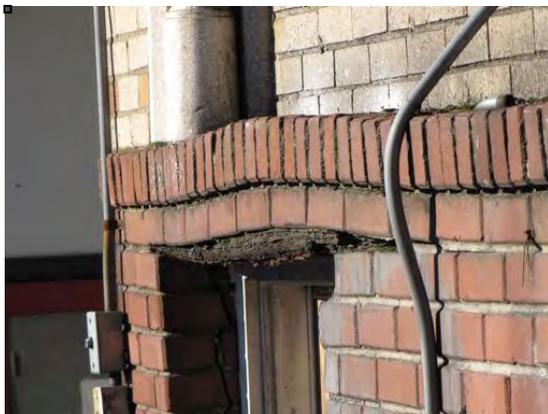
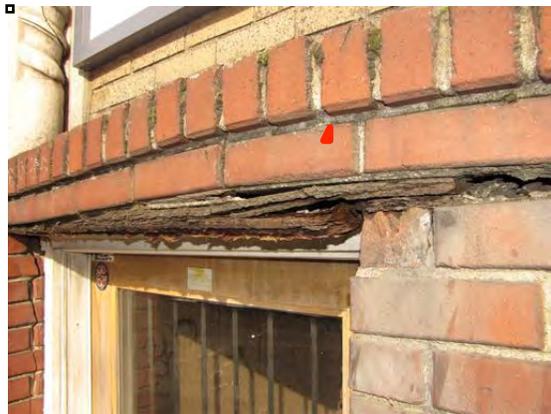
The lintels will continue to corrode, and leakage may persist above some of the weather-exposed windows as a result of the absence of flashings and drainage provisions. This will lead to laminar corrosion, wherein the steel corrodes in distinct layers, causing the brick above to become lifted, which also often causes the supporting brick below the lintels to spall. Figures II-4.7(13 & 14) depict the eventual fate of these lintels, as photographed on another project.

Fig. II-4.7(13): Severe Lintel Corrosion **Fig. II-4.7(14): Spalling Bel. Lintel**

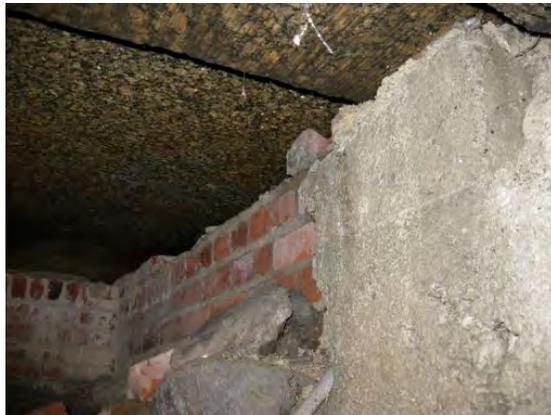
Fig. II-5.1(1): Portico Sub-Structure
