SUMMARY EVALUATION,
CORRECTIVE OPTIONS,
AND ESTIMATED CORRECTIVE COSTS

ALASKA STATE
CAPITOL

Juneau, AK.

Date: 2/20/13

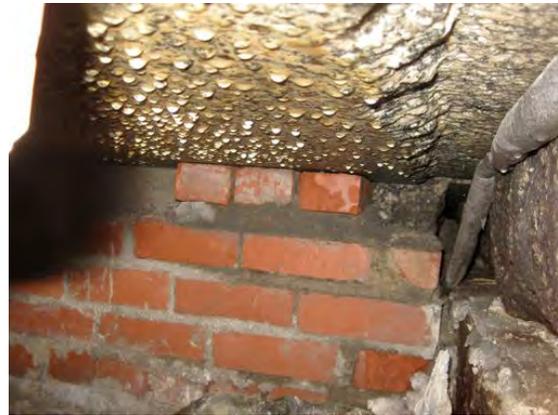
Fig. II-5.1(2): Condens. @ Granite

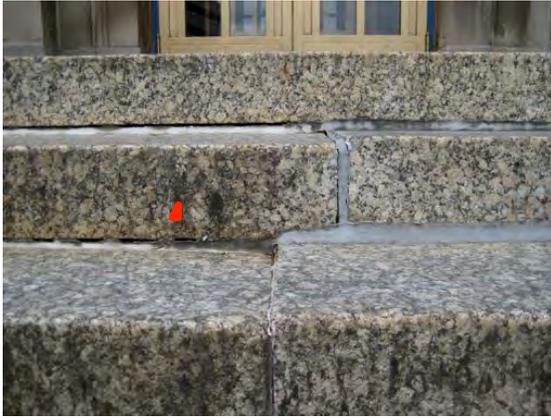
My 2010 field examination revealed signs of stress and deflection that had affected this portion of the portico, as well as other parts of the building. Observed symptoms included obvious differential movement between portions of the entry stairs and the portico floor, as well as cracking of the granite paving and elements above it. The entry stairs and portico floor varied by up to about 3/4" from their original installation elevations, with those portions located below the marble columns typically having been deflected downward.

Fig. II-5.1(3): Granite Stair Deflection

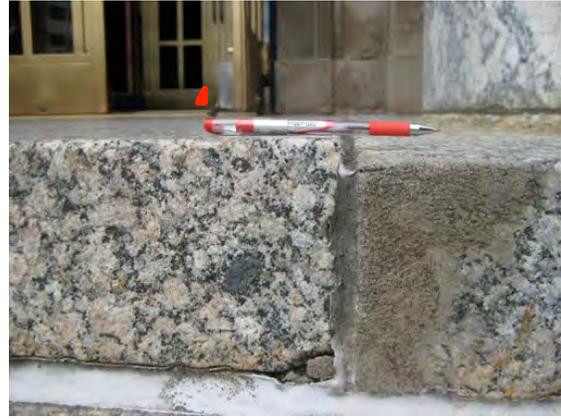
Fig. II-5.1(4): Paving Deflection

These seismically induced stresses may also have deflected the supporting walls under the portico and caused these to settle down differentially, causing the uneven paving and stairs.

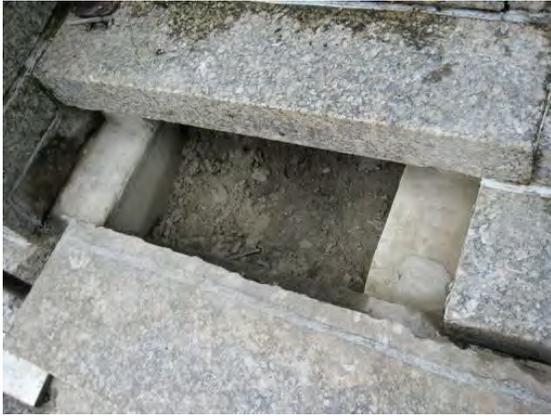
Much of this differential deflection had been corrected by my 2012 visit, by which time the stairs and paving had been re-leveled, though not entirely.

Fig. II-5.1(5): Re-Leveling of Granite Stairs

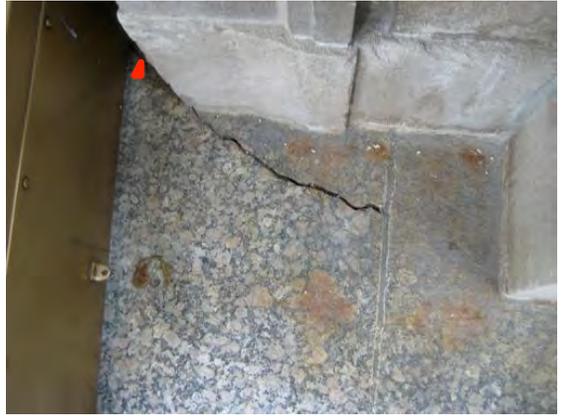
Fig. II-5.1(6): Paving Crack

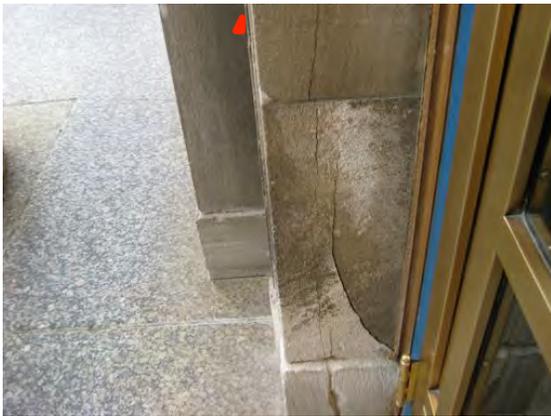
Fig. II-5.1(7): Cracked Portico Roof Support

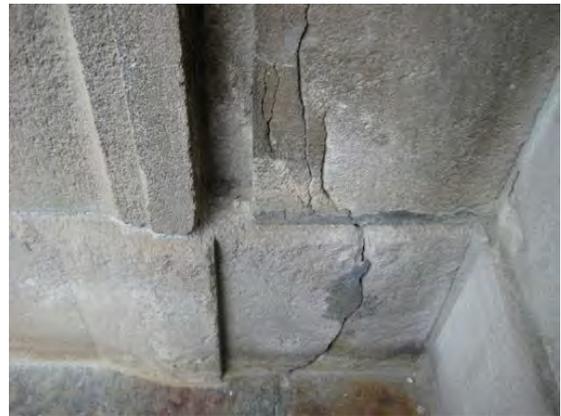
Fig. II-5.1(8): Cracked Support Stone

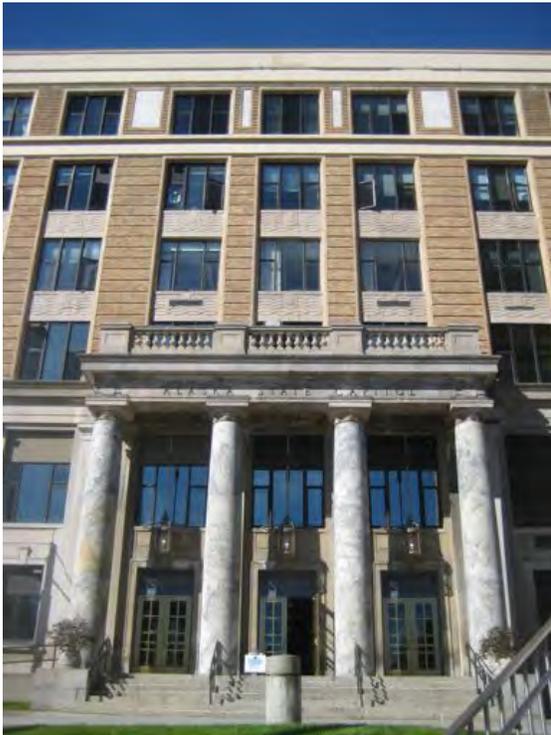
Fig. II-5.2(1): Marble Portico Columns

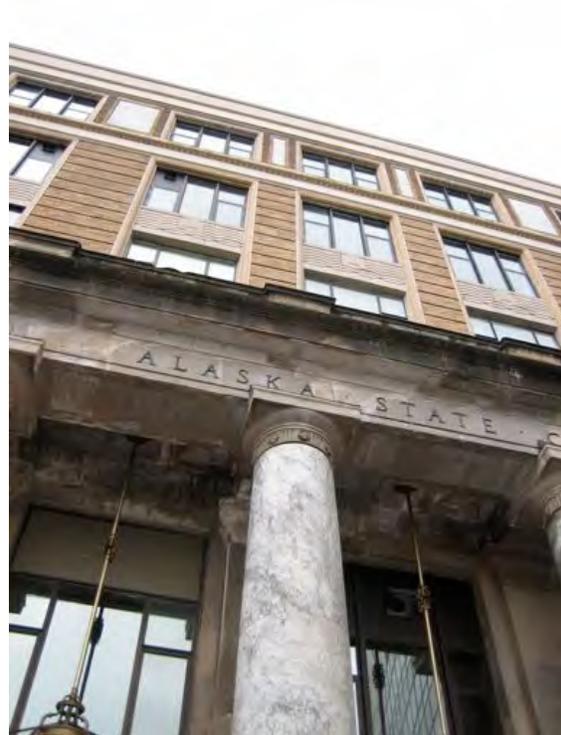
Fig. II-5.2(2): Portico Beams & Cols.

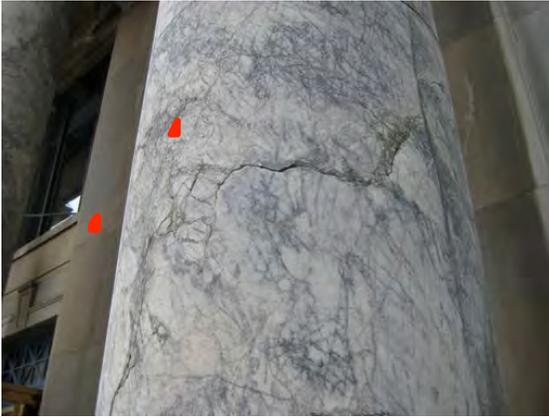
The marble columns had become weathered and seriously eroded on their SW, SE, and NE exposures. Reddish-brown oxide staining was also observed on some columns. Many cracks, some hairline in width while others appreciably wider, affect the column surfaces. Very high water absorption at such cracks indicates that the cracks are deep.

Fig. II-5.2(3): Deep Cracking in Columns

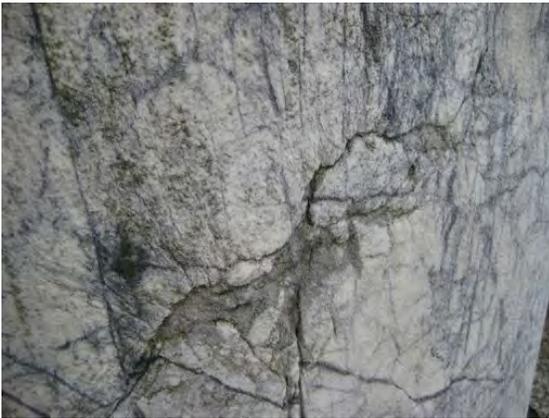
Fig. II-5.2(5): Erosion & Cracking in Cols.

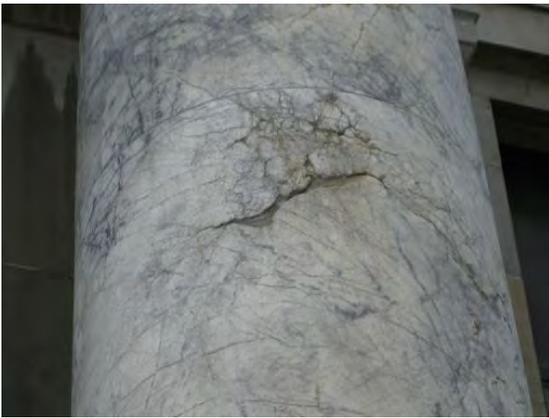
Fig. II-5.2(7): Deep Cracking in Columns

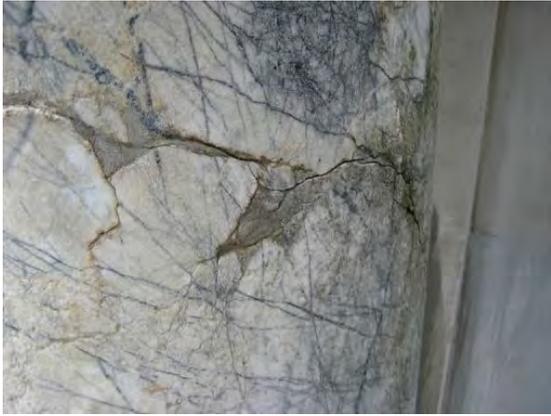
Fig. II-5.2(9): Erosion & Cracking in Cols.

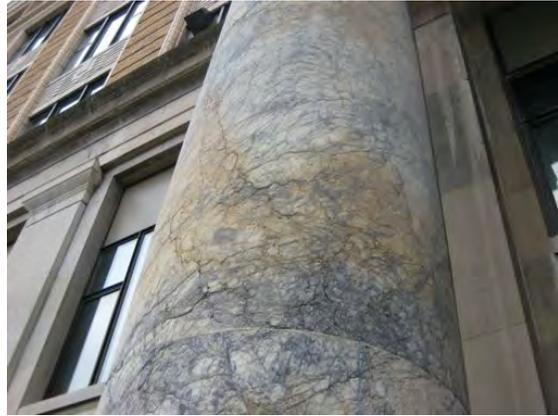
Fig. II-5.2(10): Oxide Staining

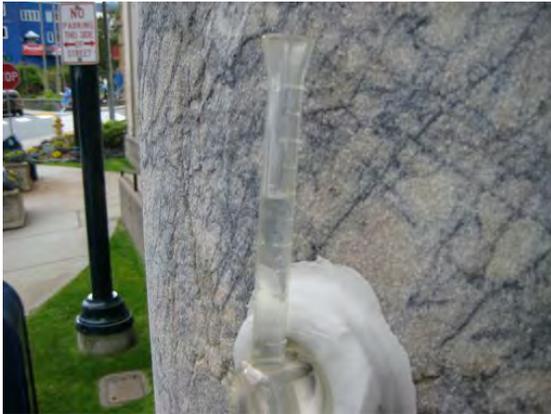
Fig. II-5.2(11): High Moist. Absorp. @ Crack

Such cracks, once formed, allow subsequent infiltration of water, and when this is combined with freezing temperatures, the expansion of the entrapped ice leads to progressive pushing apart of the stone. Conditions when these columns are both wet and freezing occur frequently in Juneau, and in view of the building’s 80 years of existence, this phenomenon is likely to have already begun compromising the integrity of these columns. Appreciable water infiltration into even the minutest hairline cracks was confirmed by testing.

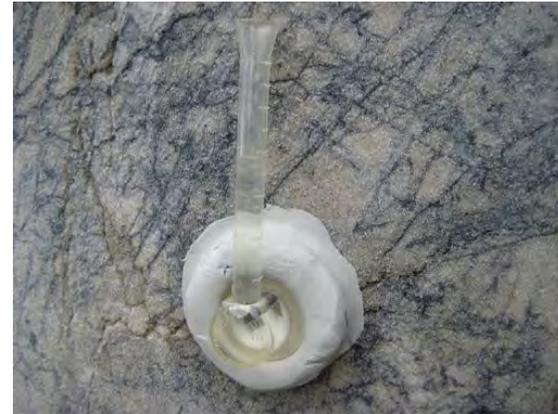
Fig. II-5.2(12): High Absorption

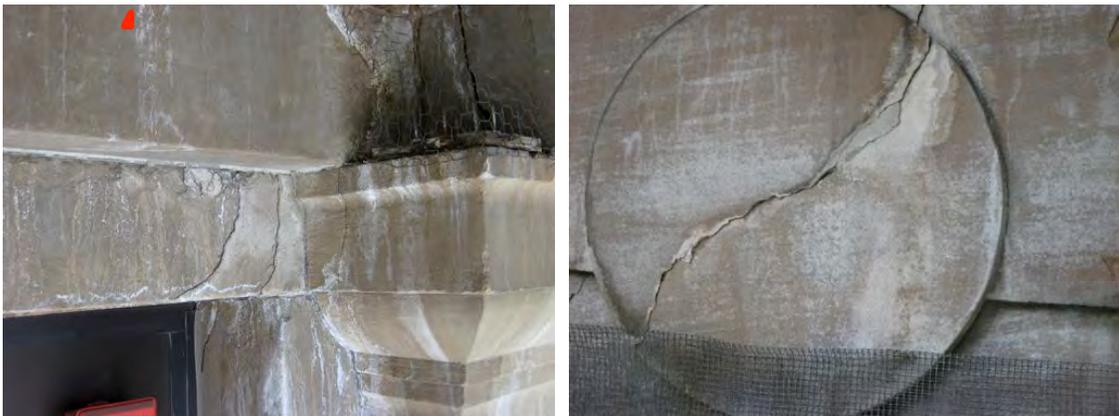
Two primary observations relate to this cladding's condition. The first pertains to widespread and, in places, severe cracking of the structural cladding pieces as well as in the portico base below this cladding and in the portico roof structure supported by this cladding. Wide, sometimes closely spaced cracks occur in the granite paving directly below the cladding pilasters, in the pilaster pieces, at the stone window heads below the portico roof, and in the stone capitals as well as in the stone beams supporting the portico roof. While I found relatively minor symptoms of such stress in the stone cladding away from the portico, major cracks were observed at the bases of the jambs of all three entry doors below the portico. These also occur below the large, short stone crossbeams at the portico ceiling. Figures II-5.3(1-8) depict such cracking, generally starting at the top and proceeding downward.

Fig. II-5.3(1): Cracks in Head, Capital, Beam Fig. II-5.3(2): Cracked Roof Beam

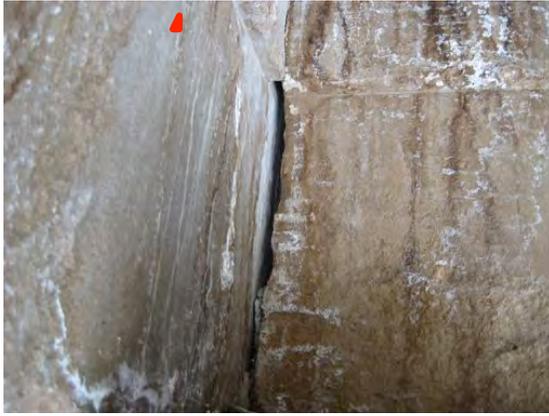
Fig. II-5.3(3): Beam-Building Separation

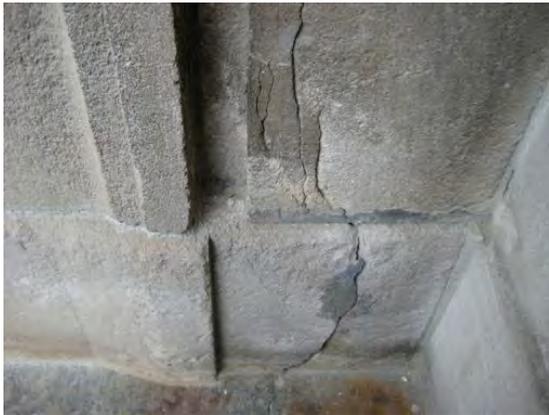
Fig. II-5.3(5): Cracked Structural Cladding

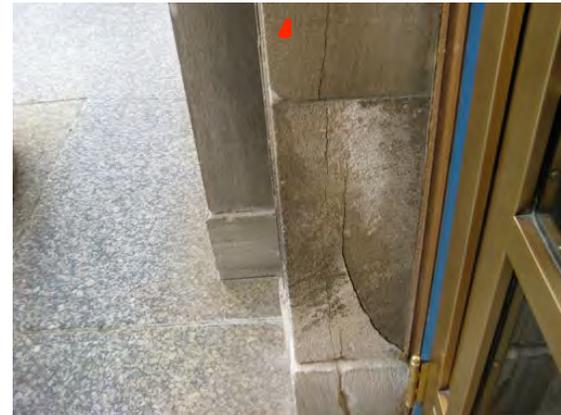
Fig. II-5.3(6): Cracked Str. Cladding

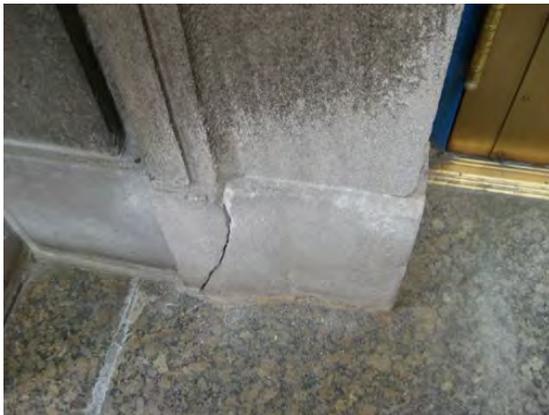
Fig. II-5.3(7): Cracked Structural Cladding

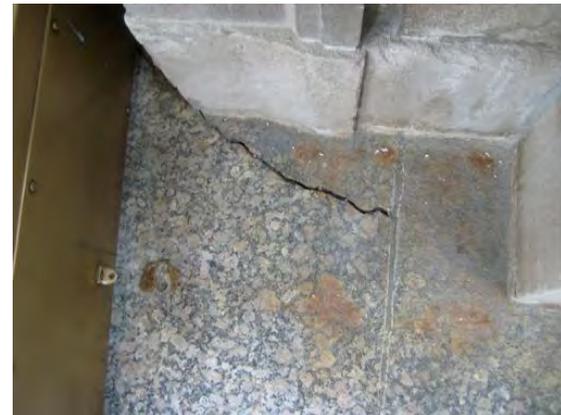
Fig. II-5.3(8): Cracked Fl. Bel. Pilaster

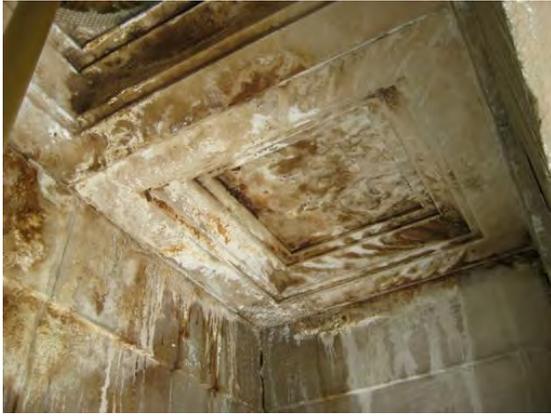
Other “condition-related” observations pertain to widespread, severe moisture infiltration, which is much more pronounced in the sheltered location below the portico roof than at the adjacent, weather-exposed locations. For example, severe staining and efflorescence affect the cladding’s upper reaches and the adjacent ceiling. Moderate corrosion affects the steel window lintels below the portico’s ceiling, and infiltration is apparent inside these sheltered windows. Highly elevated moisture and reddish staining on the interior marble tile imply that anchor corrosion is occurring. Highly elevated moisture near the cladding’s bottom also indicates moisture intrusion. Further, the bottoms of all metal doorjambes display serious corrosion. See Figures II-5.3(9-16).

Fig. II-5.3(9): Staining Below Portico Roof

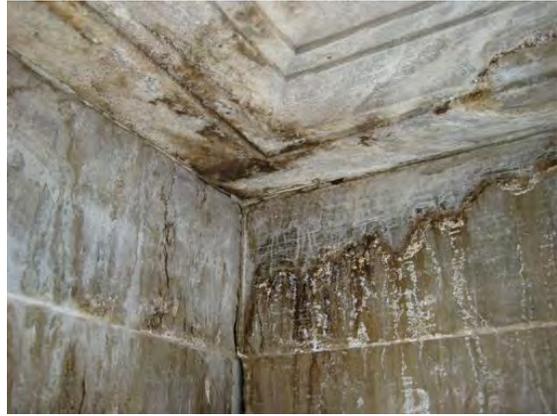
Fig. II-5.3(10): Staining Below Roof

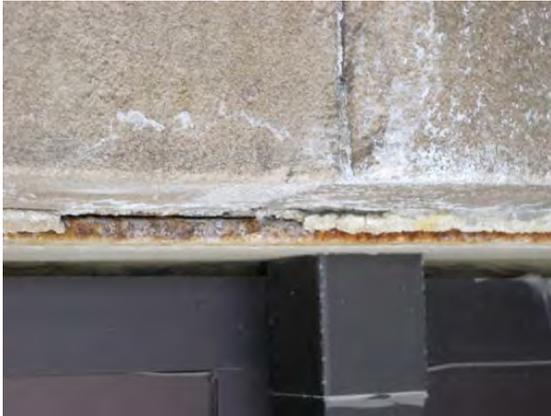
Fig. II-5.3(11): Sheltered Lintel Corrosion

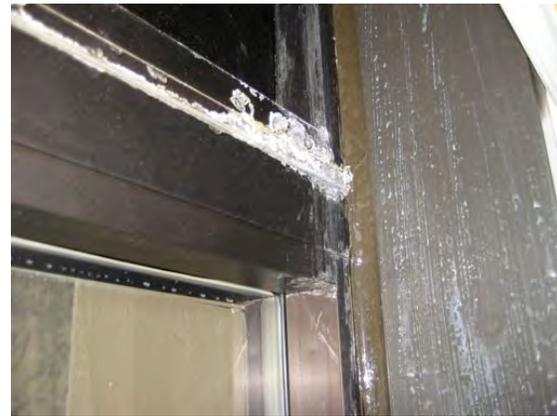
Fig. II-5.3(12): Interior Window Leaks

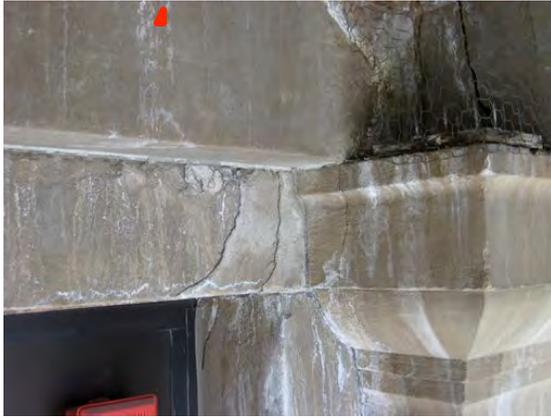
Structurally-related observations pertaining to the three E-W entablature beam sections spanning across the tops of the marble columns concern the absence of any direct mechanical connections between these beams and the column tops, as well as apparently limited bearing surfaces afforded by the stone column capitals. In brief, no mechanical connections secure these beam sections to the columns or capitals below, although a composite concrete-steel beam spanning in the E-W direction above the beam at least connects the various sections together. Further, the E-W beam sections bear mostly on the cantilevered portions of the column capitals.

Fig. II-5.4(1): Cracks in Head, Capital, Beam Fig. II-5.4(2): Cracked Crossbeam

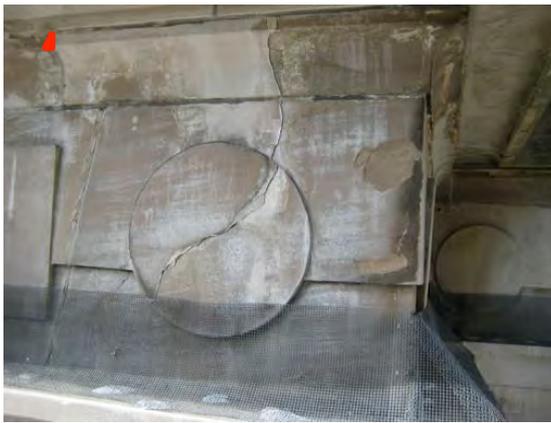
Fig. II-5.4(3): Cracked Beam End

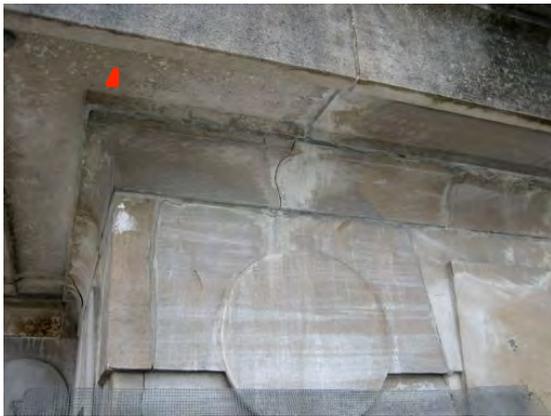
Fig. II-5.4(5): Cracked Beam End

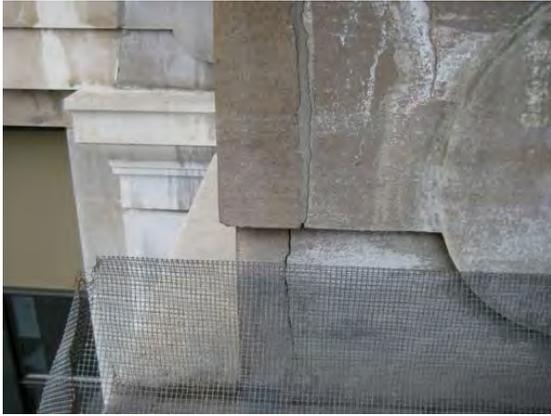
Fig. II-5.4(7): Cracked Beam End

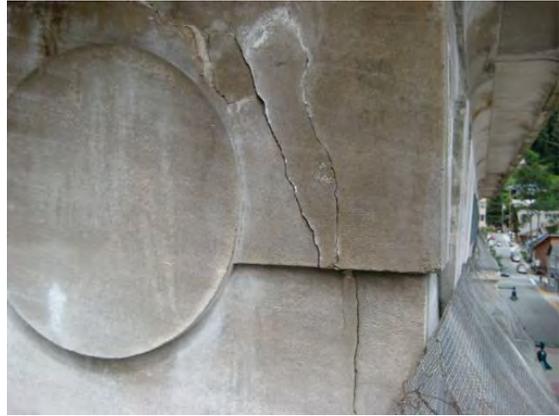
Fig. II-5.4(8): Cracked Beam End

Cracking and separation at the portico roof's N-S crossbeams appear to reflect additional seismic damage and further threaten the integrity of the roof structure.

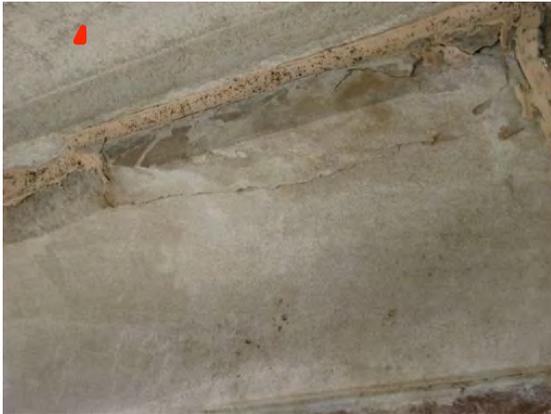
Fig. II-5.4(9): Cracked, Hanging Bm. Chunk

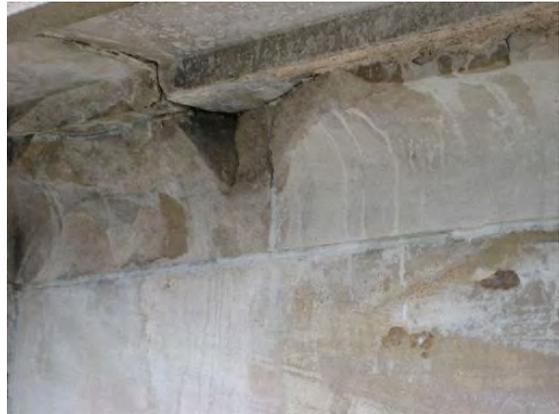
Fig. II-5.4(10): Cracked-Off Chunk

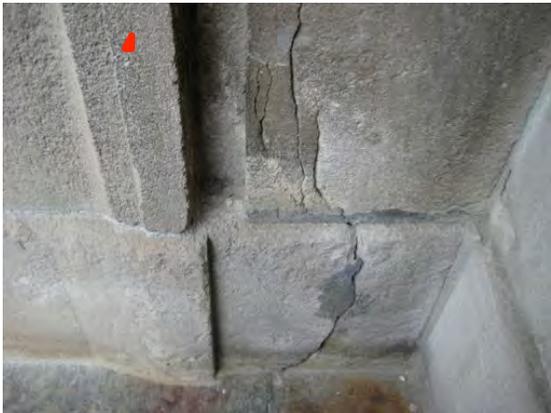
Fig. II-5.4(11): Cracked Support Pilaster

Similarly, the stone pilasters supporting the portico roof's crossbeams are inadequately secured to the building structure as designed, and the metal ties which secure these have probably been damaged by seismic events, and have almost certainly been compromised by corrosion resulting from long-term infiltration. Cracking at both the tops and bottoms of these stone pilasters has further compromised the integrity of the structure supporting the portico roof.

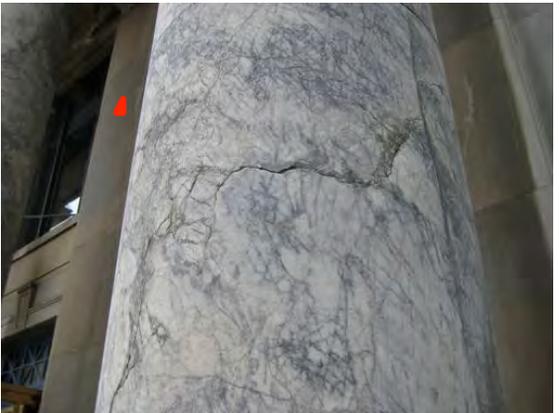
Fig. II-5.4(12): Cracked Column

Starting at the bottom of the roof-supporting structure, the marble columns and their stone capitals consist of separate sections with no connections between these, and cracking of possible structural significance has affected these columns.

Cracking in the marble columns may progress deeper, again largely through the action of freezing expansion of entrapped moisture within these cracks.

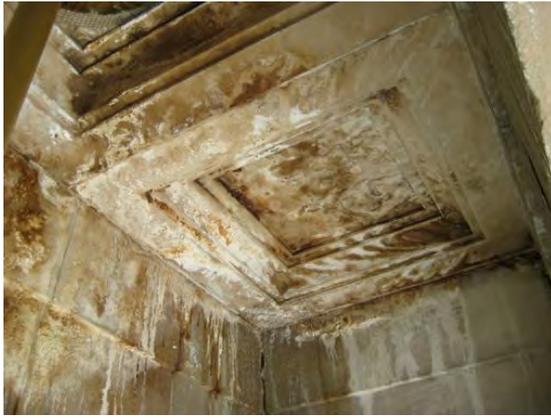
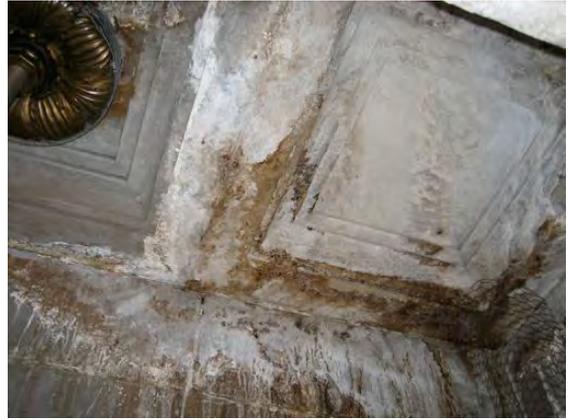
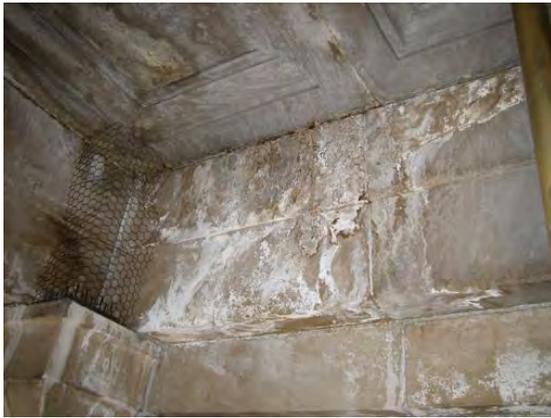
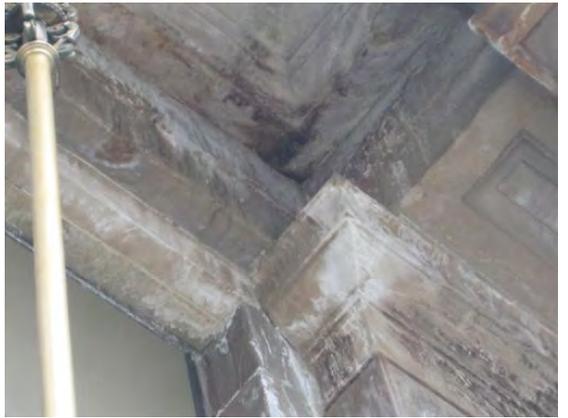
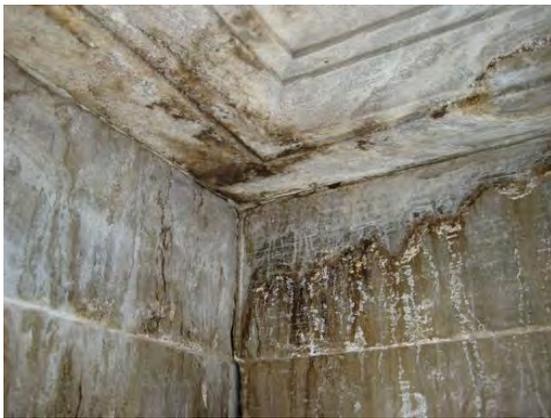
A further observation concerns both structural and water-infiltration issues. Namely, profuse signs of long-term infiltration are apparent at the portico ceiling, and such infiltration can be traced fully down within the stone wall cladding. These signs include efflorescence, lime, and brownish as well as reddish staining. Tapping on the stone ceiling indicates that the moisture degradation may by now have caused internal, concealed delamination within the stone. The reddish staining may be an indication that the minimal steel straps securing the four marble column tops to the building have been compromised by corrosion. Further, the large, projecting stone water table pieces had become moderately degraded, with surface erosion, some spalling, loss of mortar, lichens growth, and similar manifestations. No through-wall flashings were found anywhere in the portico roof structure, or anywhere else on the building. See Figures II-5.4(13-18).

Absence of any mechanical connections securing the stone ceiling panels, combined with apparent damage from long-term infiltration, poses additional hazards to pedestrians below.

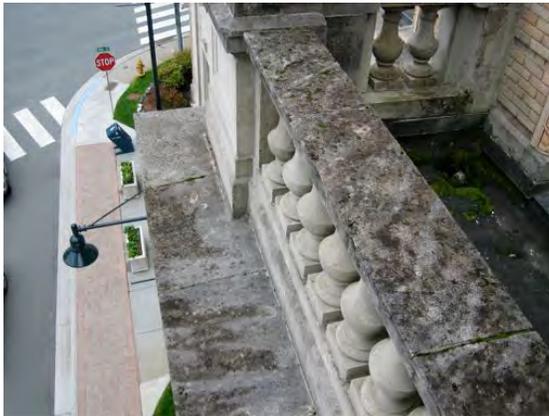
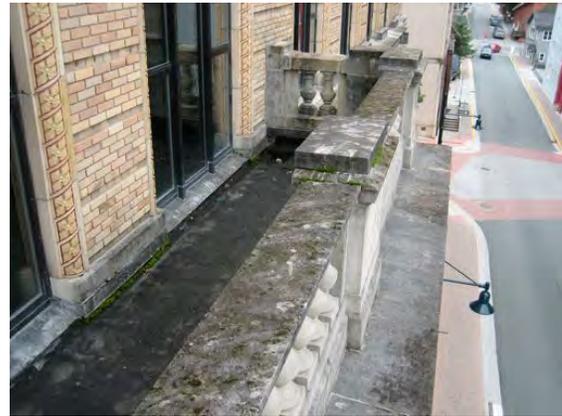
This leads suitably to a discussion of the railing's general condition, which has been partly compromised by both seismic damage and weathering. In terms of weathering, the railing displays appreciable degradation, including extensive surface erosion, spalling, and loss of mortar bond and integrity, which in turn exacerbates water infiltration into the masonry below. Figures II-5.5(1-6) illustrate the weathering damage.

With regard to design and materials, stone generally does not perform well if placed in weather-exposed locations with any skyward-facing surfaces. It absorbs water, which with subsequent freezing causes it to spall, exfoliate, and erode, and these symptoms are apparent on this railing. Flashing caps and through-wall flashings should have been incorporated to limit water intrusion and protect the stone from weathering.

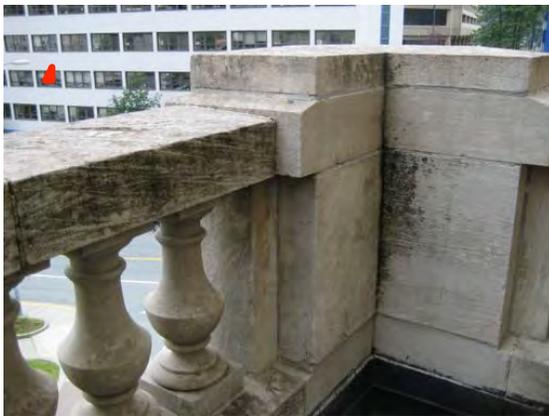
Fig. II-5.5(3): Railing Spalling

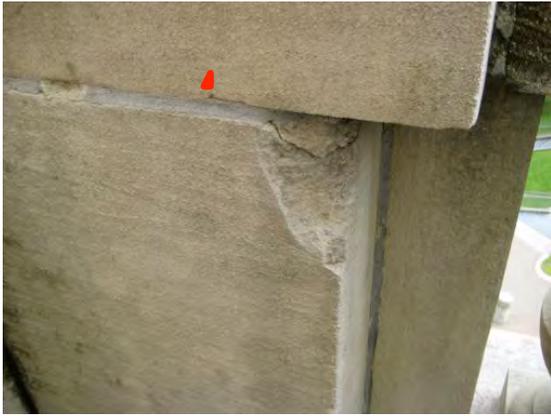
Fig. II-5.5(5): Railing Spalling

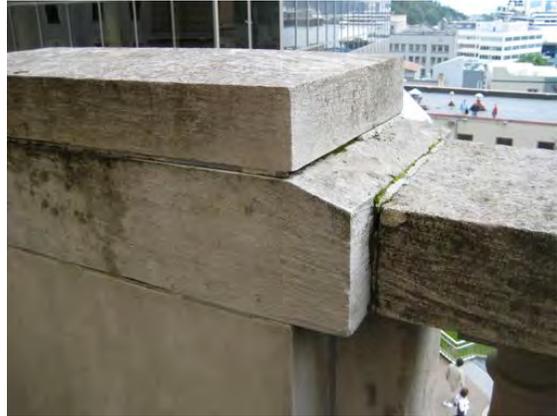
Fig. II-5.5(6): Loss of Mortar Bond

Cap can be moved freely.

The absence of mechanical connections between the railing's various pieces and abutting elements poses significant hazard in case of earthquake. This risk is greatly exacerbated by the significant loss of mortar bond observed at various locations, as well as by the seismic damage that already affects it.

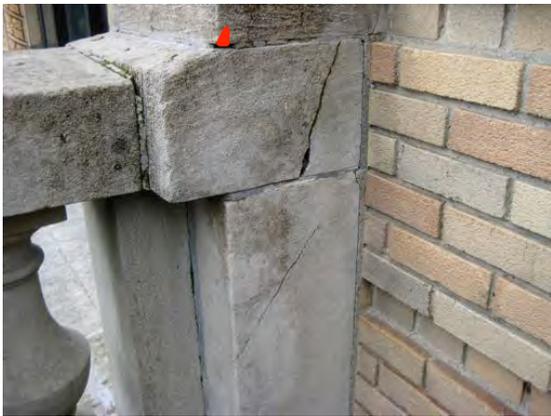
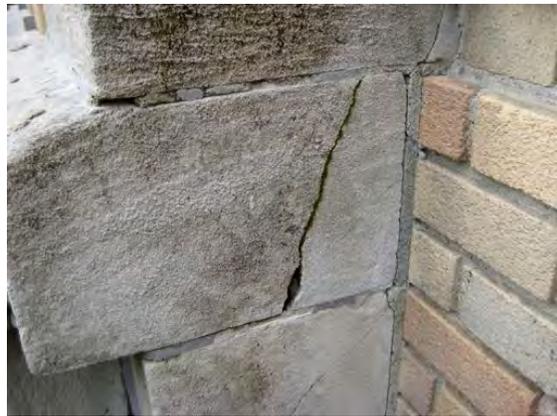
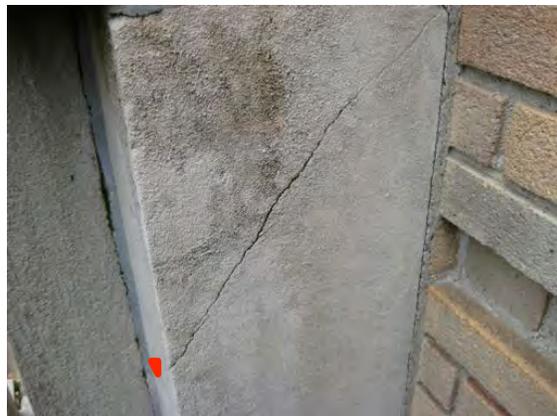
The railing also displays seismic stress, including cracking and dislocation, which is most evident at its juncture to the building face at the portico's NW corner. See Figures II-5.5(7-10).

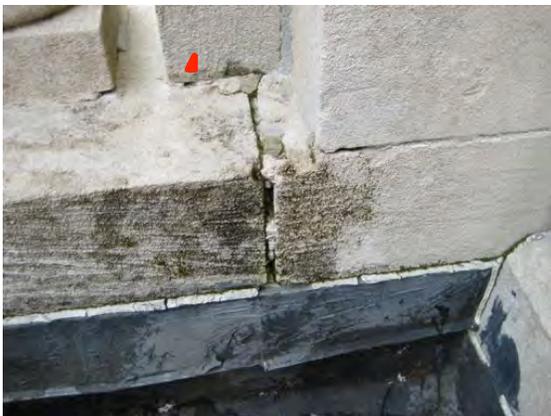
Fig. II-5.5(9): Seismic Dislocation

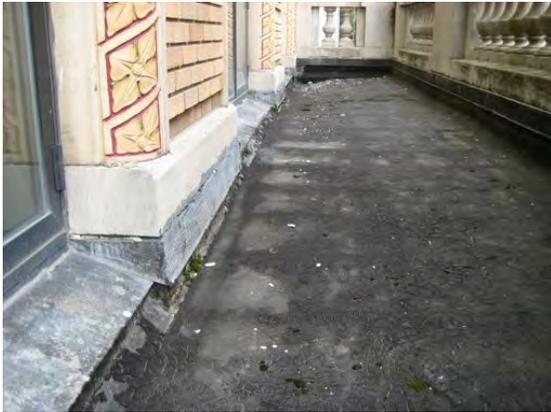
The drawings show this roof as consisting of copper. However, my examination revealed that it consists of an asphaltic built-up roof membrane. Along the edges, the built-up roof laps over copper, which I initially took as flashings. However, the drawings, combined with my field examination, imply that perhaps copper sheet roofing had been installed originally, but due to leakage, a built-up roof may have been installed over the copper in an unsuccessful effort to address the leakage.

Fig. II-5.6(1): Portico Roof Configuration

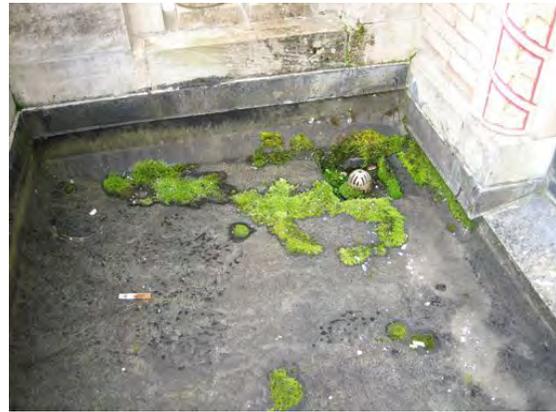
Fig. II-5.6(2): Roof Drain in Sump

The absence of overflow drains poses some risk of overloading and possibly increased leak risk if either of the two primary drains clogs. In this case, the risk of overloading appears improbable.

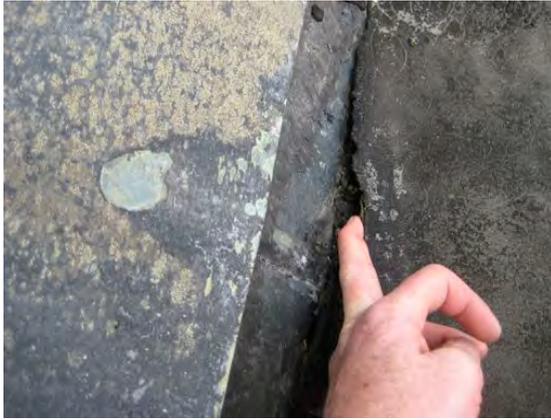
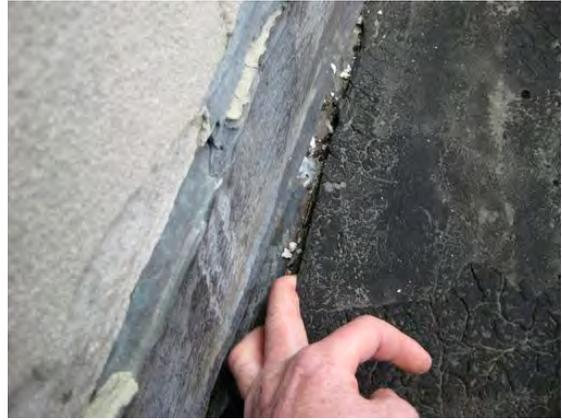
My field examination of the built-up roof revealed that it is quite degraded, and that it has largely delaminated from the copper at the interface to the building, allowing water to drain under the roof membrane. This may be a factor contributing to severe leakage apparent at the ceiling below.

With regard to the roof's condition, the built-up membrane is quite deteriorated, and its delamination from the underlying copper along the building juncture makes this roof ineffective.

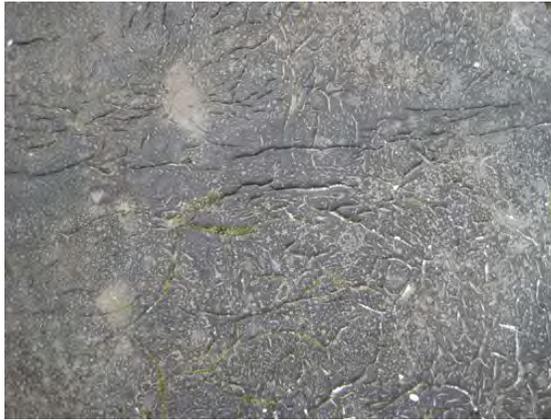
Fig. II-5.6(5): Roof Alligatoring

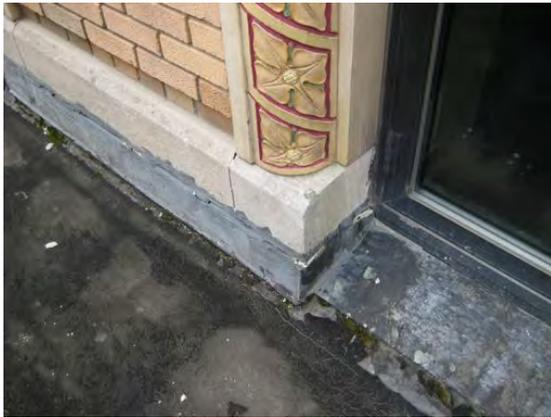
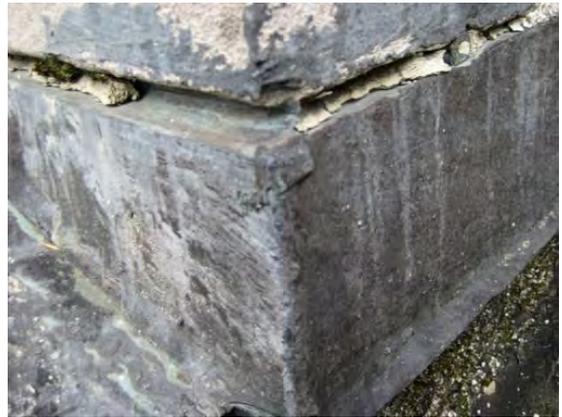
Three window sills occur very close to the roof surface. Their sill flashings turn up along their edges and tuck under separate copper flashings inserted about an inch into the horizontal mortar joint below a stone band at the base of the masonry wall. These sill flashings penetrate under the aluminum windows, whose sills are sealed to these flashings, with no weep provisions. Figures II-5.6(1-8) illustrate these observations.

Several flaws also occur at the roof-window sill junctures. First, the close proximity of the roof surface to the sills is problematic, and increases leak risk, particularly during wet snow periods.

The fact that the copper sill flashings are sealed to the aluminum windows above them, combined with the absence of weep provisions in these windows, further exacerbates leak risk. Water inherently enters the aluminum window sills, and as these windows lack weeps and the copper flashings are sealed to the window extrusions, drainage is precluded from under the window sills, which probably contributes to the leakage.
