The Alaska State Capitol Building is a concrete-frame structure built in 1930. Its exterior skin consists of a multitude of masonry elements, extruded aluminum and steel sash windows, and EPDM and built-up asphaltic roofs. The building's exterior masonry elements include multi-wythe brick walls; terra-cotta claddings, water tables, and window surrounds; stone claddings, water tables, ceilings, and similar elements; marble columns and decorative panels; and granite cladding and paving at the entry. Small areas of stucco also occur near the building's upper reaches, in the back.

In 2012, PL:BECS was asked to assemble a team of specialized consultants who could perform a multidisciplinary evaluation of the entire structure, help determine recommended solutions, and provide very rough cost estimates for executing seemingly viable options. This report represents the culmination of this 3rd phase of this building's evaluation.

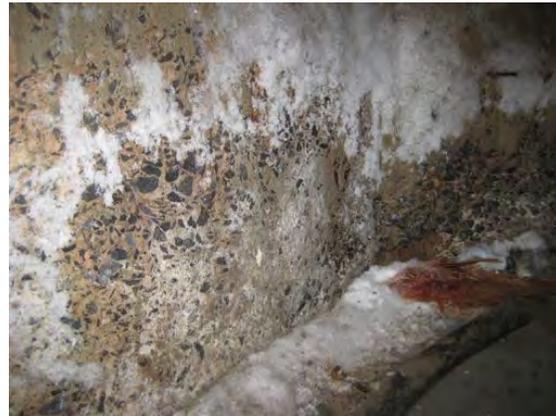
A cursory examination of accessible portions of the crawl space under the building revealed rather wet conditions, with a small but continuous stream running through this space. Consequently, the individual foundations displayed expected symptoms, including variable degrees of corrosive spalling and efflorescence, a powdery white crystalline substance that invariably indicates moisture passage through masonry materials.

Fig. II-2.2(4): Efflorescence

The concrete spalling and efflorescence reflect degradation caused by moisture intrusion into the concrete. Some of the moisture enters the concrete from the damp atmosphere resulting from the running water within the crawl space. However, the specific pattern of the efflorescence on the concrete columns reveals that water also enters from the soils directly below the footings.

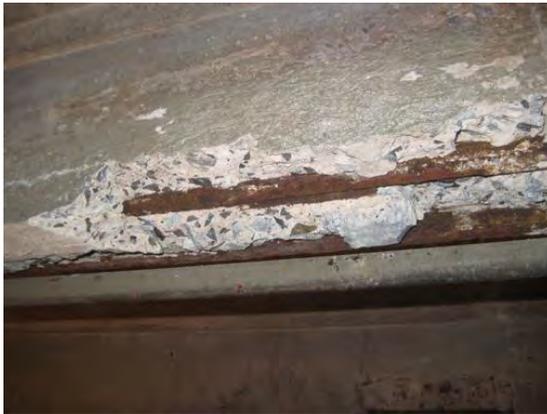
Examination of this floor framing from the crawl space revealed widespread and fairly serious corrosive spalling, which appeared to affect most of the integrally cast joists, particularly near their midspans. The bottoms of these joists had in most locations spalled off, exposing corroding reinforcing steel.

Fig. II-2.3(1): Spalling @ Joist Midspan

The concrete joist spalling reflects degradation caused by moisture intrusion. However, in contrast to the spalling affecting the foundations, the only moisture source reaching these joists consists of atmospheric humidity resulting from the wet crawl space.

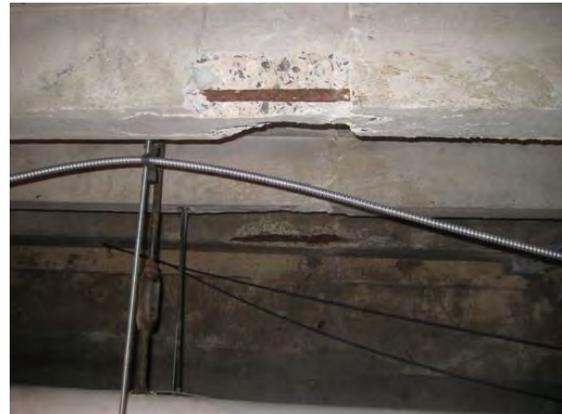
Fig. II-2.3(2): Spalling @ Jst. Bottoms

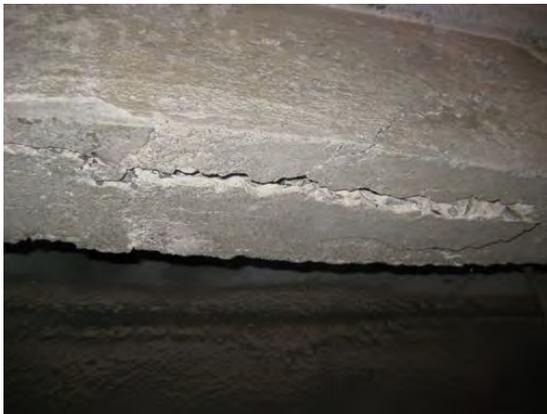
Fig. II-2.3(3): Spalling @ Joist Midspan

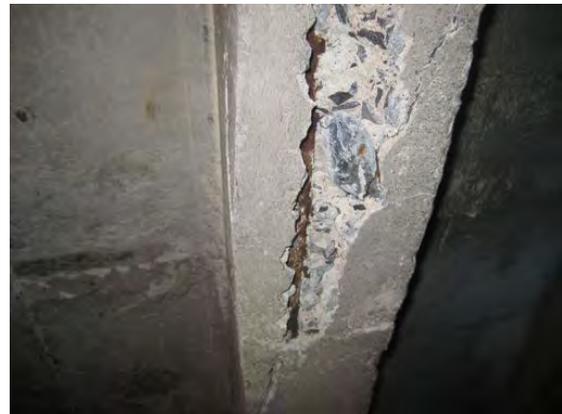
Fig. II-2.3(4): Spalling @ Jst. Bottom

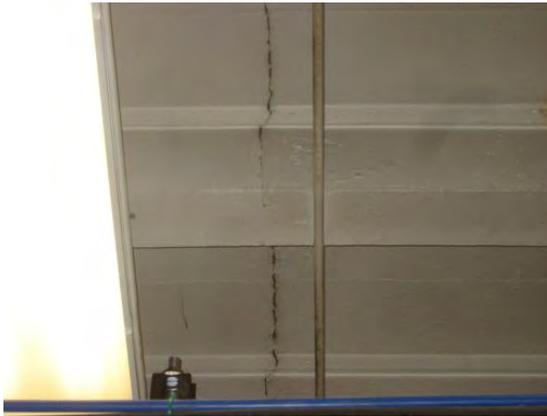
In addition, one continuous, completely straight crack was observed running a few feet south of the wall separating the boiler room from the shop. The crack parallels this wall, and runs across the entire width of the west wing.

Fig. II-2.4(1): Straight Crack in Floor Slab

The straight crack across the west wing most likely occurs along a pour joint, where curing shrinkage would be expected to create such a crack. However, this crack is wider than one would expect from shrinkage alone, and it appears probable that it has been exacerbated by subsequent seismic displacement.

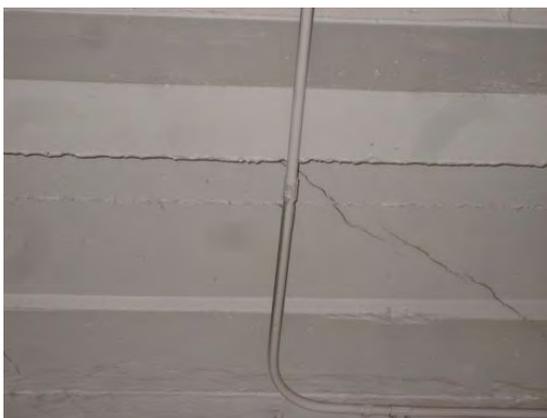
Where it was visible, significant cracking was observed very near the building's outer corners, where typically fairly wide, often closely spaced cracks were located.

Fig. II-2.4(3): Diagonal Crack in Floor Slab

The diagonal cracks near the outer building corners cannot reflect curing shrinkage restraint, as these cracks are also typically far too wide, and often occur in closely spaced pairs. Shrinkage cracks would not occur closely spaced, as the initial crack would relieve any tensile stress, thus precluding the second crack from occurring. Due to their size, locations, and spacing, these cracks appear seismically induced.

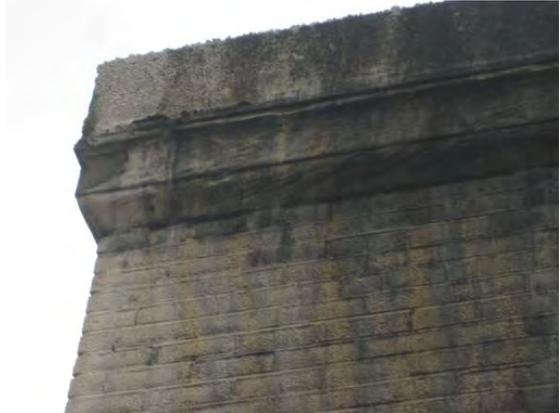
The chimney brick and stone caps are largely painted with an elastomeric coating, apparently to limit moisture intrusion into the brickwork, which is fairly degraded, with extensive erosion of outer brick faces and mortar, mortar cracking, etc. The coating is delaminating in various locations, indicating moisture intrusion behind it.

Fig. II-2.5(4): Coating & Brick Degr.

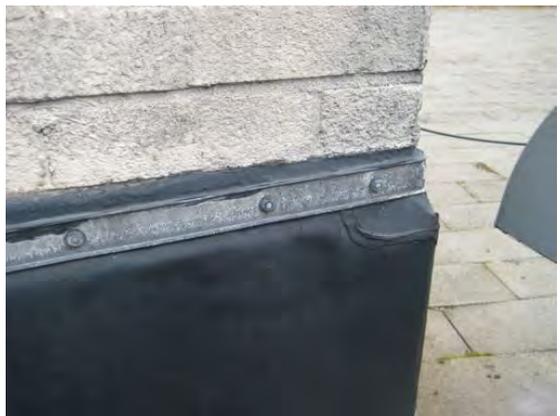
In addition, the chimney's junctures to the roof and parapets are not executed properly, in that the EPDM roof membrane and parapet flashings are sealed to the outer brick face, with no through-wall flashings to drain water out from behind the outer brick wythe.

Fig. II-2.5(6): Improper Roof Junct.

Along the chimney's base, its juncture to the roof membrane and parapets is improperly executed, as any water that permeates into and behind the outer brick drains downward into the roof assembly, posing a risk of interior leakage. The application of the elastomeric coating to the brickwork may in fact reflect an effort to limit interior moisture intrusion, although it may well exacerbate degradation by entrapping moisture. These junctures should have included continuous through-wall flashings above the roof membrane and flashing terminations to drain water harmlessly from behind the outer brick wythe and to preclude its drainage into construction elements below.

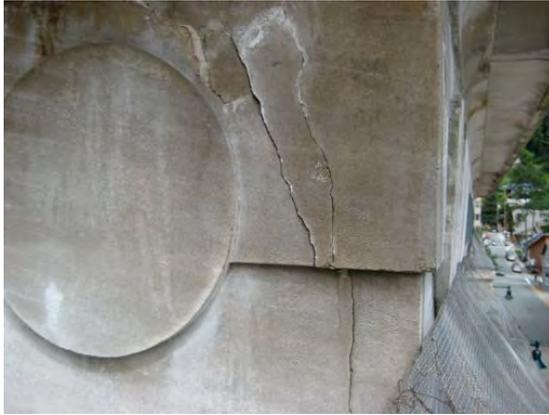
Some elements have a degree of mechanical securement, via steel dowels, straps, and similar methods, but such securement appears blatantly inadequate for holding these components in place under plausible seismic stresses. For example, the entire portico structure, which in totality weighs roughly 170 tons and consists of many individual stone elements, is secured to the primary structure with 7 or 8 small steel straps, each 2 ½” wide and ½” thick. These straps cannot resist lateral racking of the portico in the E-W direction, and the cracking pattern affecting the portico elements and the supporting stone cladding indicates that such racking had taken place. Further, though these straps, which are embedded within the portico ceiling, could not be examined, widespread staining on the portico ceiling indicates that these minimal straps have by now been largely compromised by corrosion. See Figures II-2.6(11-14).

Fig. II-2.6(13): Cracked Portico Beams

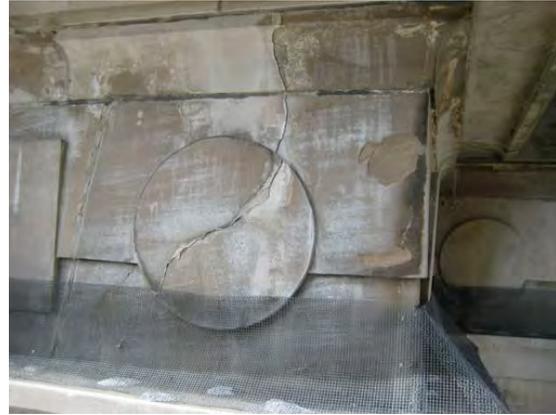
Fig. II-2.6(14): Cracked Portico Beams

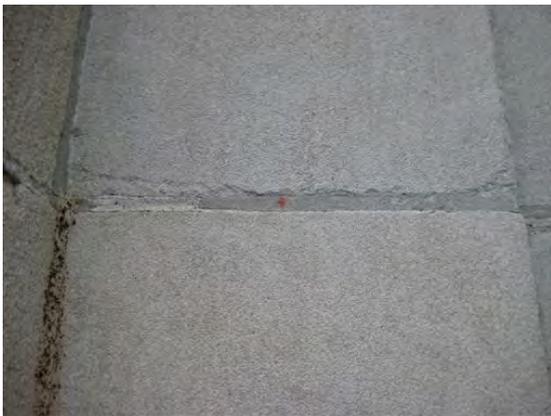
Similarly, the large stone cladding pieces along the bottom two levels of the south façade are secured with a single 3/8" \varnothing steel wire looped around the concrete columns and recessed into the stone about 2". In some cases, this yields a single point of marginal attachment for stones with a 13 SF face area, 20 CF volume, and over 3,000 lb. weight. The distribution of such anchors allows these stone pieces to rotate or buckle away from the building, and the cracking pattern in some of these elements under the portico indicates that such rotation had taken place, compromising these elements further. Also, though the drawings in a few locations call for "non-corroding" metal anchors, evidence of corroded anchors was observed in various locations. Figures II-2.6(15-18) illustrate these observations.

Fig. II-2.6(15): Minimal Anchor Location

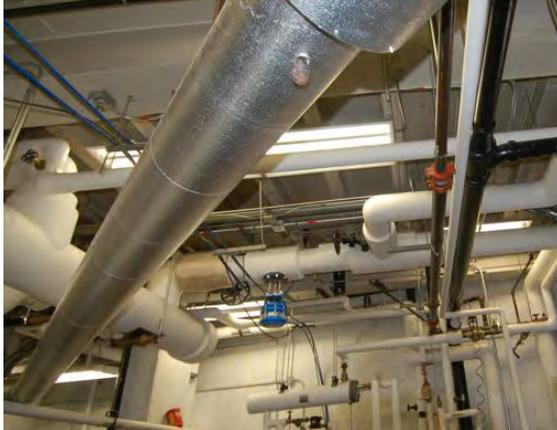
The building contains various large mechanical equipment units, such as the boiler, ductwork, piping, and similar elements that are not secured or braced in any fashion. Figures II-2.8(1 & 2) depict a couple of examples.

Fig. II-2.8(1): Un-Braced Piping & Ducts

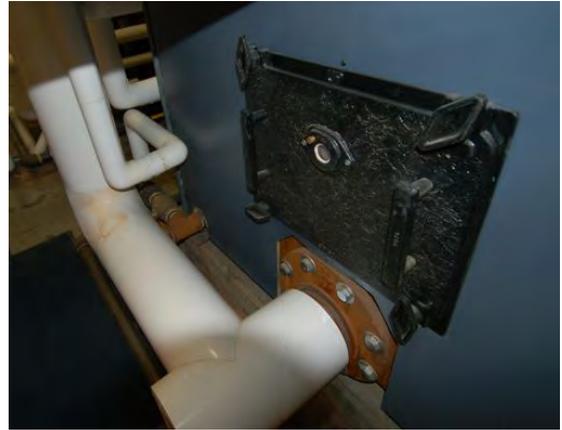
Fig. II-2.8(2): Un-Secured Boiler

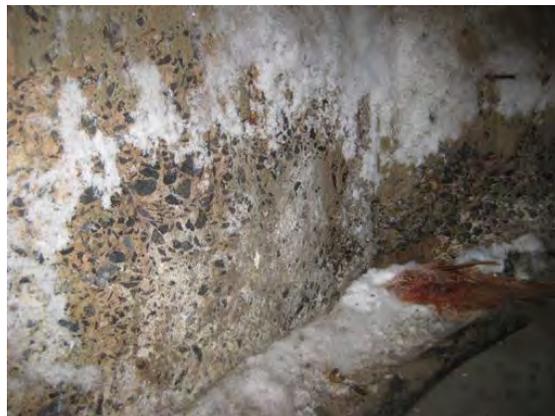
A crawl space of variable height occurs below the building's main body and southerly portions of both wings. Exposed sloping soil forms the crawl space floor, and the underside of the concrete-framed ground floor level comprises its ceiling. As also outlined in subsections II-2.2.1 and II-2.2.2, very wet conditions prevail, and even a small but continuous stream runs through this space. Perceived humidity was also palpably high. Consequently, many visible concrete elements, such as the foundations and ground floor level concrete floor joists, displayed corrosive spalling and efflorescence, both absolute indicators of water's passage through concrete or other masonry. Corrosive spalling appeared to be affecting most floor joists. See Figures II-3.1(1-8).

Fig. II-3.1(4): Fndtn. Efflorescence

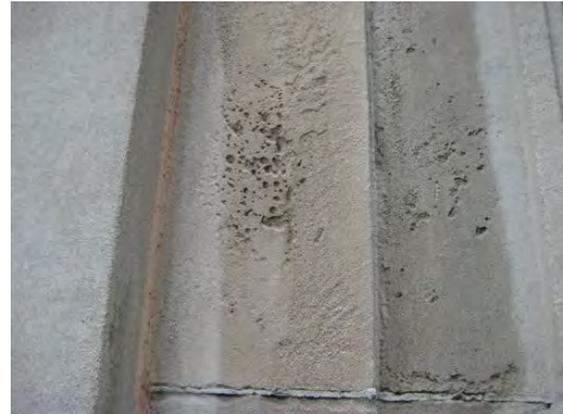
With regard to its general condition, this cladding displays scattered erosion, cracking, mortar delamination, and similar symptoms. See Figures II-3.5(1-6).

Fig. II-3.5(1): Stone Cladding Erosion

This leads to the second issue concerning the cladding's condition. The stone is moderately degraded, and displays scattered erosion, cracking, mortar delamination, etc. Though less visible, it also appears very likely that the metal anchorage has also been at least partly degraded by corrosion. The cracking of the stone sills appears to reflect seismic damage, and it further exacerbates moisture intrusion and anchor corrosion.

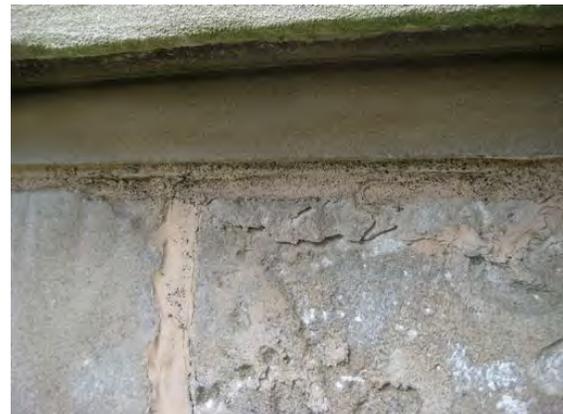
Fig. II-3.5(4): Stone Cladding Spalling

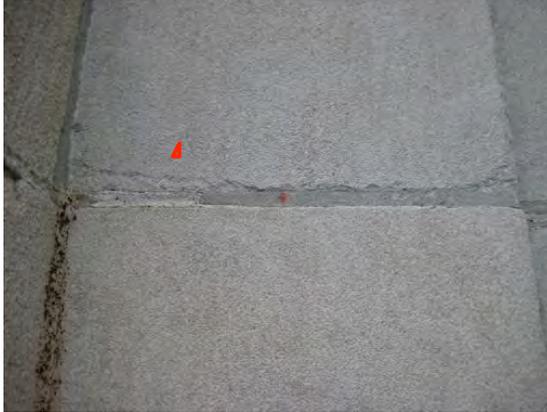
The stone cladding's securement to the structure is also addressed in a general fashion in subsection II-2.6. In brief, at least two observations can be made with regard to the stone cladding's securement. First, the drawings indicate that the securement is achieved with a single 3/8" \varnothing steel wire drilled 2" into each of the largest stones. In some cases, this yields a single point of marginal attachment for stones with a 13 SF face area, 20 CF volume, and over 3,000 lb. weight. Second, though the drawings in a few locations call for "non-corroding" metal anchors, evidence of corroded anchors was observed. See Figures II-3.5(11 & 12).

Fig. II-3.5(11): Location of Wire Anchor

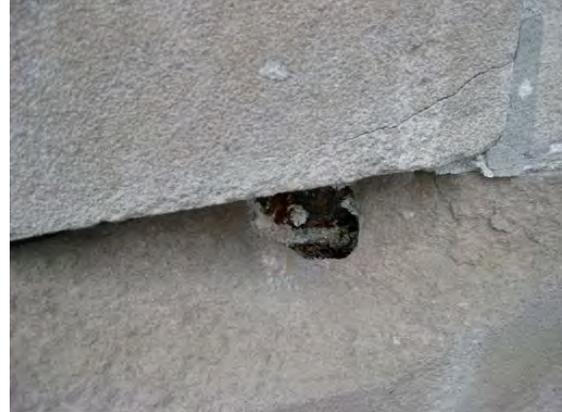
Fig. II-3.5(12): Corroded Wire Anchor

The anchorage of the stone cladding to the structure was insufficient to begin with, and this inadequacy has been further exacerbated by anchor corrosion. Many of the stone elements weigh several thousand pounds each, and anchorage failure would cause these, and the supported brick above, to fall off the building.

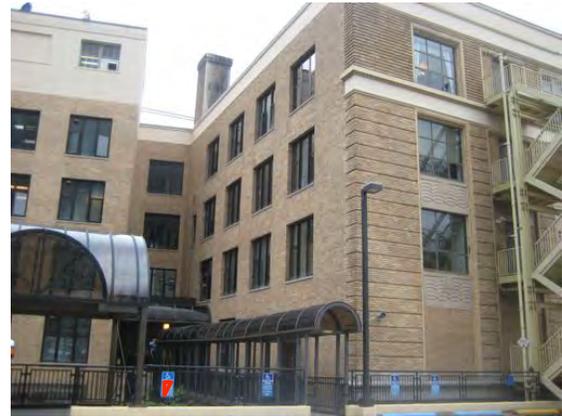
With regard to their construction, these walls are effectively identical to the other courtyard walls, differing primarily in being taller, protruding a floor level above the roof line, with this upper portion over-clad with directly adhered stucco. The east and west stairwell walls consist of triple-wythe brickwork, while the north wall consists almost entirely of concrete columns wrapped with a single brick wythe. The south wall, which occurs only above the roof, consists of double-wythe brick coated with stucco. The upper stucco band, as well as the entire height of the east-facing wall, is painted with an elastomeric coating. Figures II-3.9(1 & 2) illustrate these observations.

Fig. II-3.9(2): Stairwell's North Wall

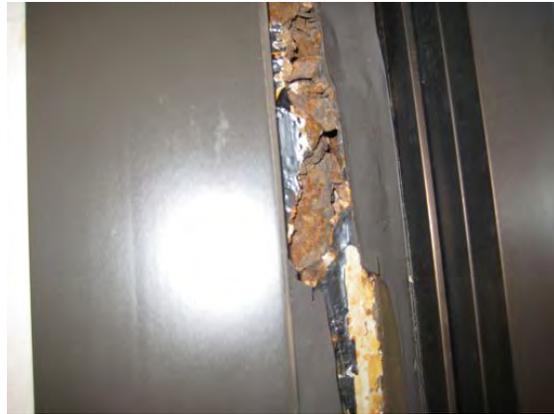
A few loose and deflected window frames revealed that the new aluminum windows had been installed over the original steel frames, which were corroding. See Figures II-3.12(5 & 6).

Fig. II-3.12(5): Corroding Steel Frame

Fig. II-3.12(6): Corroding St. Frame

The severely corroded steel frames behind the aluminum extrusions appear to reflect electrolytic corrosion, wherein fastening of the aluminum and steel elements together greatly accelerated corrosion. Water intrusion and condensation within the frames may have exacerbated this effect.

To the extent that any of the original steel frames still retain any integrity, continued corrosion will destroy these, and if the aluminum windows are secured to these frames, as appears probable to some degree, such securement will also become compromised.

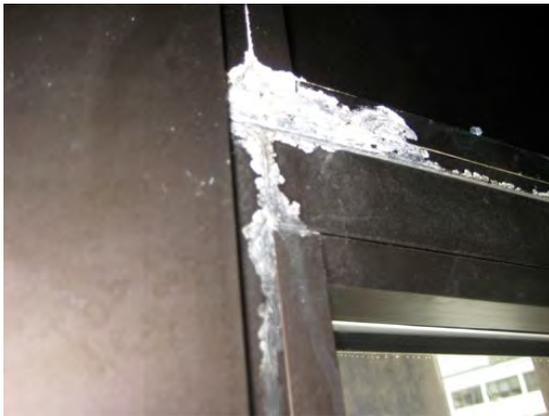
Fig. II-3.12(22): White Dep. At Frame Jts.

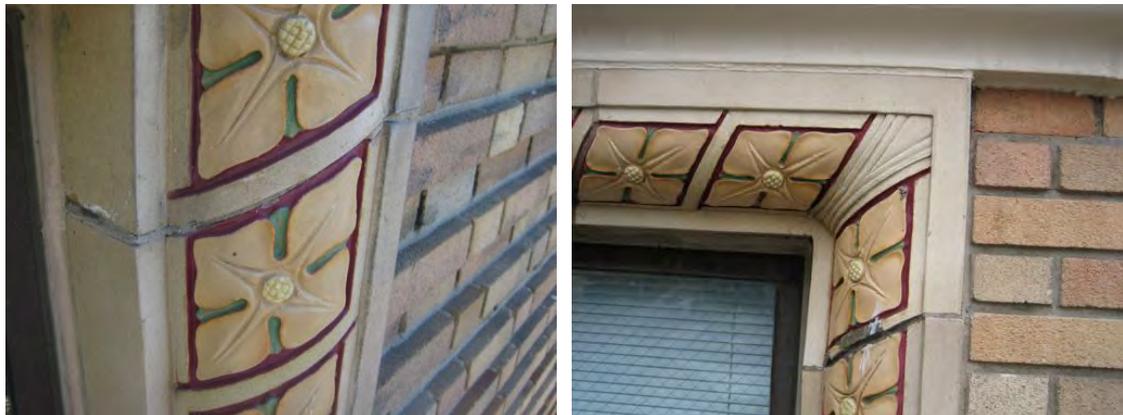
The condition of these terra-cotta elements varies greatly around the building. In many locations, these elements appear to still be in generally good condition, with no visible weathering symptoms, other than some color fading. See Figures II-4.2(1 & 2).

Fig. II-4.2(1): Terra-Cotta in Good Condition Fig. II-4.2(2): T.-C. in Good Condition

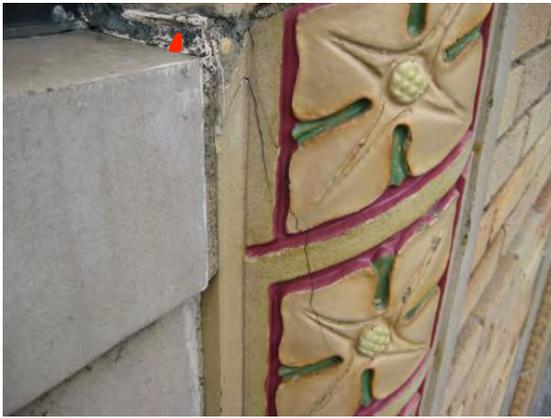
Fig. II-4.2(7): Terra-Cotta Cracking

Proceeding up the damage scale, a still fairly limited number of pieces have begun to show cracking and spalling of their outer faces, ranging from minor short cracks to complete face spalling. Figures II-4.2(6-12) illustrate the range of this type of damage.

A primary design flaw affecting these terra-cotta surrounds concerns the non-draining brickwork above the heads. As a consequence of the absence of drainage provisions above these heads, water within the brickwork drains directly into the terra-cotta heads, which then direct this water down the terra-cotta jamb surrounds. When the water freezes and expands, it rips the terra-cotta pieces, causing the observed cracking and spalling.

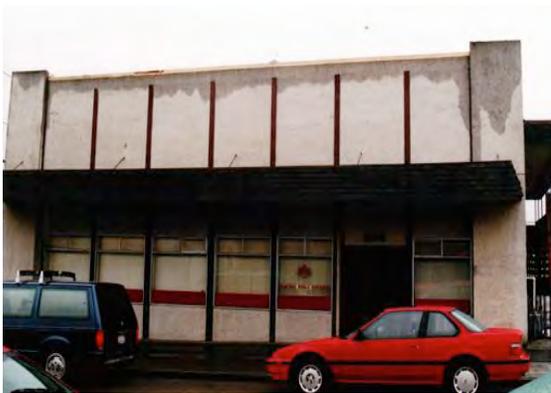
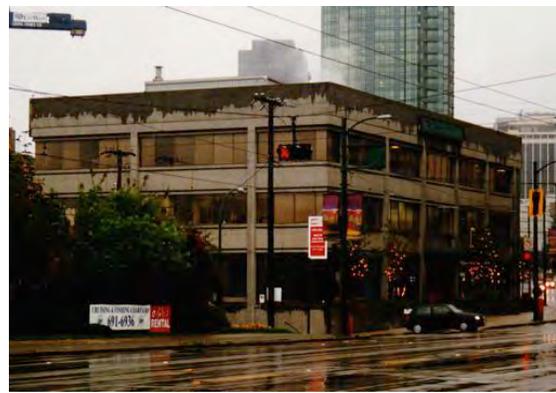
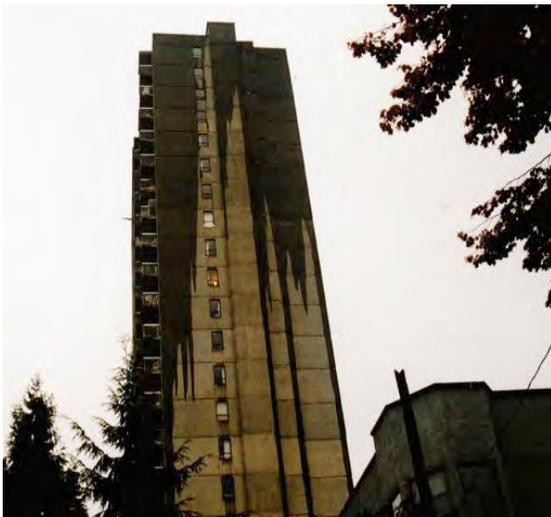
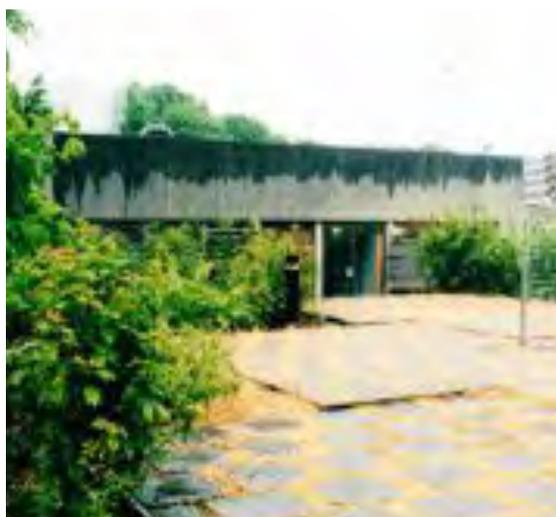
Fig. II-4.5(13): Wetting Pattern on Lee Side

Fig. II-4.5(14): 3rd Rain Day Wetting

Fig. II-4.5(15): 3rd Rain Day Wetting Pattern

Fig. II-4.5(16): 3rd Rain Day Wetting

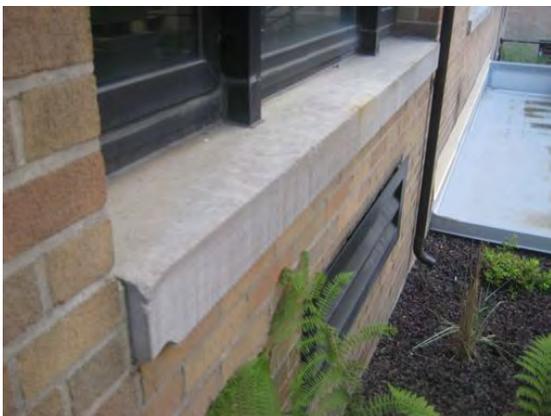
Fig. II-4.6(3): Minor Chipping & Erosion

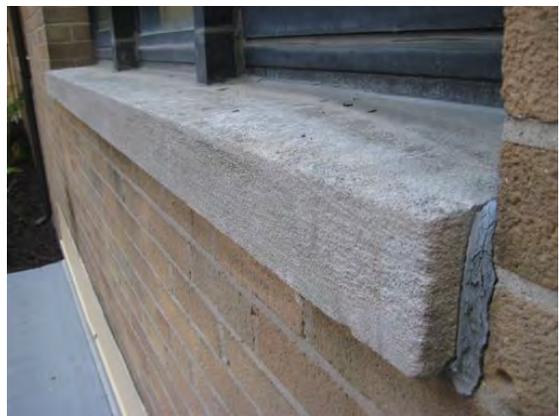
Fig. II-4.6(4): Minor Surface Erosion

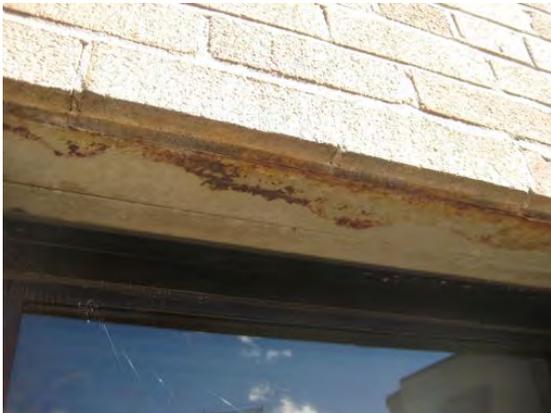
Fig. II-4.7(3): Moderate Lintel Corrosion

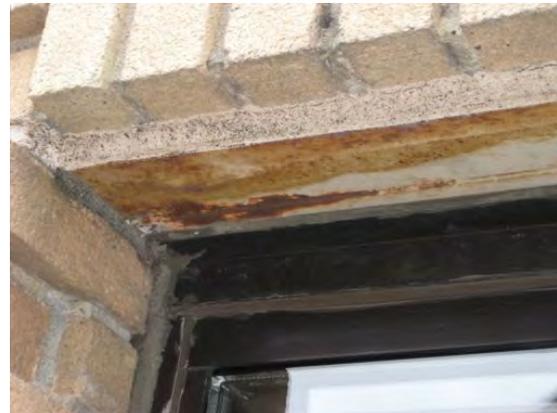
Fig. II-4.7(4): Sealed Gap Abv. Lintel

The sealing of the lintels to the brick above is counter-productive, as it entraps moisture atop these lintels, accelerating corrosion and exacerbating leak risk.

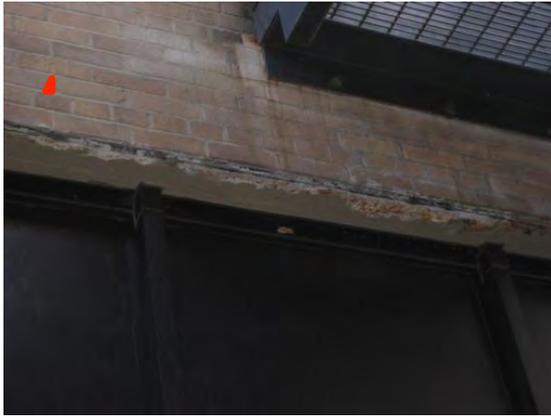
Fig. II-4.7(7): Moderate Lintel Corrosion

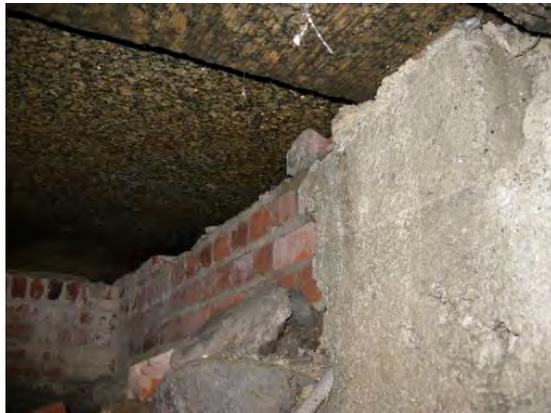
Fig. II-5.1(1): Portico Sub-Structure

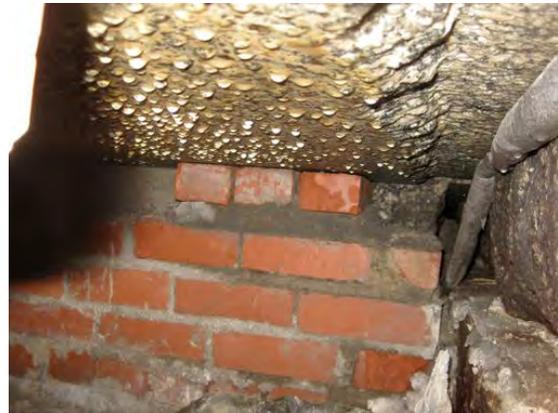
Fig. II-5.1(2): Condens. @ Granite

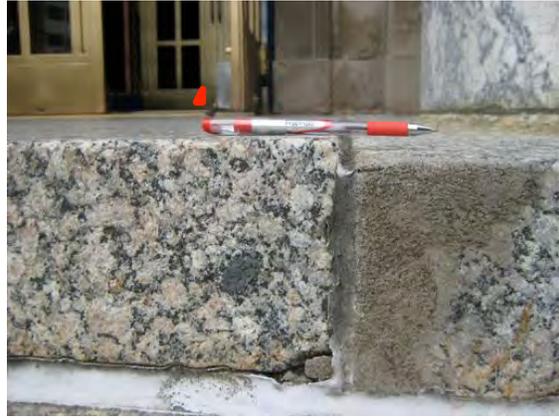
Fig. II-5.1(4): Paving Deflection

These seismically induced stresses may also have deflected the supporting walls under the portico and caused these to settle down differentially, causing the uneven paving and stairs.

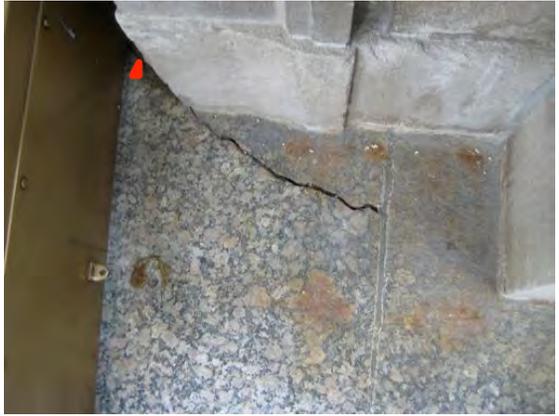
Fig. II-5.1(6): Paving Crack

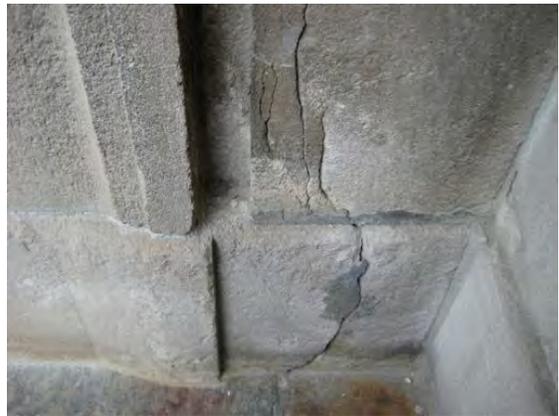
Fig. II-5.1(8): Cracked Support Stone

With regard to the genesis of the observed deflections and cracking, a variety of causes could possibly have contributed to some of these symptoms. However, these symptoms, especially when considered together with relatively widespread manifestations of similar stresses and deflections affecting other portions of the building, are most consistent with seismically induced deflections dating back to some past earthquake(s). To be more specific, the symptoms imply that the columns had swayed in the E-W direction parallel to the building face. This caused the serious cracking of the stone beams supported by these columns. These beams moved E-W with the column tops, but rotated at the building face, which remained mostly in place. The stone cladding supporting these beam ends also rotated with these beams, as its minimal wire anchors allow free rotation of this cladding. This rotation caused the closely spaced cracking of the stone support cladding's bottom pieces, as well as the large, though short crack in the nearby granite paving. This same mechanism caused the cracking observed in the supporting pilaster capitals and adjacent stone window head.

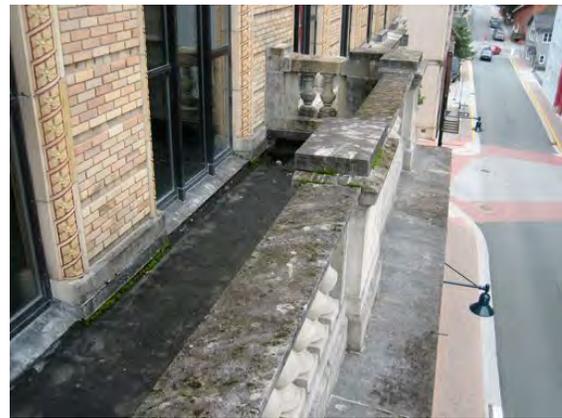
This leads suitably to a discussion of the railing's general condition, which has been partly compromised by both seismic damage and weathering. In terms of weathering, the railing displays appreciable degradation, including extensive surface erosion, spalling, and loss of mortar bond and integrity, which in turn exacerbates water infiltration into the masonry below. Figures II-5.5(1-6) illustrate the weathering damage.

Fig. II-5.5(2): Railing Weathering

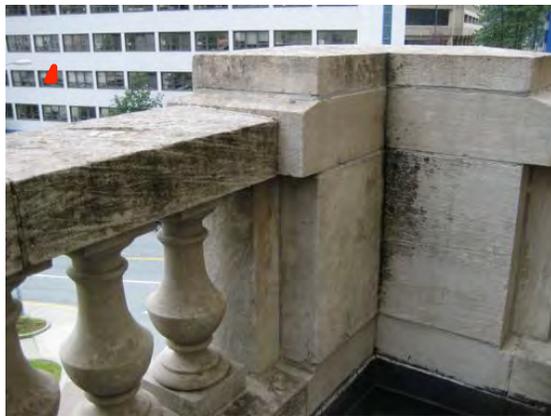
Fig. II-5.5(3): Railing Spalling
